Queen City Substation

Vandalism and Theft

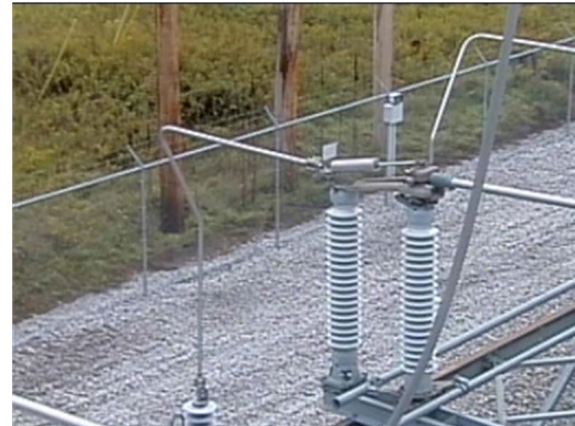
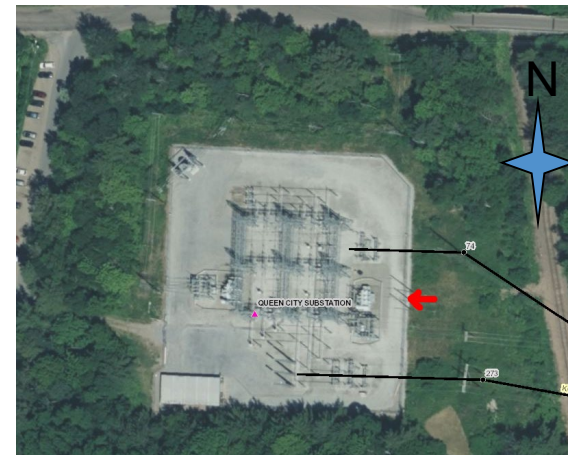
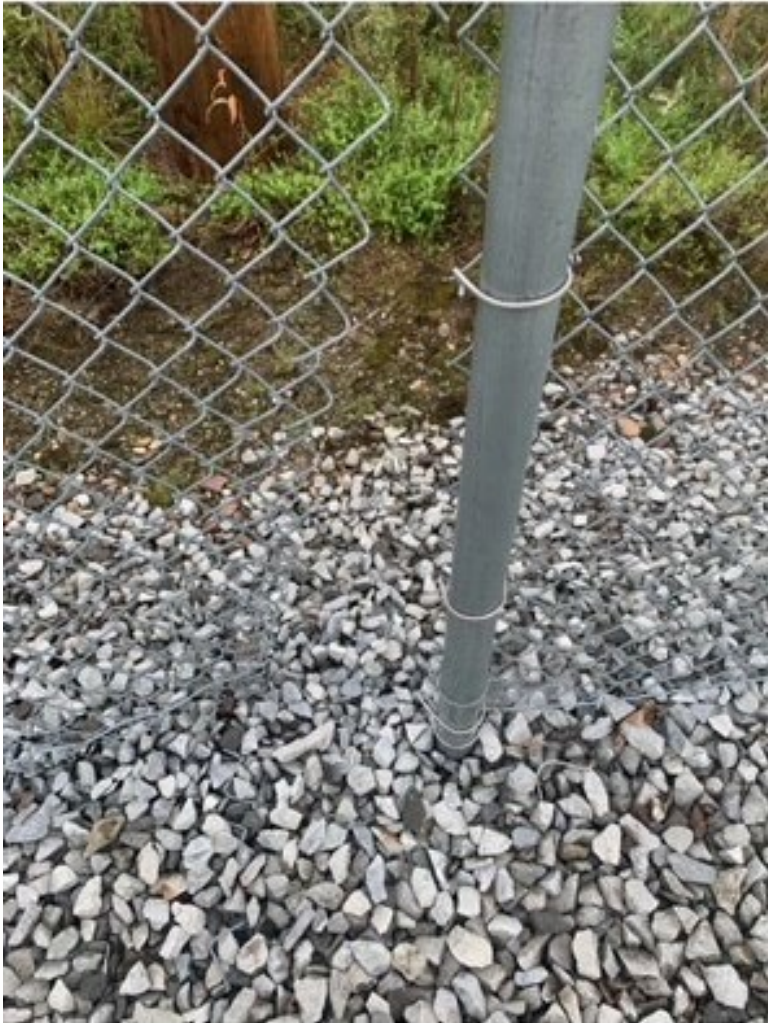
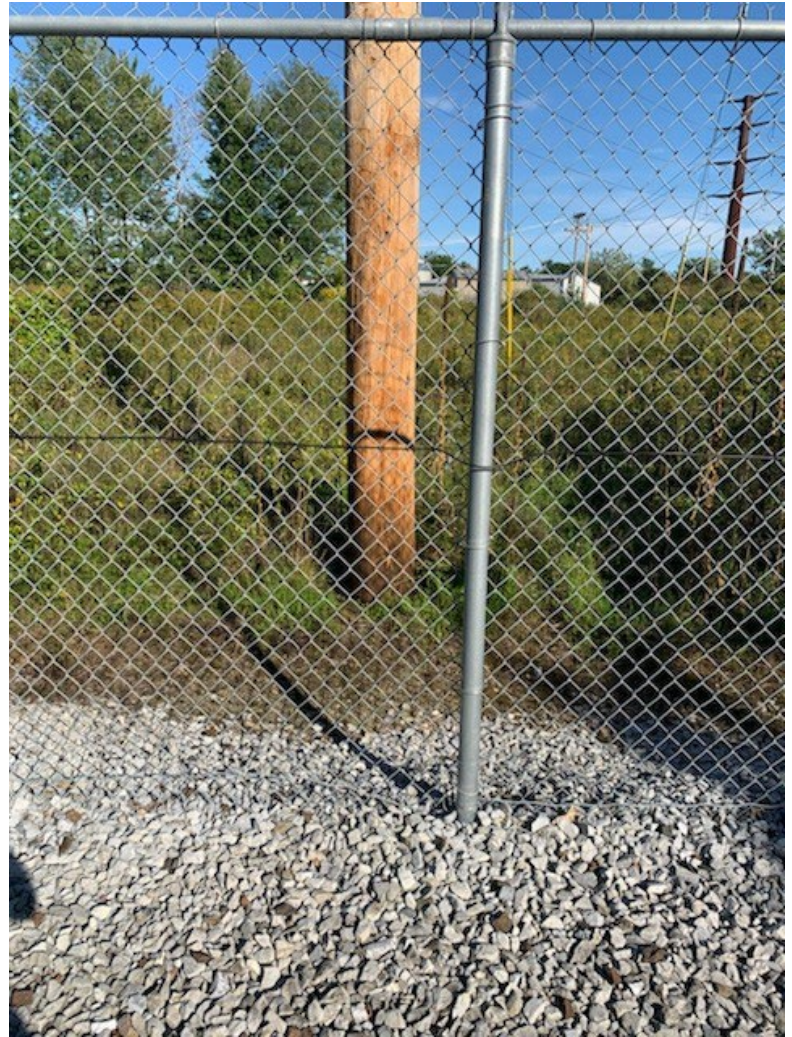
- On 9/21/22, a cut was observed in the east side of the substation fence, approximately 2-3 feet from the ground up.
- Fence detection cable was not cut.
- No alarms were received in this area of the fence for more than one month.
- Security observed/reported no unusual activity or suspicious activity just prior to this discovery.
- Security systems were working properly.
- No obvious theft or additional damage was noted at this time.

- Alarm history reviewed.
- Several alarms noted on 8/13/22 beginning at 0304 hours approximately.
- Alarms were acknowledged and area evaluated by on duty Security Officer who noted the site was secure and the reason for the alarm was unknown.
- No video was available due to “first in, first out” recording and duration of time that passed
- No evidence to support subject(s) entered the yard.
- No report to law enforcement at this time.

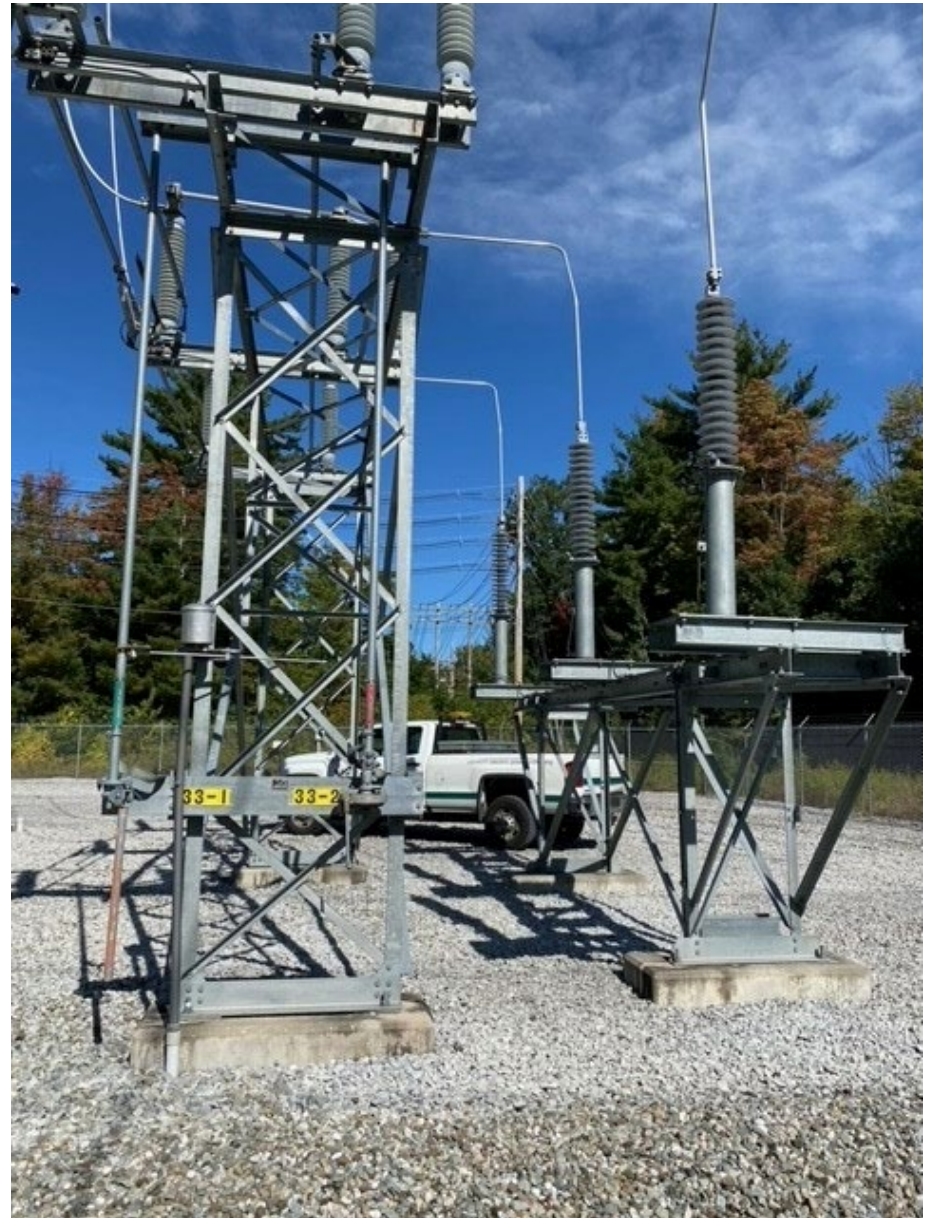
- During the 10/3/22 substation inspection, approximately 20 feet of copper grounds were observed cut/missing from the LA stand and the 33-1 and 33-2 switching structure.
- No additional vandalism/entry points were located in the fence.
- (Assumption that:) The theft occurred at approximately the same time as the fence alarms on 8/13/22.
- Damage repaired
- Notifications made;
 - Law enforcement
 - VT Department of Public Service
 - ISO-NE
 - GMP and BED
