Client/Project
VELCO
New Haven Operations Facility

Title
Natural Resources Map

INDIANA BAT HABITAT ASSESSMENT DATASHEET

LANDSCAPE MITIGATION PLAN

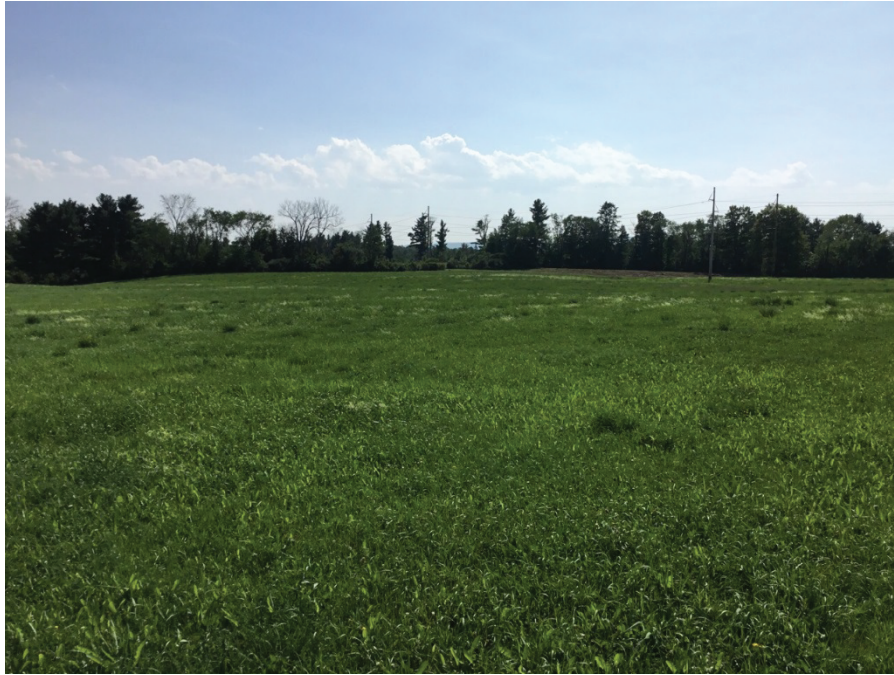
Photo 1. Representative mowed field, looking south from Vermont Rt. 17, VELCO New Haven Operation Facility, August 9, 2018, Stantec.

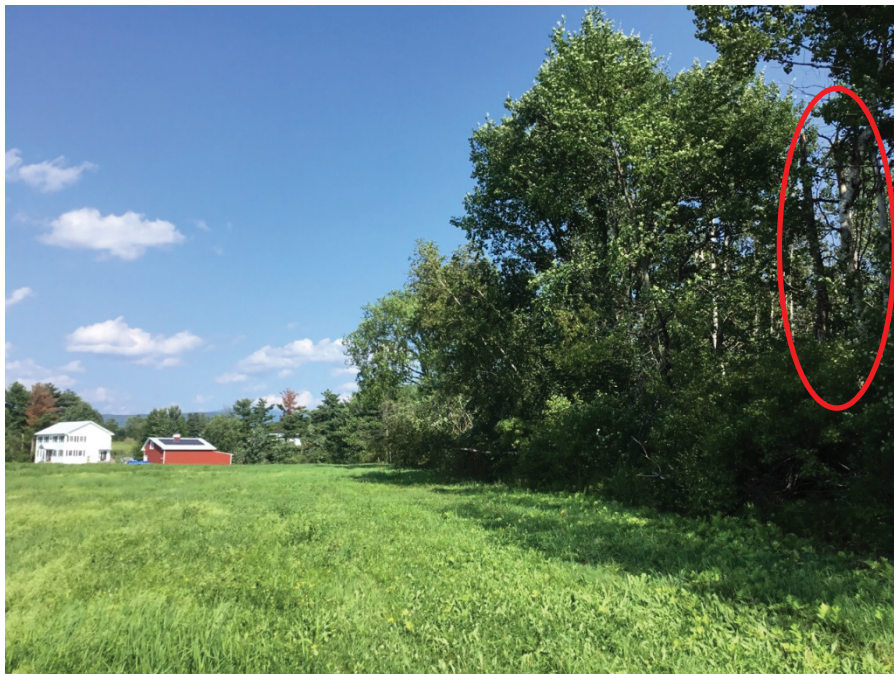
Photo 2. Typical tree hedge row looking east towards the Study Area edge, VELCO New Haven Operation Facility, August 9, 2018, Stantec. Note potential suitable snag outline in red.

Forest Resources at Sample Site				
Closure/Density	Canopy (> 50') 0	Midstory (20-50') 2	Understory (<20') 5	1=1-10%, 2=11-20%, 3=21-40%, 4=41-60%, 5=61-80%, 6=81-100%
Dominant Species of Mature Trees	Red maple, sugar maple, eastern white pine, poplar species (Populus sp.)			
% Trees w/ Exfoliating Bark	0%			
Size Composition of Live Trees (%)	Small (3-8 in) 75	Med (9-15 in) 25	Large (>15 in) 0	
No. of Suitable Snags	1

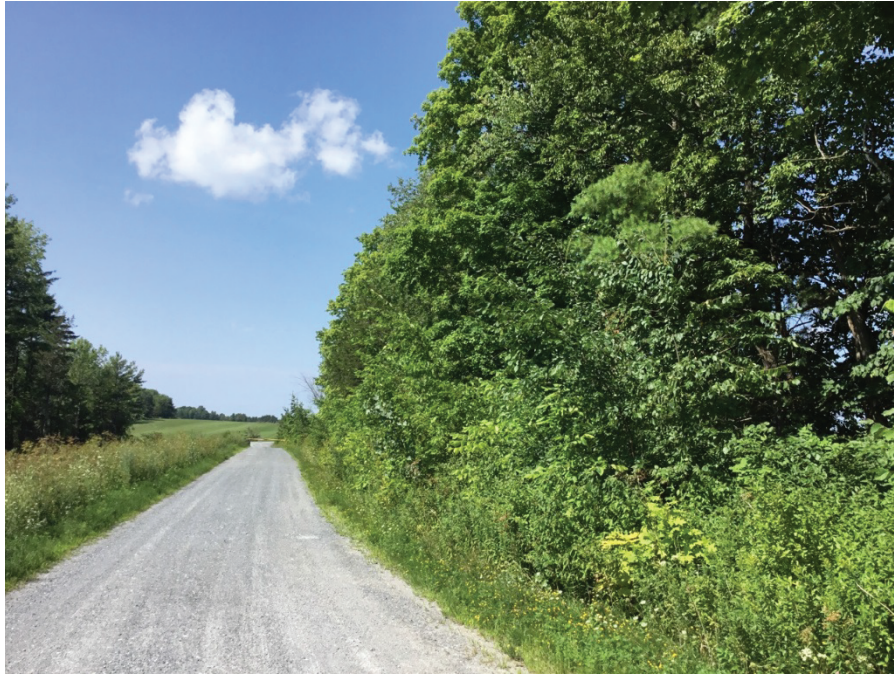
Photo 3. Access road to Study Area and adjacent substation from Rt. 17, VELCO New Haven Operation Facility, August 9, 2018, Stantec.

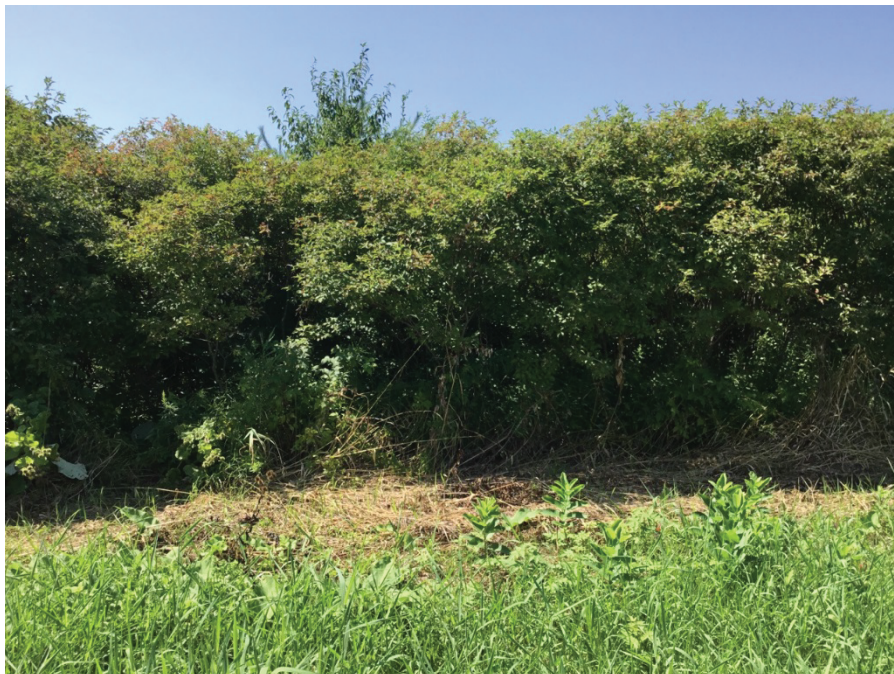
Photo 4. Scrub hedge separating existing laydown yard from mowed field, looking west, VELCO New Haven Operation Facility, August 9, 2018, Stantec.

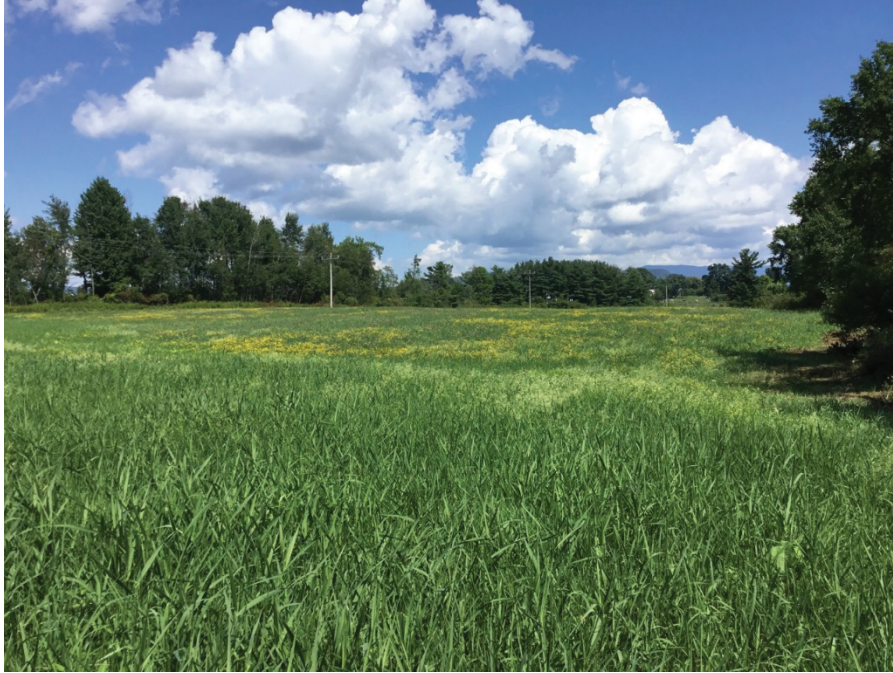
Photo 5. Mowed field looking northeast, photo taken adjacent to wet meadow NH-203, VELCO New Haven Operation Facility, August 9, 2018, Stantec.

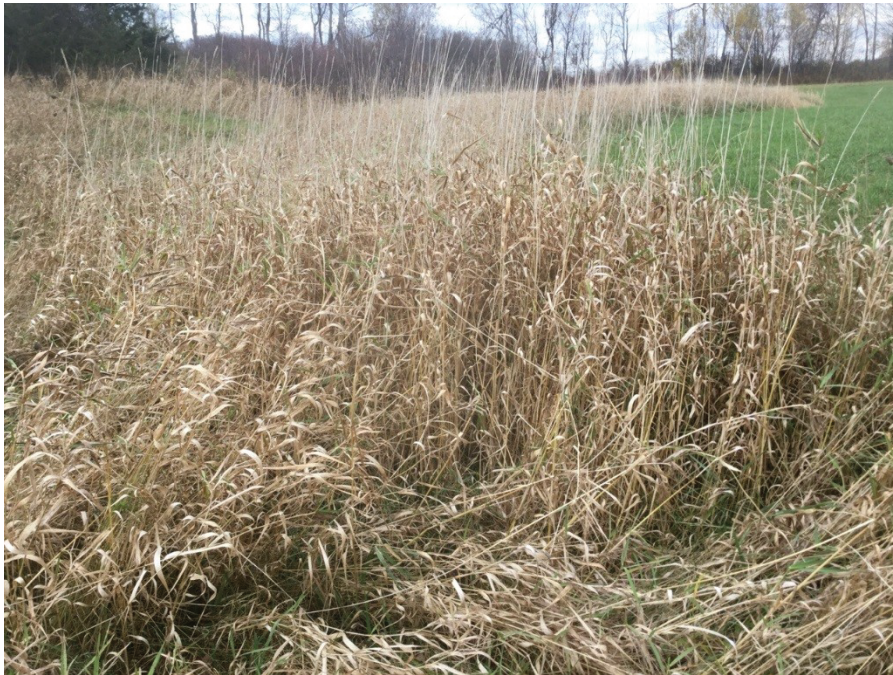
Photo 6. Wetland NH-203, VELCO New Haven Operation Facility, November 1, 2017, Stantec.

Water Resources at Sample Site				Describe existing condition of water sources: Wet meadow between hedgerow with seasonal high water table - no surface water observed
Stream Type (# and length)	Ephemeral 1-71 ft	Intermittent 1	Perennial 0	
Pools/Ponds (# and size)	0 Open and accessible to bats? NA			
Wetlands (approx. ac.)	Permanent	Seasonal		
		0.5

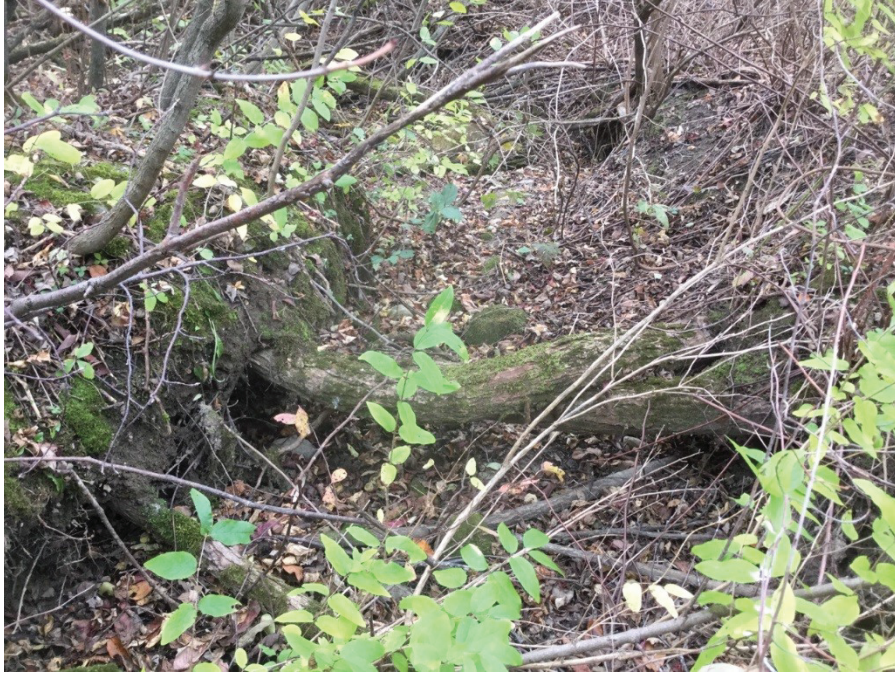
Photo 7. Ephemeral stream NH-204, VELCO New Haven Operation Facility, November 1, 2017, Stantec.

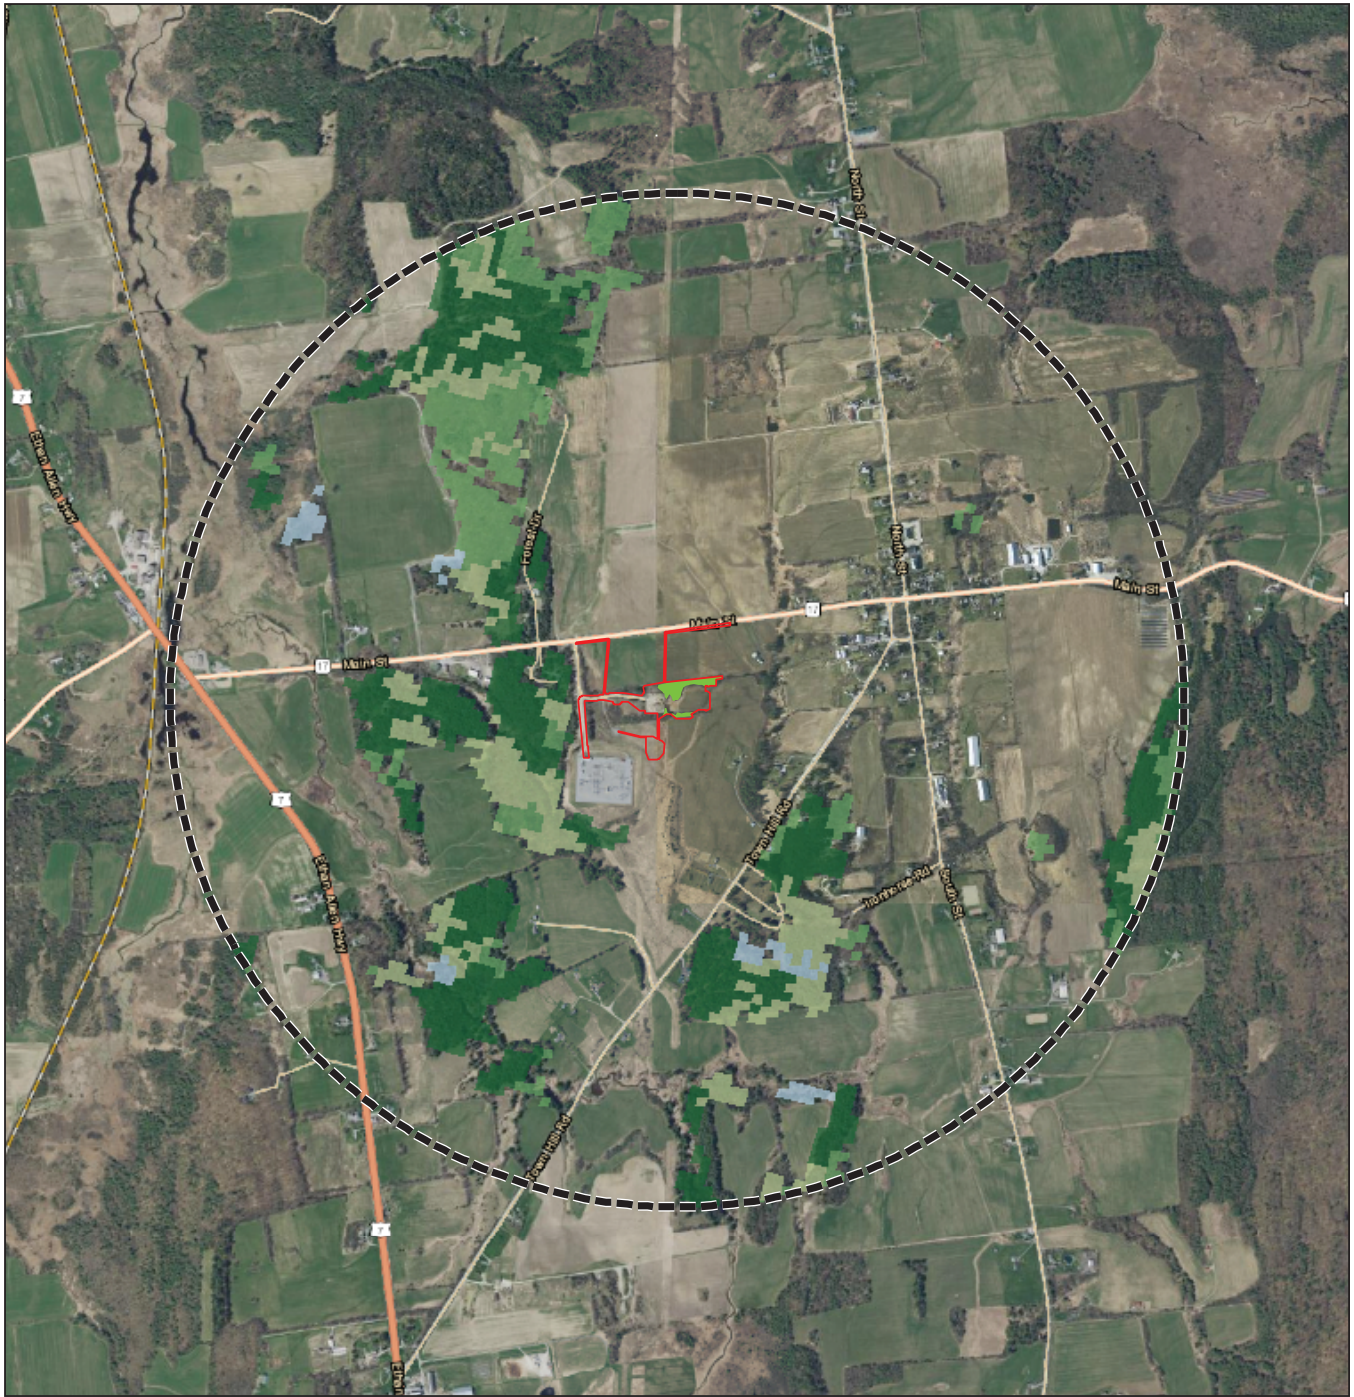
Figure No.

Title
Location Map
