**TECHNICAL MEMORANDUM, TRC 2021 SURVEY RESULTS
FLORENCE SUBSTATION CONDITION ASSESSMENT PROJECT
PITTSFORD, VERMONT**

SURVEY DATE:	September 28, 2021
LOCATION:	8042 Whipple Hollow Road, Pittsford, Vermont
PROJECT:	Florence Substation Condition Assessment Project
SUBJECT:	TRC 2021 Field Survey Results
PARTICIPANTS:	Duane Choquette – TRC Survey Lead Scientist Art Gilman – Gilman & Briggs Environmental Scientist

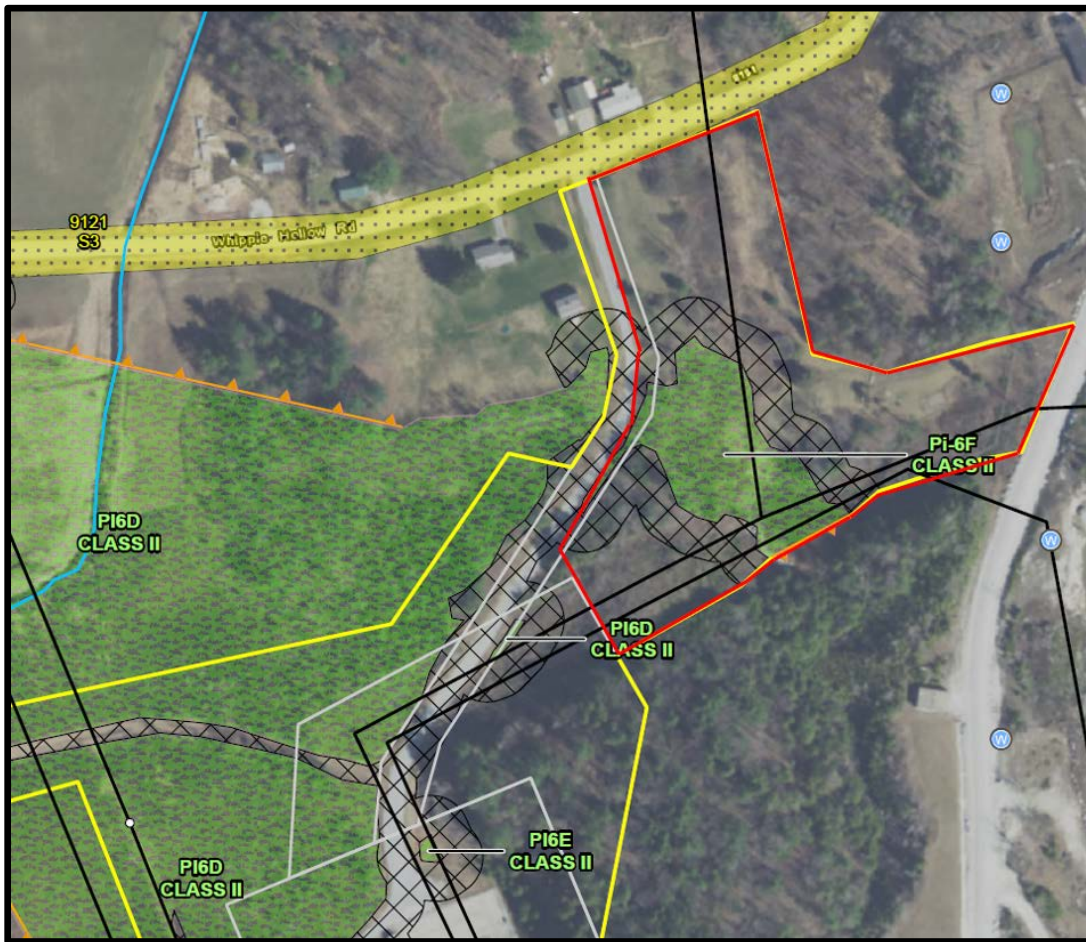
Inset 1: The expanded assessment area identified in this memo is outlined in red. The overall assessment area for the entire Project can be seen in the updated figures in Attachment 1.

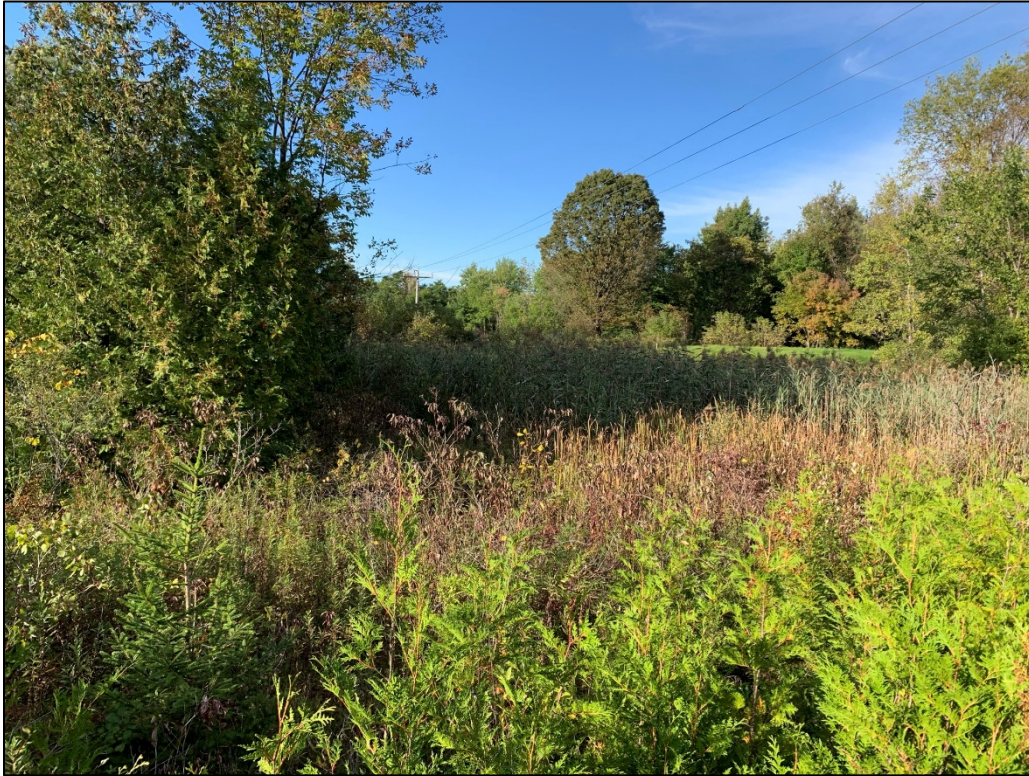
Photo 1. Facing North, looking across wetland Pi-6F and down the GMP corridor.

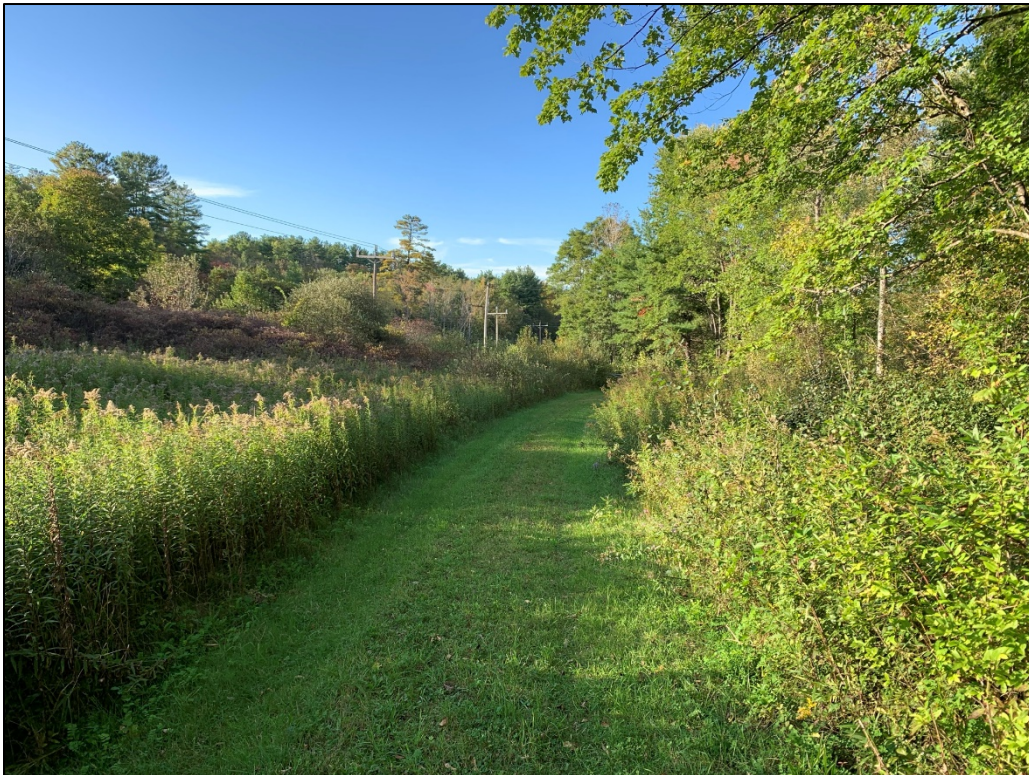
Photo 2. Facing North along GMP's transmission corridor to Whipple Hollow Road.

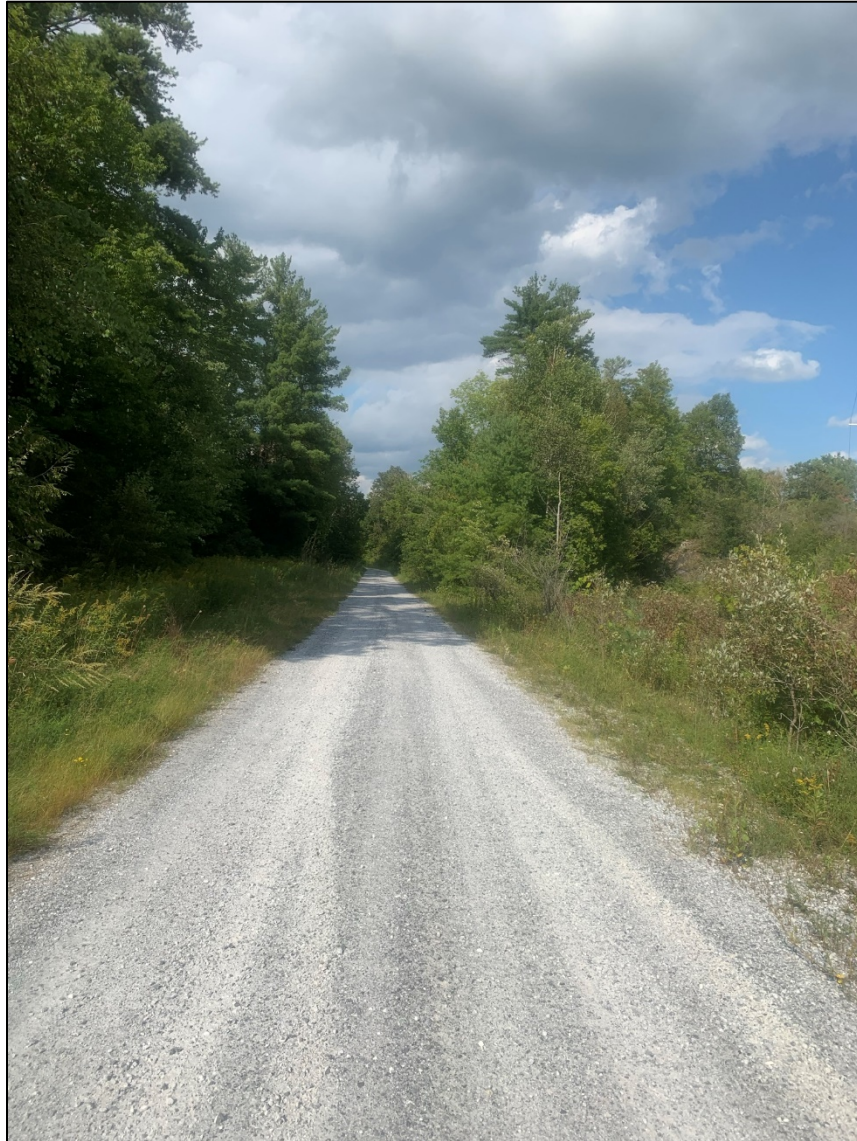
Photo 3. Facing Northeast along the existing VT TRANSCO access road. New assessment area is located along the northeastern side of the road (right side of the photo).

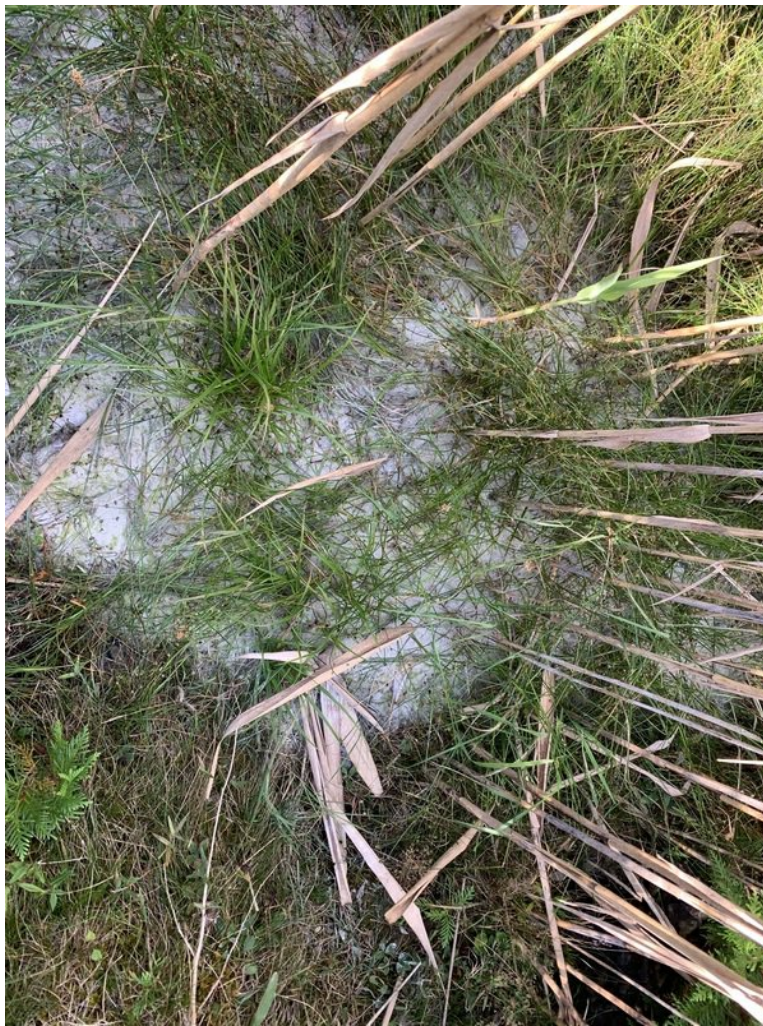
Hydrology Photos

Field Observations:	
Surface Water Present? Yes <input type="checkbox"/> No <input checked="" type="checkbox"/>	Depth (inches): _____
Water Table Present? Yes <input checked="" type="checkbox"/> No <input type="checkbox"/>	Depth (inches): <u>4</u>
Saturation Present? Yes <input checked="" type="checkbox"/> No <input type="checkbox"/>	Depth (inches): <u>2</u>
(includes capillary fringe)	
Describe Recorded Data (stream gauge, monitoring well, aerial photos, previous inspections), if available:	
There is evidence of surface flow from off property, uphill to the east, which carries sediment laden with white limestone powder, and deposits it within the wetland.	
Remarks:	
The criterion for wetland hydrology is met.
