MEMO

DATE: February 2, 2024
TO: Andy McMillan, Senior Environmental Specialist, VELCO
FROM: Austin White, WSP
SUBJECT: **VELCO 2023 Franklin County Line Upgrade Project, Franklin County, Vermont: Updated Viewshed, K42 Line**

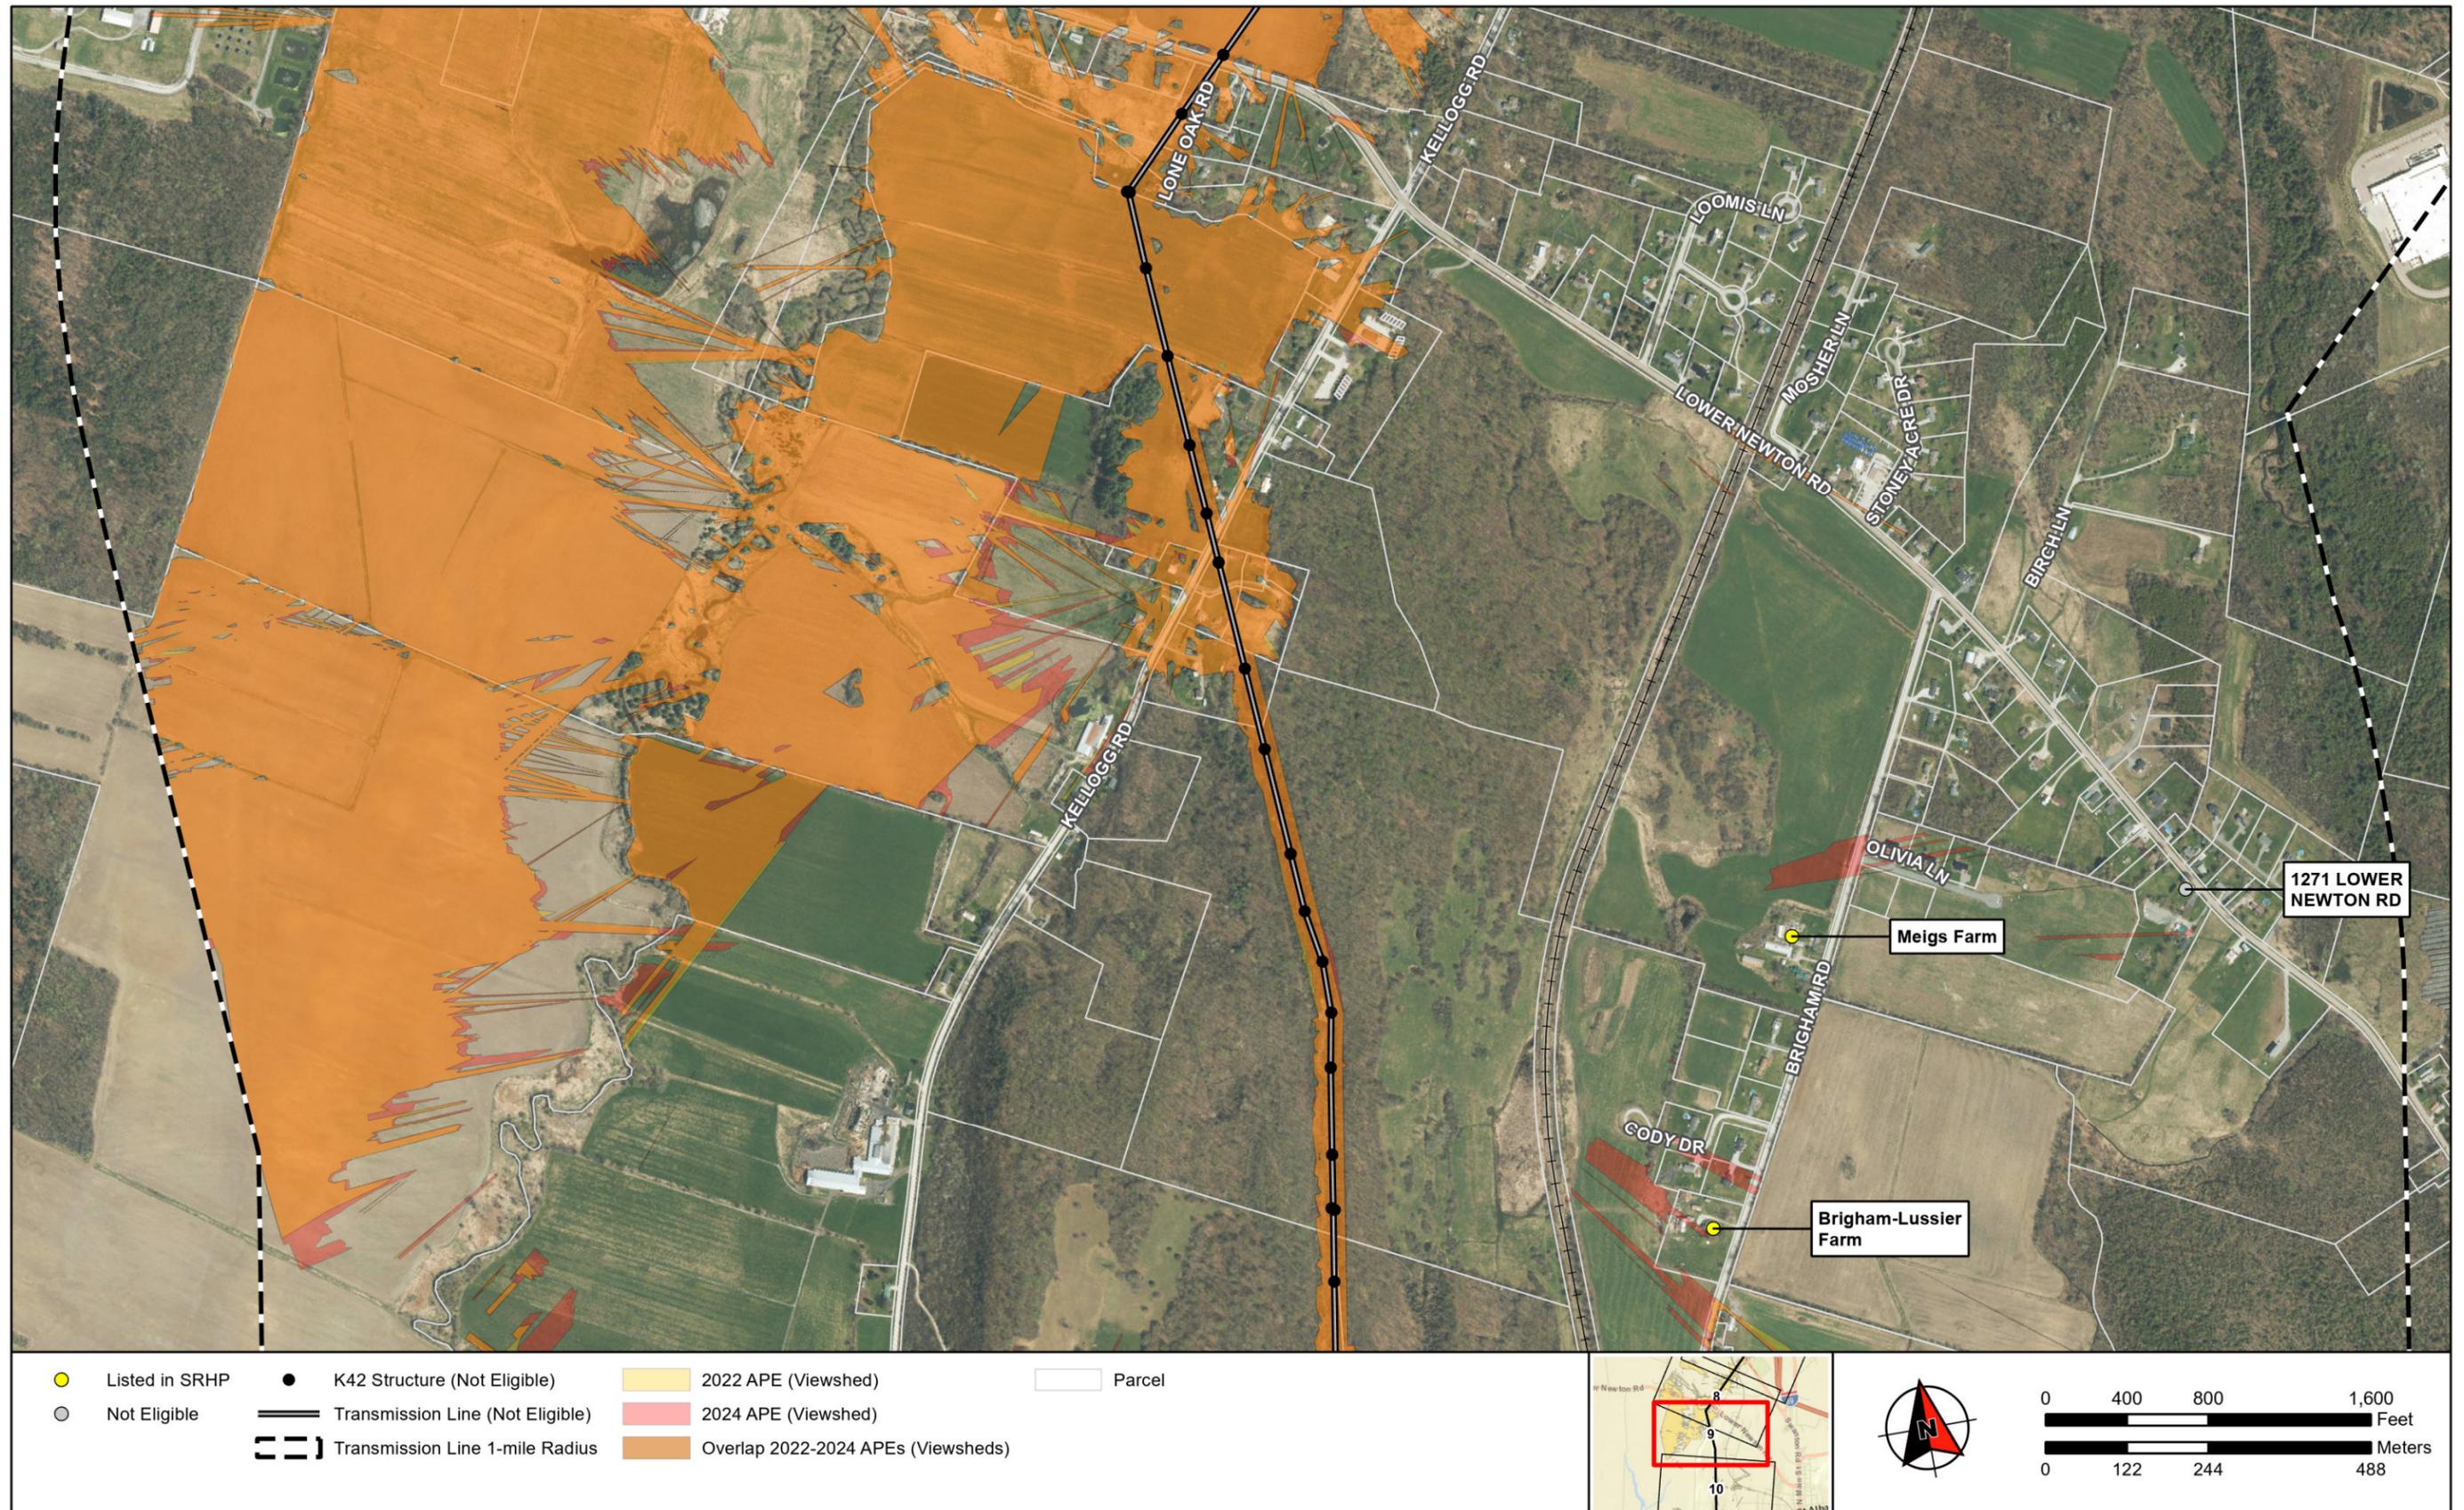
FIGURE 1 (Sheet 9 of 17): Original and Updated Viewshed for K42 Line (ESRI World Imagery 2022)

The updated viewshed model demonstrates almost identical potential visibility compared to the previous model (Figure 1). The original viewshed encompassed an APE of 1,253.07 hectares (3,096.41 acres). The updated viewshed encompasses an APE of 1272.78 hectares (3,145.12 acres).

The updated viewshed model shows that the transmission line will be visible from the open field north of the Meigs Farm's cluster of structures, and west of the structures behind the Brigham-Lussier farmhouse. Although the field is associated with the Meigs Farm, the transmission line would not be visible from the structures of the farmstead and would not diminish the farmstead's setting. The Project will constitute no adverse effect on the historic property.

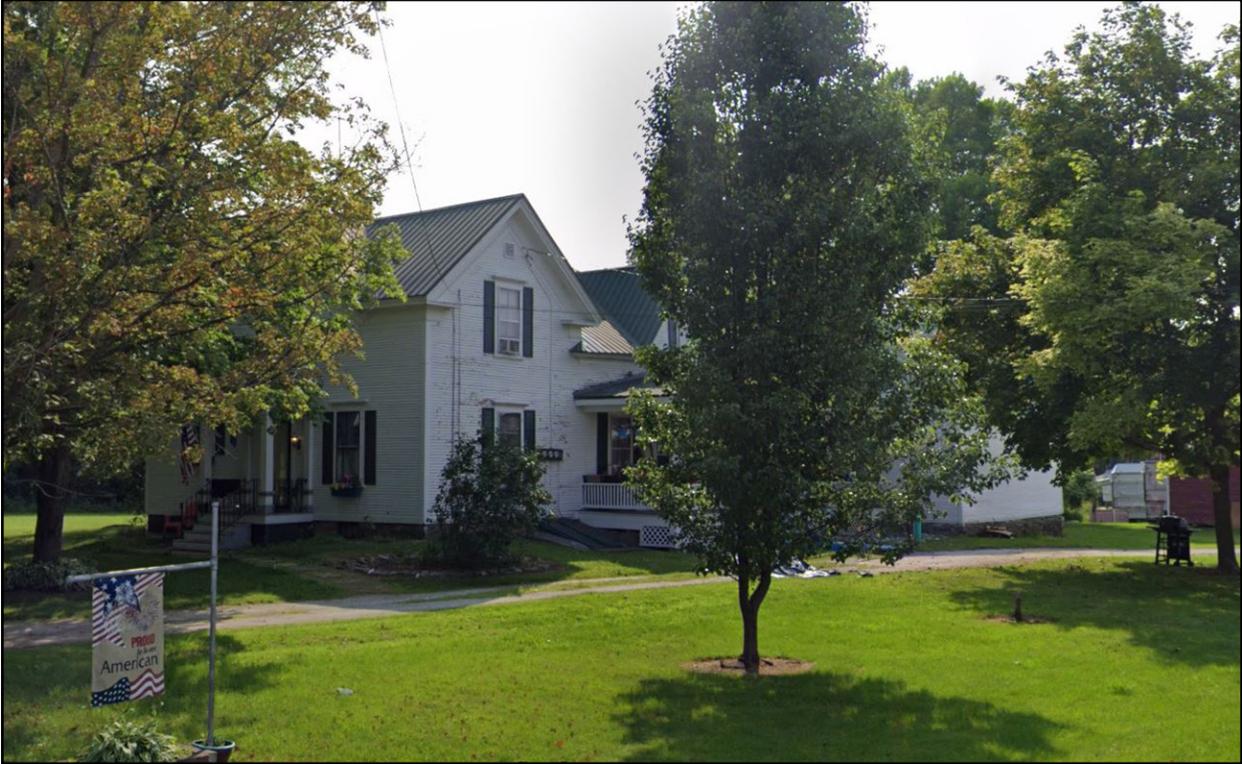
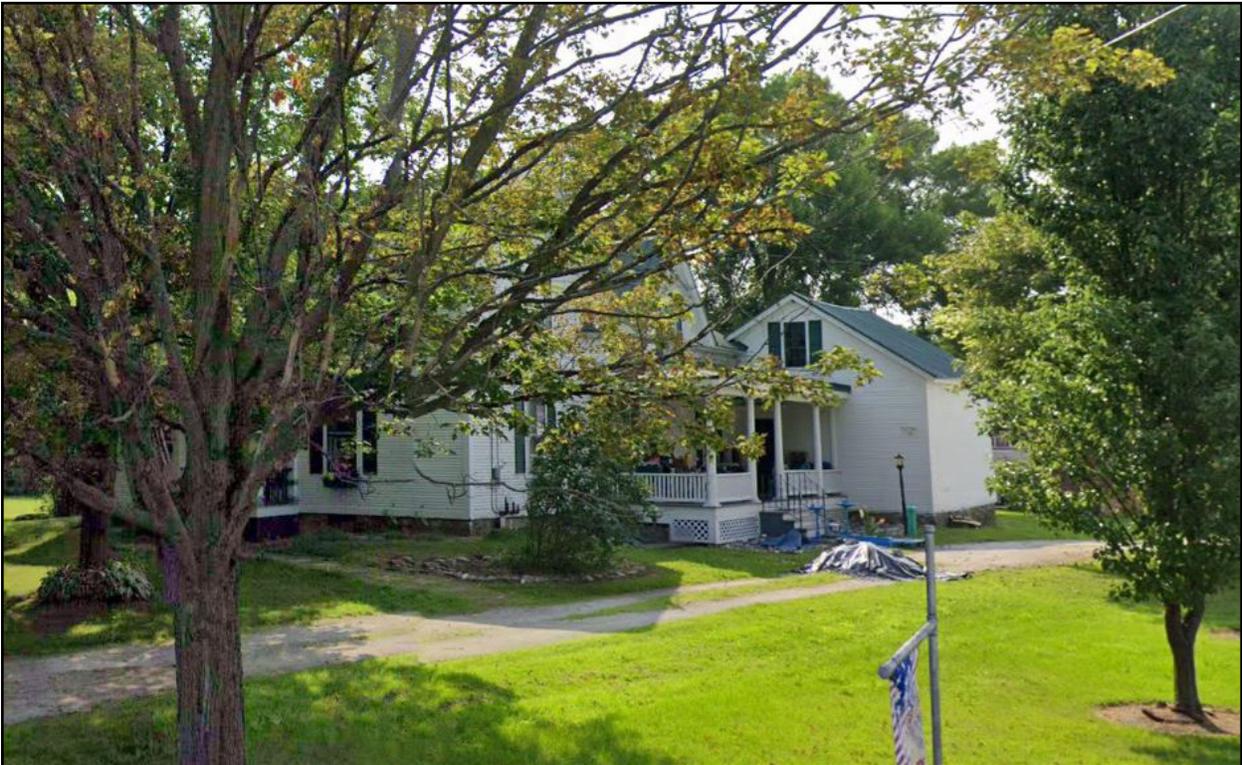
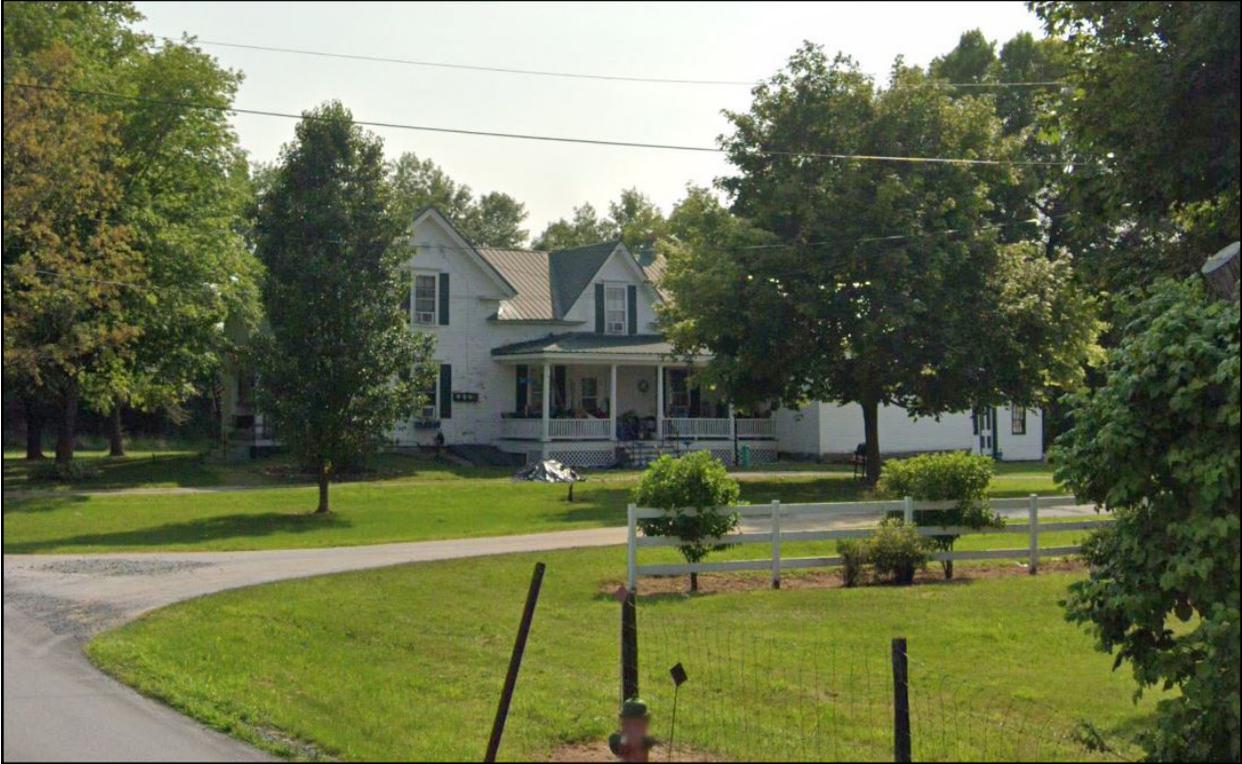
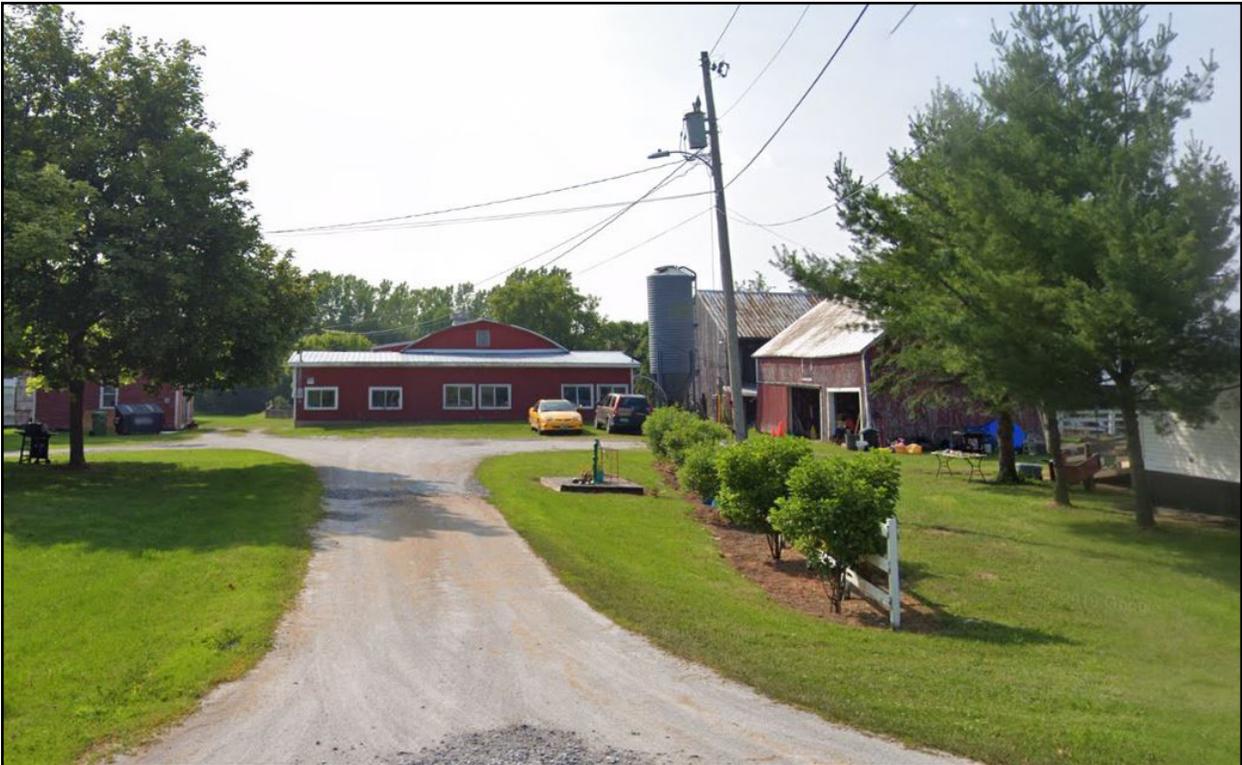
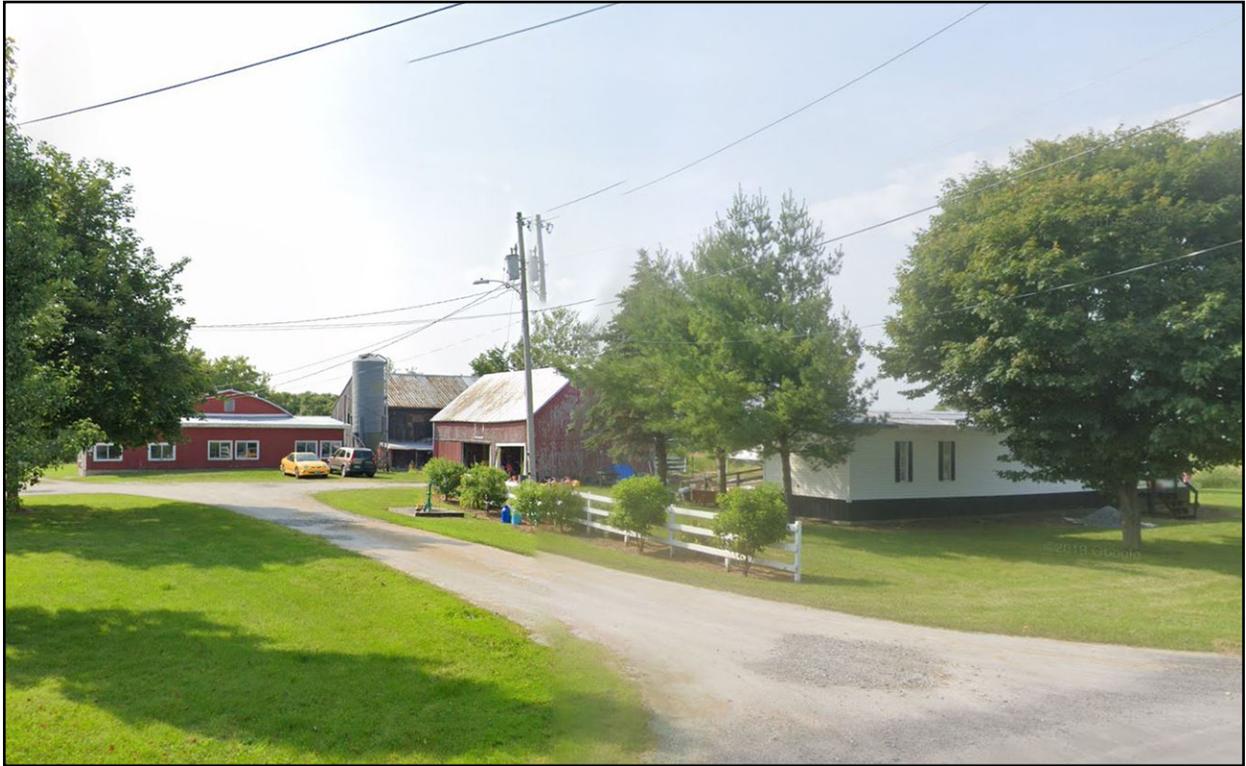
Meigs Farm, 1505 Brigham Road, St. Albans (Figures 2-6)

The Meigs Farm (see Figure 1, Sheet 9) is anchored by a ca. 1900 farmhouse with two rear additions. This massed side-gable residence stands one and one-half stories tall on a stone foundation. The roof has cornice returns and is covered in modern standing-seam metal. The dwelling is clad in narrow clapboards with cornerboards. The symmetrical three-bay façade

contains one-over-two double-hung sash windows. The central entrance is covered with a small portico with square post supports. A three-bay side porch shelters the side entrance to the rear ell.

The farmstead also contains several outbuildings, including a ca. 1860 side-gable barn, a ca. 1870 side-gable barn with attached chicken coop, and a ca. 1840 side-gable barn. A ca. 1965 round gable-front barn with attached milking parlor and a ca. 1965 large hay/machine shed are also present.

Since the farm was first surveyed (VDHP 1986), several outbuildings have been demolished, including a ca. 1840 machine shed, a ca. 1930 wood silo, and a ca. 1960 cement silo. A mobile home has been added on the east side of the farmstead. As the overall historic integrity of Meigs Farm remains intact, it is WSP's opinion that an updated Determination of Eligibility for the NRHP may be warranted if the property is involved in future projects.

In WSP's opinion the Meigs Farm and Brigham-Lussier Farm retain their overall historic integrity, and updated Determinations of Eligibility for the NRHP may be considered for any future projects that may affect the historic resources. Furthermore, in WSP's opinion the four remaining previously unsurveyed properties lack historic integrity and should be precluded from further evaluation.

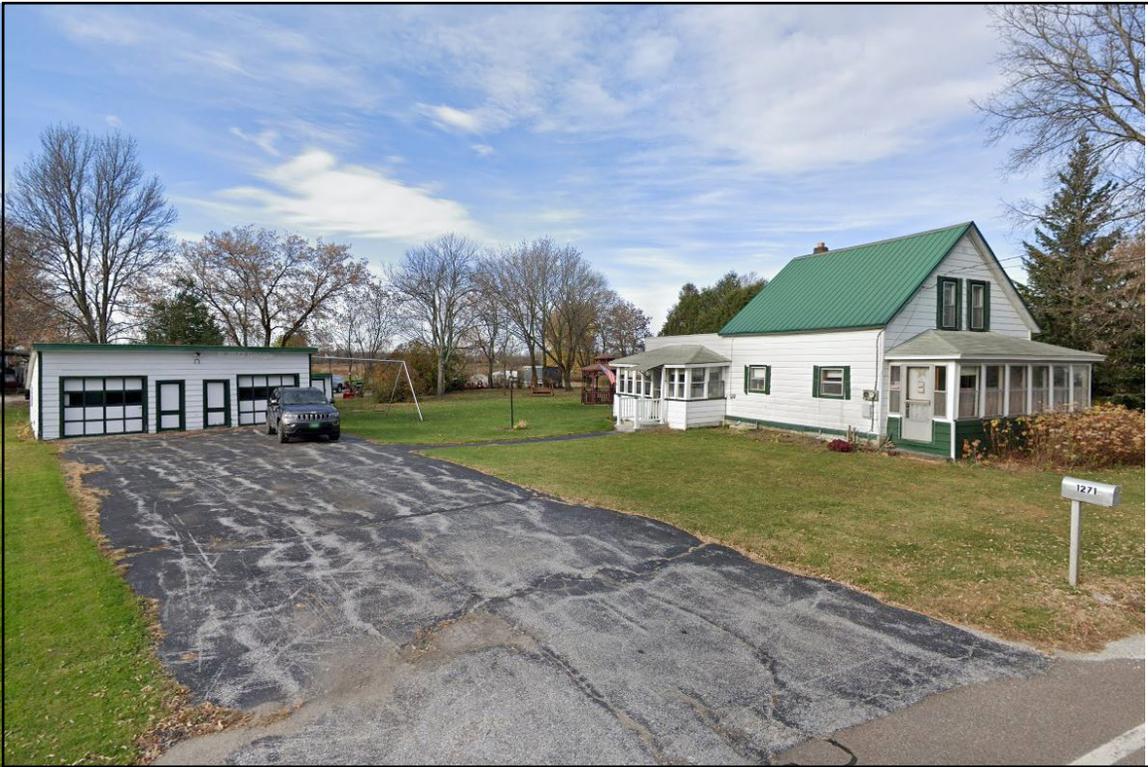
House, 1271 Lower Newton Road, St. Albans (Figure 7)

The property at 1271 Lower Newton Road (see Figure 1, Sheets 8 and 9) is a ca. 1870 one-and-one-half-story front-gable vernacular residence. The house has a standing-seam metal roof with a chimney, an aluminum siding exterior, one-over-one aluminum windows, a hipped-roof enclosed front porch, and a smaller similar secondary porch on the rear addition. The sole outbuilding is a four-bay shed-roof garage; its form indicates previous use as a hog or poultry shed.

The house's historic integrity has been compromised by replacement fenestration, siding, and roofing. It is not representative of an outstanding architectural style, form, or building method. It is therefore WSP's opinion that further evaluation of the property is not necessary if it is involved in future projects.

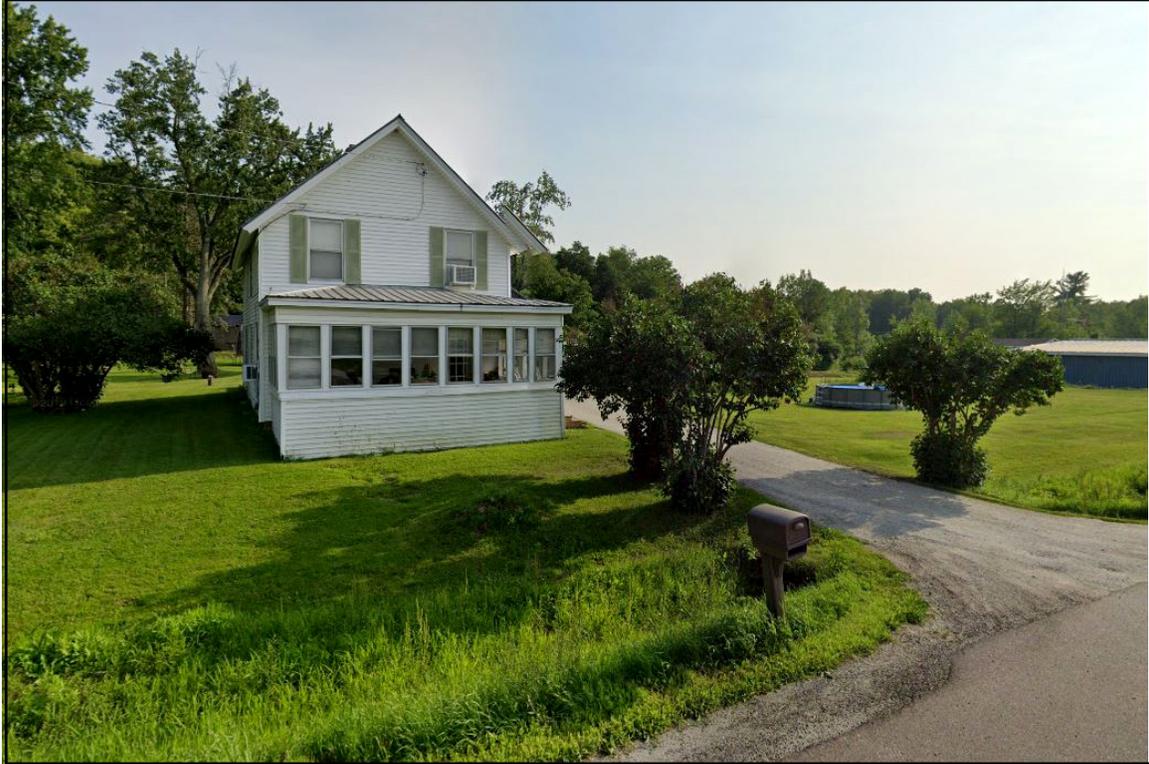
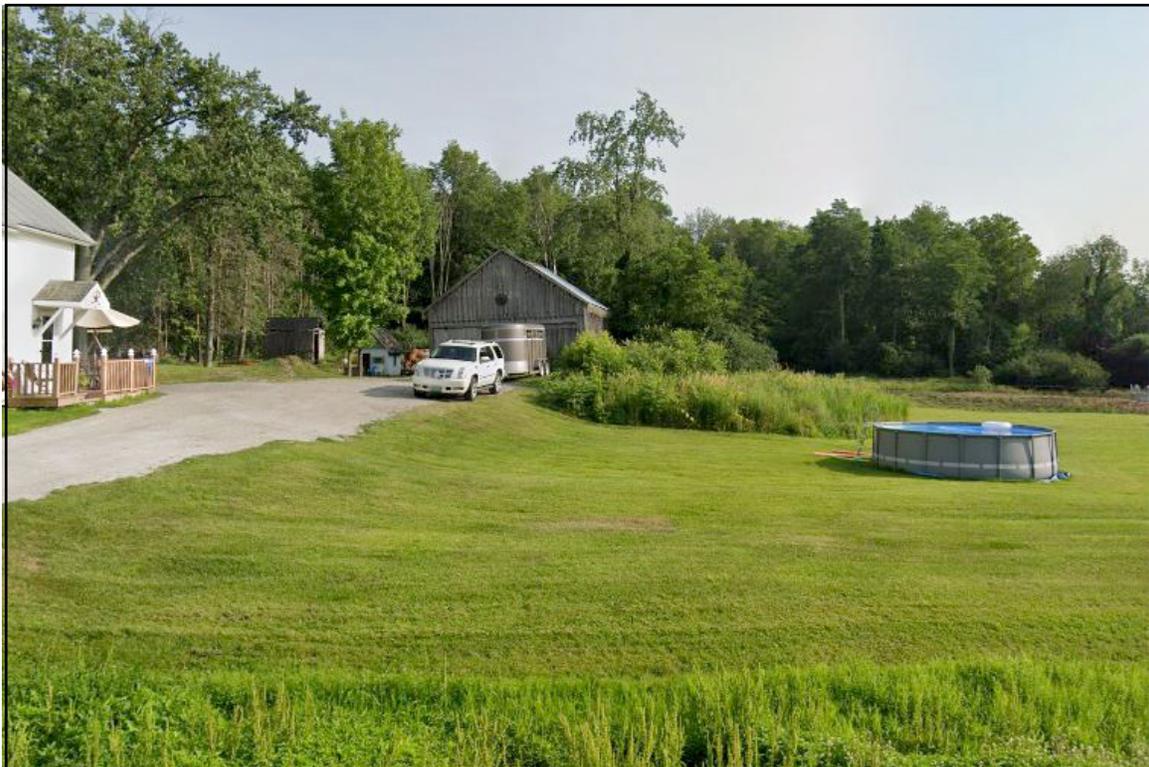
House, 424 Lake Road, St. Albans (Figures 8 and 9)

The property at 424 Lake Road (see Figure 1, Sheet 11) is a ca. 1900 two-and-one-half-story two-bay front-gable vernacular residence (Zillow 2024). The house has a standing-seam metal roof with a ridgeline chimney, an aluminum siding exterior, one-over-one aluminum windows, a hipped-roof enclosed front porch, and a secondary west elevation entrance covered by a gabled hood on posts. The two outbuildings consist of a front-gable barn sheathed in board-and-batten siding and a small well/pump house clad in shingles located south of the residence.

The house's historic integrity has been compromised by replacement fenestration, siding, and roofing. It is not a significant example of an architectural style, form, or building method. It is therefore WSP's opinion that further evaluation of the property is not necessary if it is involved in future projects.

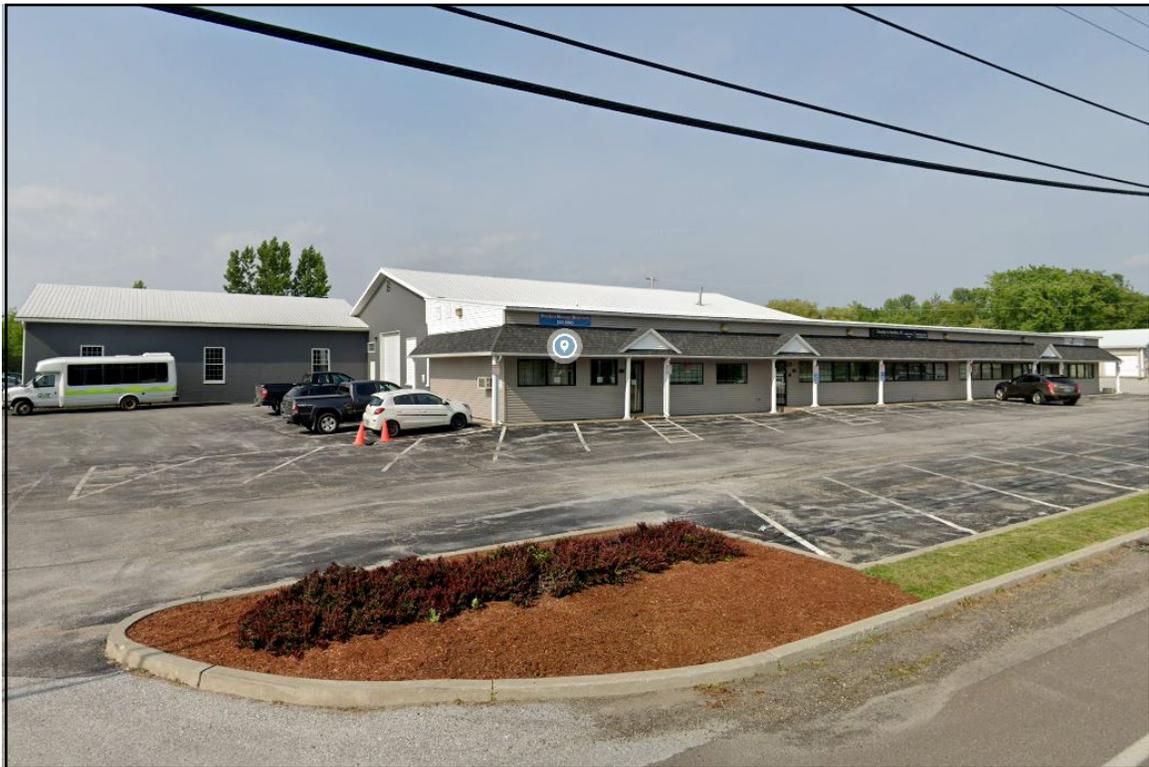
Lake Road Storage, 375 Lake Road, St. Albans (Figure 10)

Lake Road Storage (see Figure 1, Sheets 10 and 11) is a ca. 1962 a one-and-one-half story, multi-bay, utilitarian commercial industrial building (Nationwide Environmental Title Research, LLC [NETR] 2024). The property has a low-pitch standing-seam metal gable roof, a vinyl-siding exterior, a wraparound mansard roof porch surmounted on columns with gables above the entrances, and replacement multi-light doors and windows. Located on the rear elevation is a large gabled two-and-one-half-story cinderblock storage unit capped by a standing-seam metal roof. The west gable end features a central entrance bay. A smaller similarly designed appendage (likely a vehicle service garage) extends from the unit's northwest corner.

Lake Road Storage has been extensively modified by modern replacement material such as siding, windows, and doors. It is therefore WSP's opinion that further evaluation of the property is not necessary if it is involved in future projects.

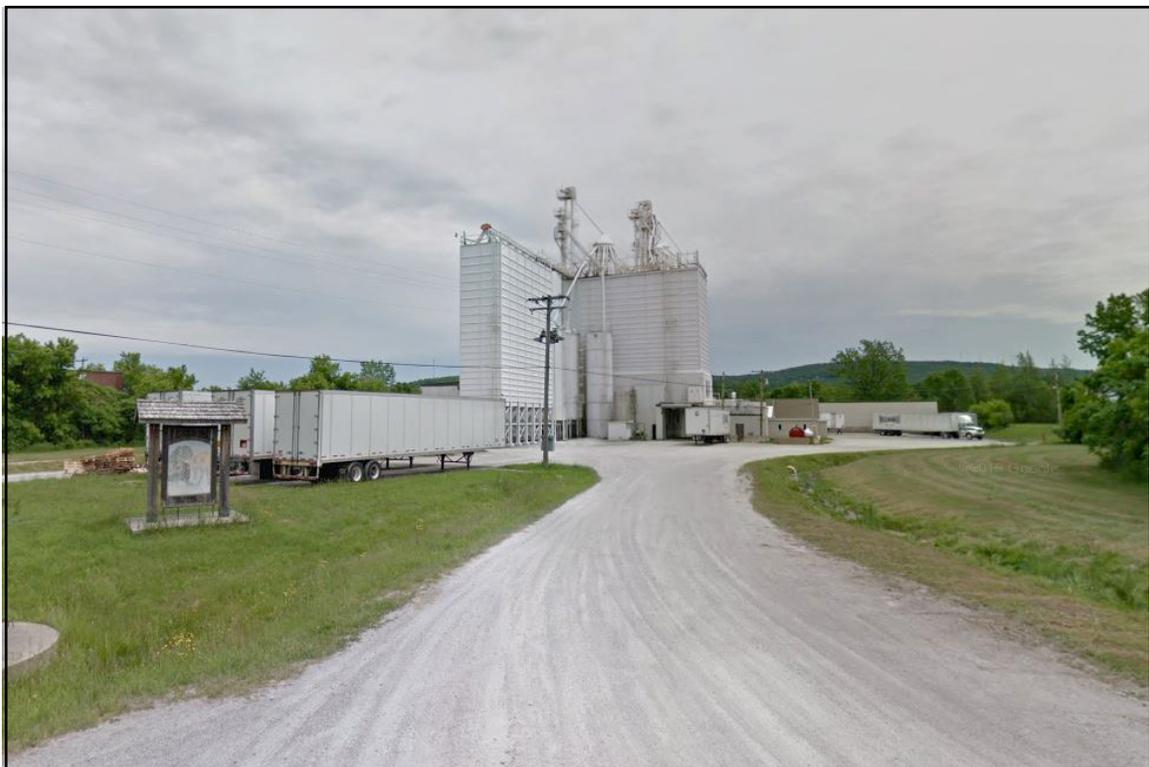
Old Mill Inc., 79 Walnut Street, St. Albans (Figure 11)

Old Mill Inc. is a ca. 1964 feed mill (see Figure 1, Sheet 10) (USGS 1964). The property contains three metal grain silos, which feed into a bin conveyor topped with spouts, hoppers, and dust collectors, and two elevators. The bin conveyor is connected to a series of tall storage silos, which stand perpendicularly to the conveyor. The mill stands on the south side of railroad tracks, which enter an east elevation reception area. Additional buildings include a large flat-roof warehouse on the parcel's western edge, and small office and power structures near the bin conveyor south entrance.

The Old Mill Inc. was determined not eligible for the SR/NRHP by the VDHP during an unrelated project review.

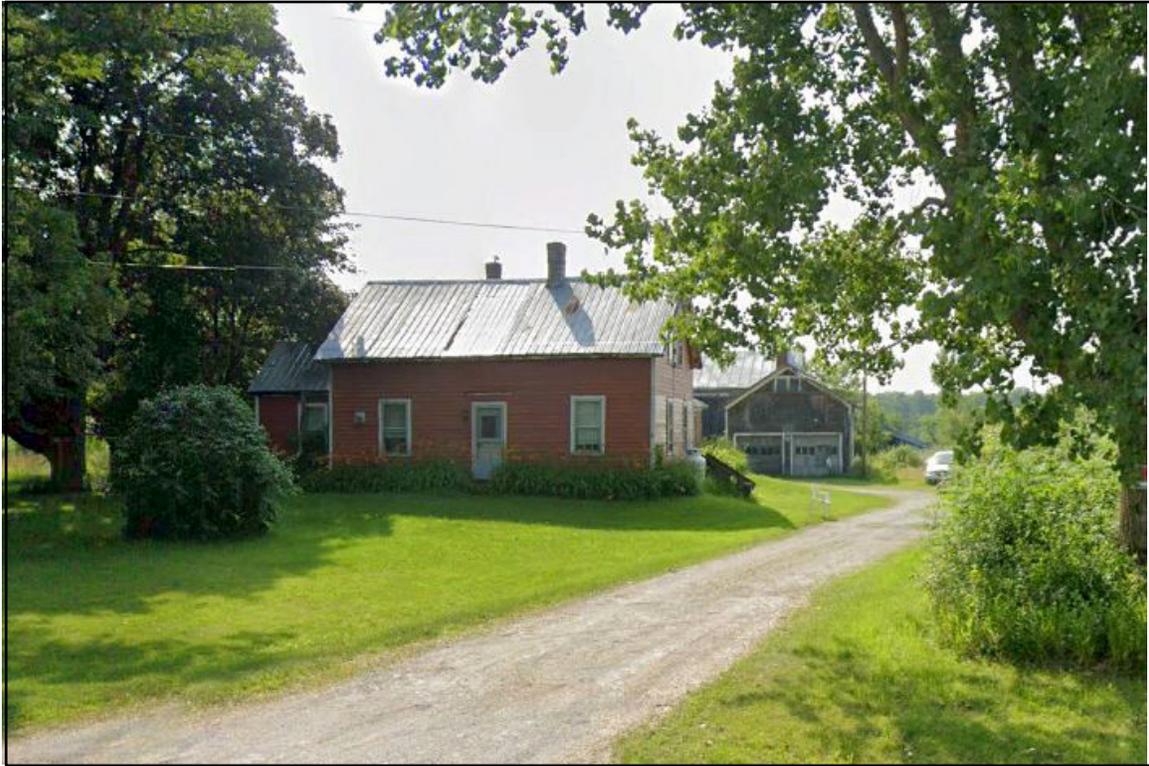
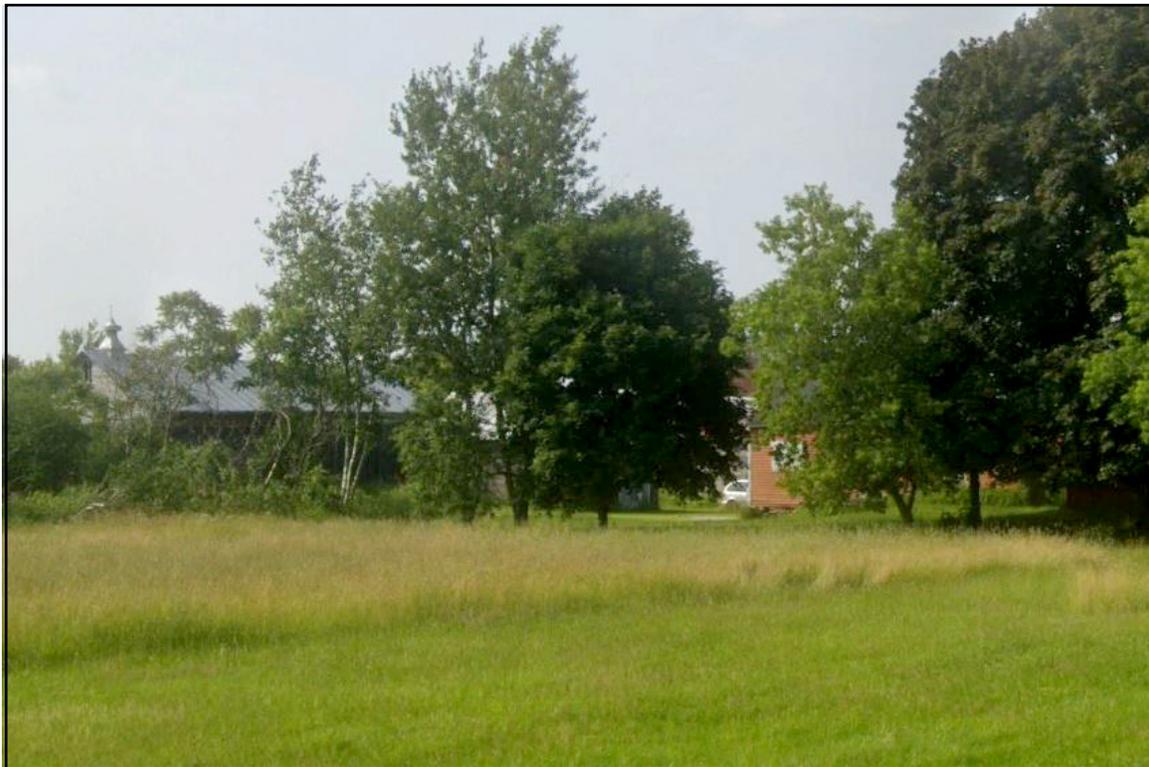
Brigham-Lussier Farm, 271 Brigham Road, St. Albans (Figure 12)

The Brigham-Lussier Farm (see Figure 1, Sheets 9 and 10) is anchored by a ca. 1870 Classic Cottage farmhouse. This one-and-one-half-story residence rests on a stone foundation and has a side-gable roof covered in standing-seam metal punctured by an internal corbeled chimney. The exterior is sheathed in clapboards and has a symmetrical three-bay façade featuring six-over-six double-hung sash windows. The house has two rear additions (including ell) and a short appendage on the south gable end.

The farmstead also contains several outbuildings, including a ca. 1930 front-gable barn, a ca. 1935 banked side-gable barn with two crown ventilators, a ca. 1930 banked barn with an attached shed, a ca. 1940 front-gable granary, and a ca. 1930 front-gable barn chase/mating gable barn.

One building, a ground-level stable barn with a Jerkinhead roof constructed in 1927, has been demolished since the farmstead's first recordation (VDHP 1986). An unknown rectilinear structure was added south of the farmstead just beyond a cluster of large mature trees. The Brigham-Lussier Farm retains good overall integrity, and it is therefore WSP's opinion that future projects may warrant its reevaluation.

The transmission line will be visible from the cluster of structures on the Brigham-Lussier Farm, which could result in an indirect effect from the Project. However, the farmstead's historic use

and characteristics will not be altered as the dimensions and type of the replacement structures will be only negligibly different from the existing structures. Although the farmstead's integrity of setting has the potential to be minimally diminished, the Project will constitute no adverse effect on the historic property.
