2017 Operations and Construction Highlights

Board of Directors
December 7, 2017

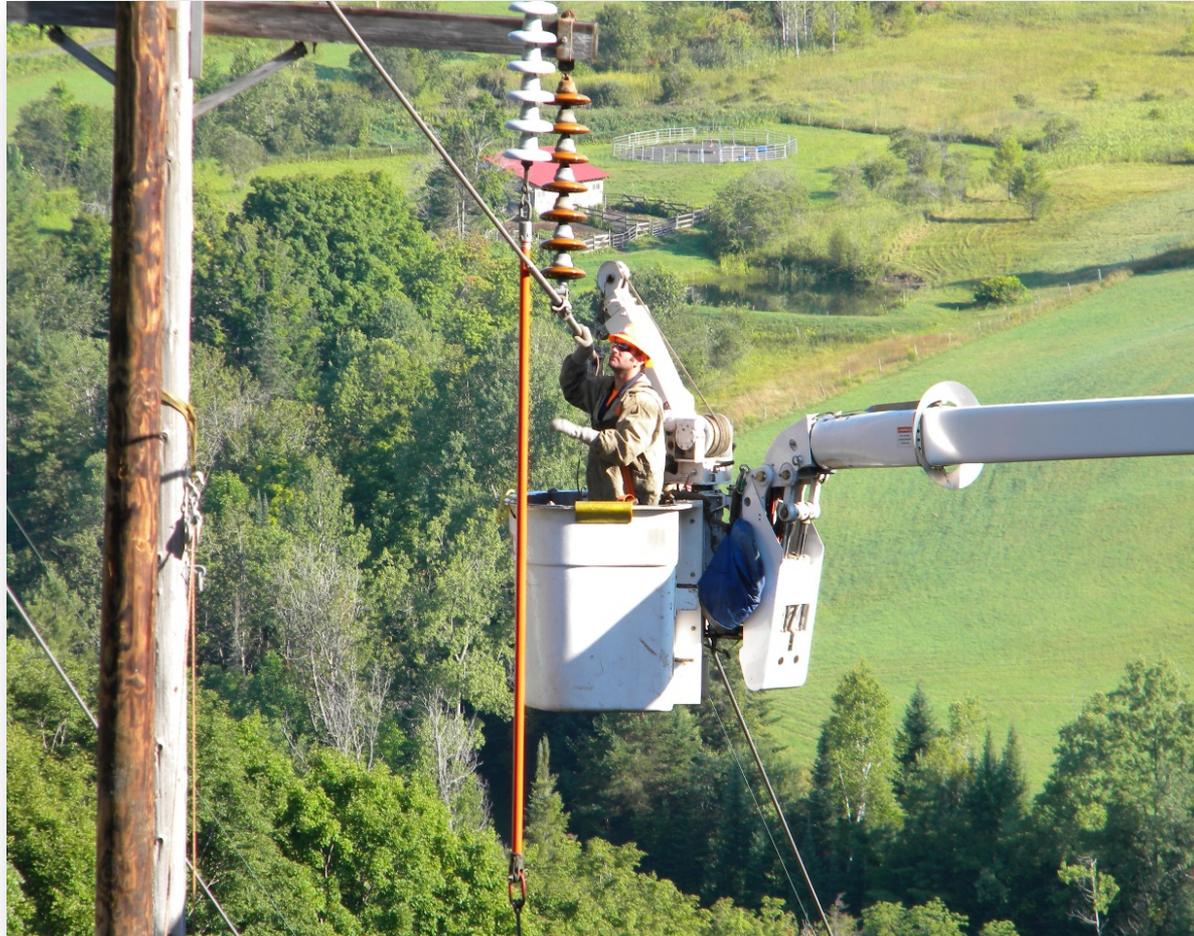
Live line work capability increase

What is live line work?

Live line work involves replacement of transmission structures and components without removing line from service

Two methods used to perform this work on VELCO system: **live line stick work** and **bare handing**

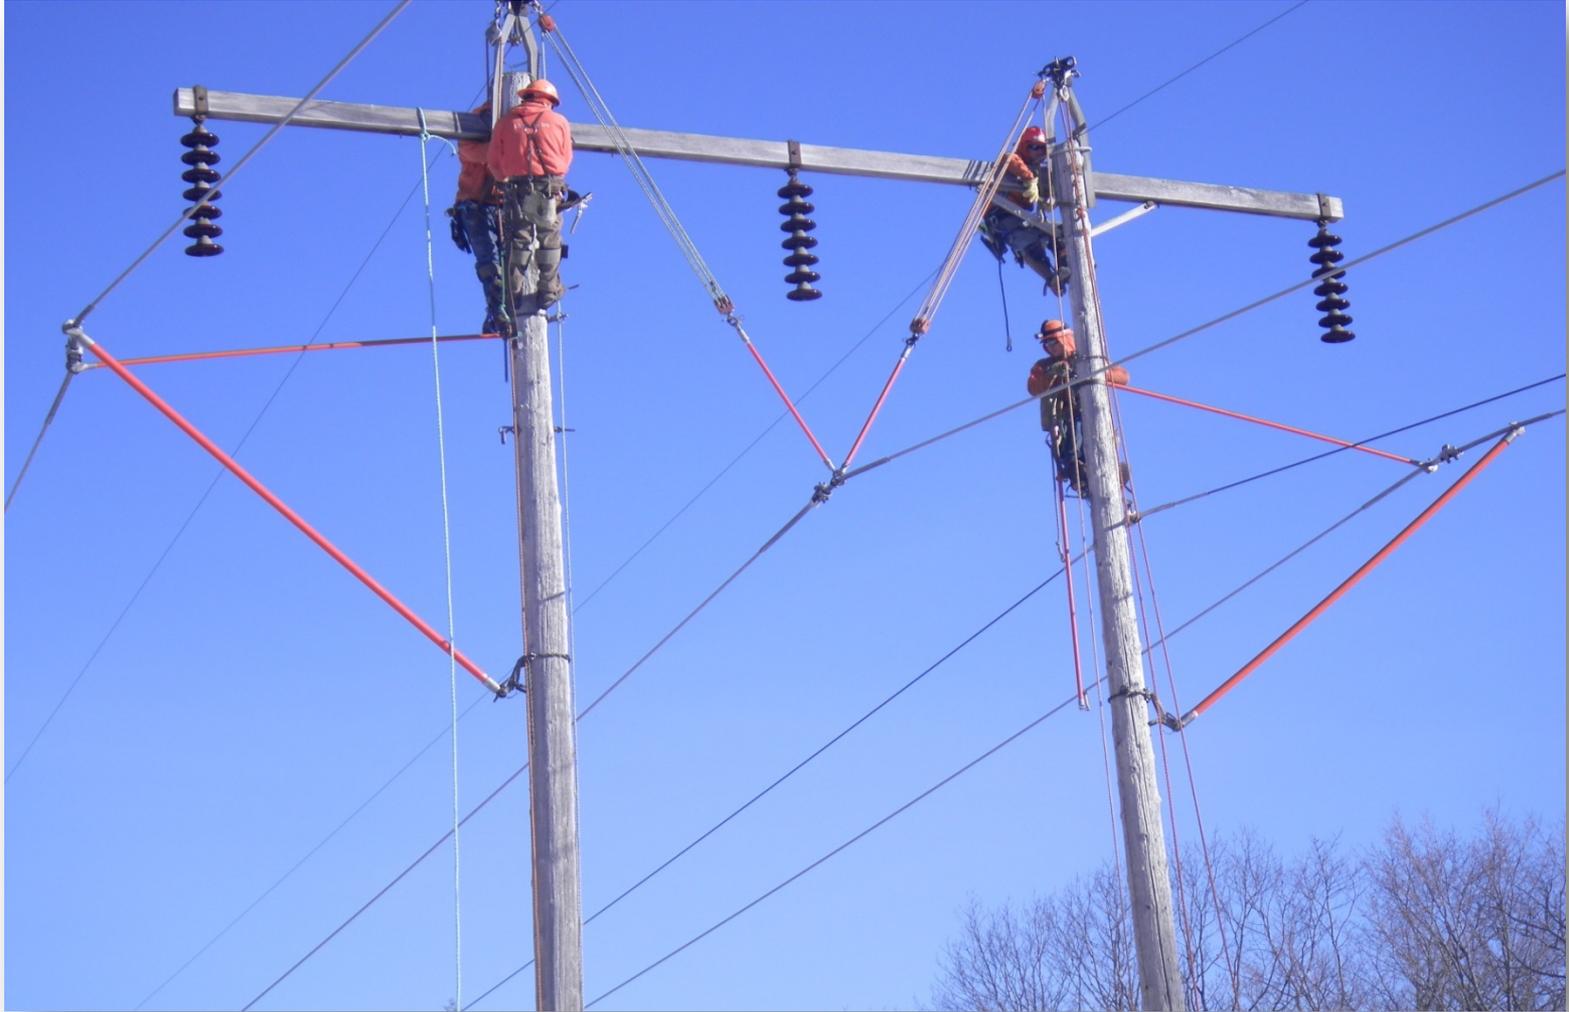
Live line stick work

- Linemen climbs pole and uses hot-line stick to control energized conductor allowing for replacement of cross arms and insulators
- Stick work ***has limitations*** based on structure configuration, steel cross arms, conductor weight span and pole conditions
- Extensive rigging is required to perform energized stick work—very time consuming
- Can be accomplished without aerial equipment
- Minimum approach distance must be maintained at all times
- VELCO line crew has 30 years experience and presently replaces 25 to 30 cross arms a year using this method

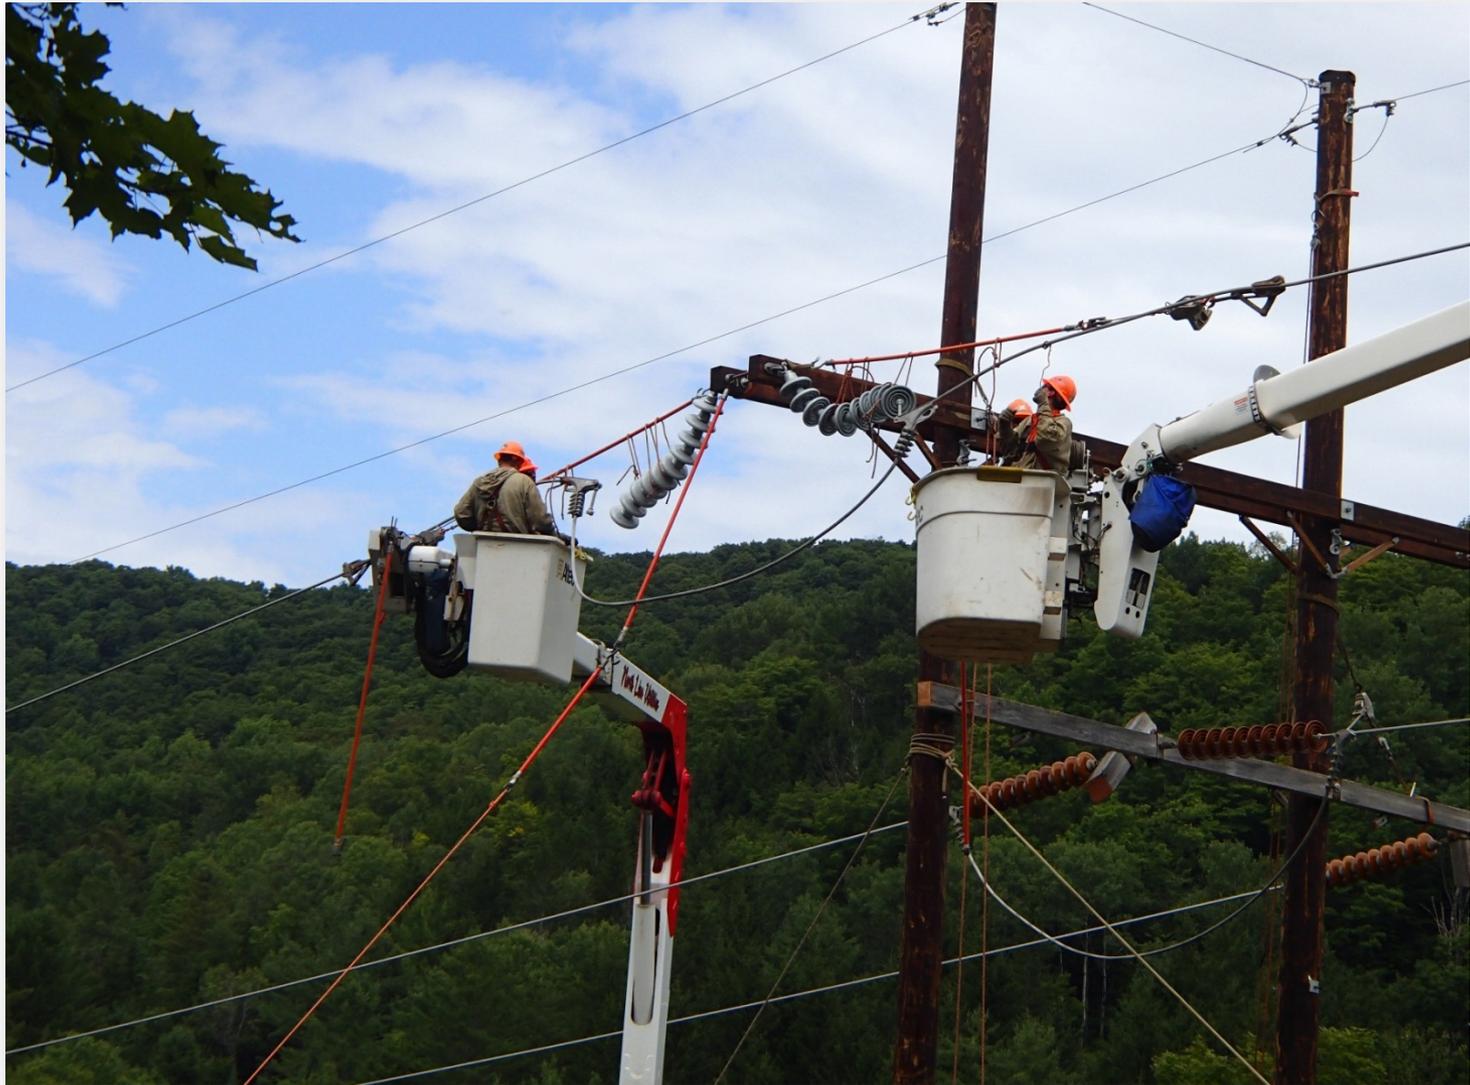
Bare hand live line

- Uses aerial equipment to assist the linemen in replacement of transmission line components
- Bare hand work limited by structure configuration. ***Not all VELCO structures can be replaced with line energized***
- Conductors are controlled with machinery requiring less rigging and less time than hot stick work
- Smaller minimum approach distance allows line workers to touch energized conductor with approved high-voltage suits and tested equipment
- Steel structures and components can be replaced safely using this method
- This is common practice within the industry and many utilities are moving in this direction
- Presently this type of work is only performed by contracted resources
- Requires extensive training, changes in work methods and safety practices, and specialized equipment
