# Sandbar Phase Shifting Transformer Incident

Operating Committee  
March 18, 2021

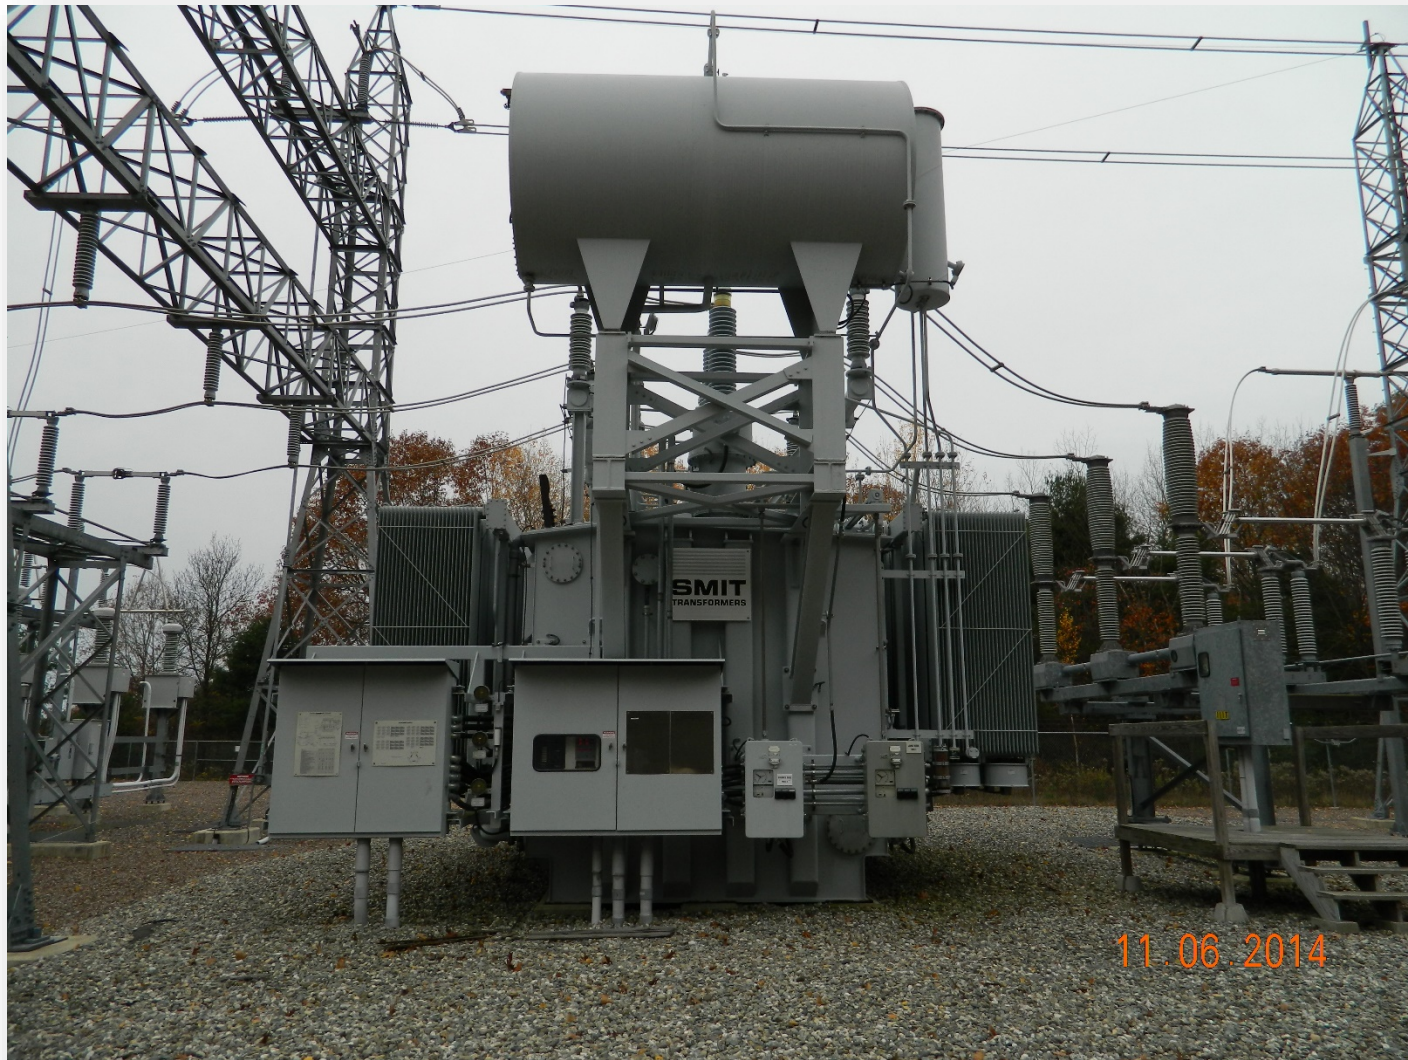
# Sandbar Phase Shifting Transformer

- What is a PST?
  - Phase Shifting Transformer is a complex device used to change the voltage angle on a line to either increase or decrease flows
  - Expensive and fairly unique
  - Due to the geography of VT, VELCO has 4 PST's
  - Approximate replacement cost is up to \$6M each
  - Sandbar (PV-20) PST was installed in 2004
- Where does VELCO have them
  - Sandbar (NY/VT) line
  - Blissville (NY/VT) line
  - Granite (2 PST's on NH/VT) 230kV line

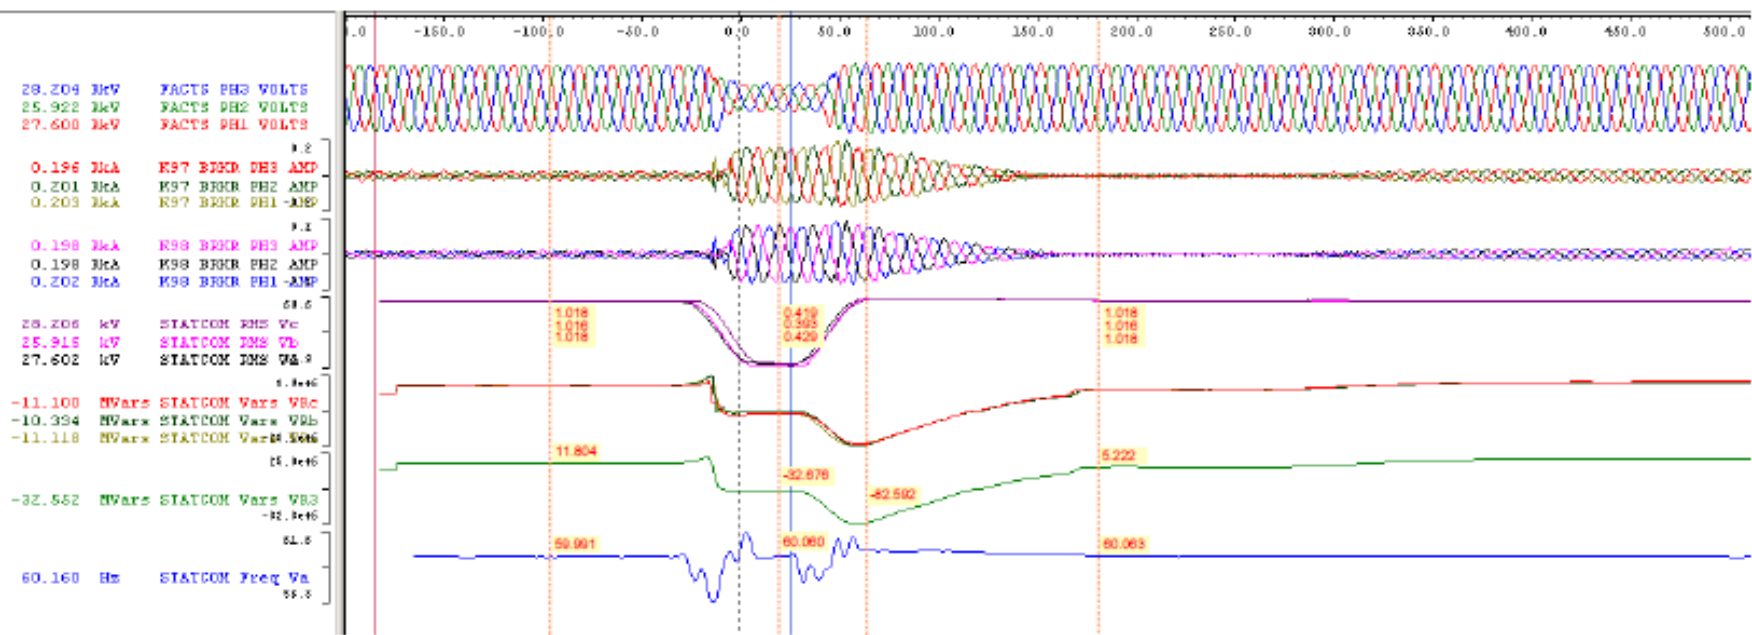
115 kV Network - Voltage Dip Impact  
of PST Fault 2/22/2021

- PST tripped off at 4:41 on February 22
- Unit was removed from service in 3.5 cycles (1 cycle is 1/60 of a second)
- Some VEC load was dropped out of South Hero substation while line work was being performed on the New York side of the PV20
- The fault in the PST was a significant short circuit lowering voltage throughout Northern VT for 3.5 cycles (see next slide)

11.804 - (-32.676) = 44.48 MVAR change (while under low voltage)  
 32.676 / 0.414 pu (ignoring filters V-q) = 78.927 MVAR (if not in under voltage) compared with post  
 recovery 82.592 MVAR. 11.804 + 82.592 = 94.4 MVAR change (compensating for undervoltage)

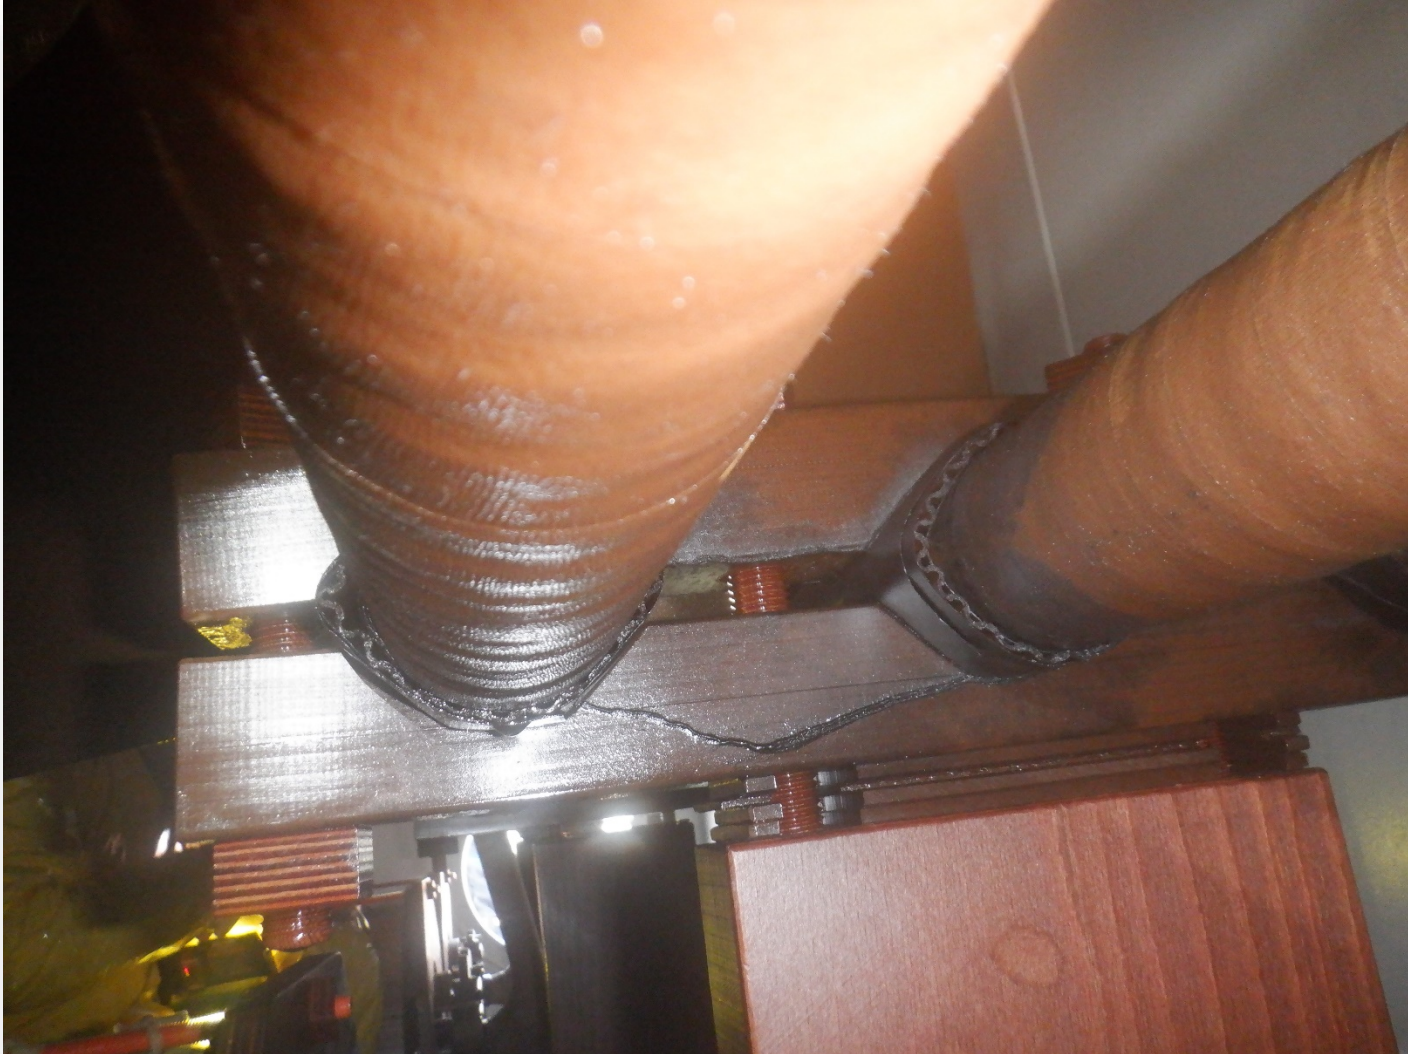
# Electrical tracking across the wood supports

- Sandbar PST to be taken apart and moved off foundation
- Granite PST Unit
  - Mineral Oil to be emptied week of March 15
  - Inspection of unit March 22
  - If ok, re-location contract to be awarded
  - Move schedule being developed
- A repair scope for the Sandbar Unit developed
  - Unit to be shipped back to Netherlands
  - Discussions on who pays and how much
    - Insurance coverage review

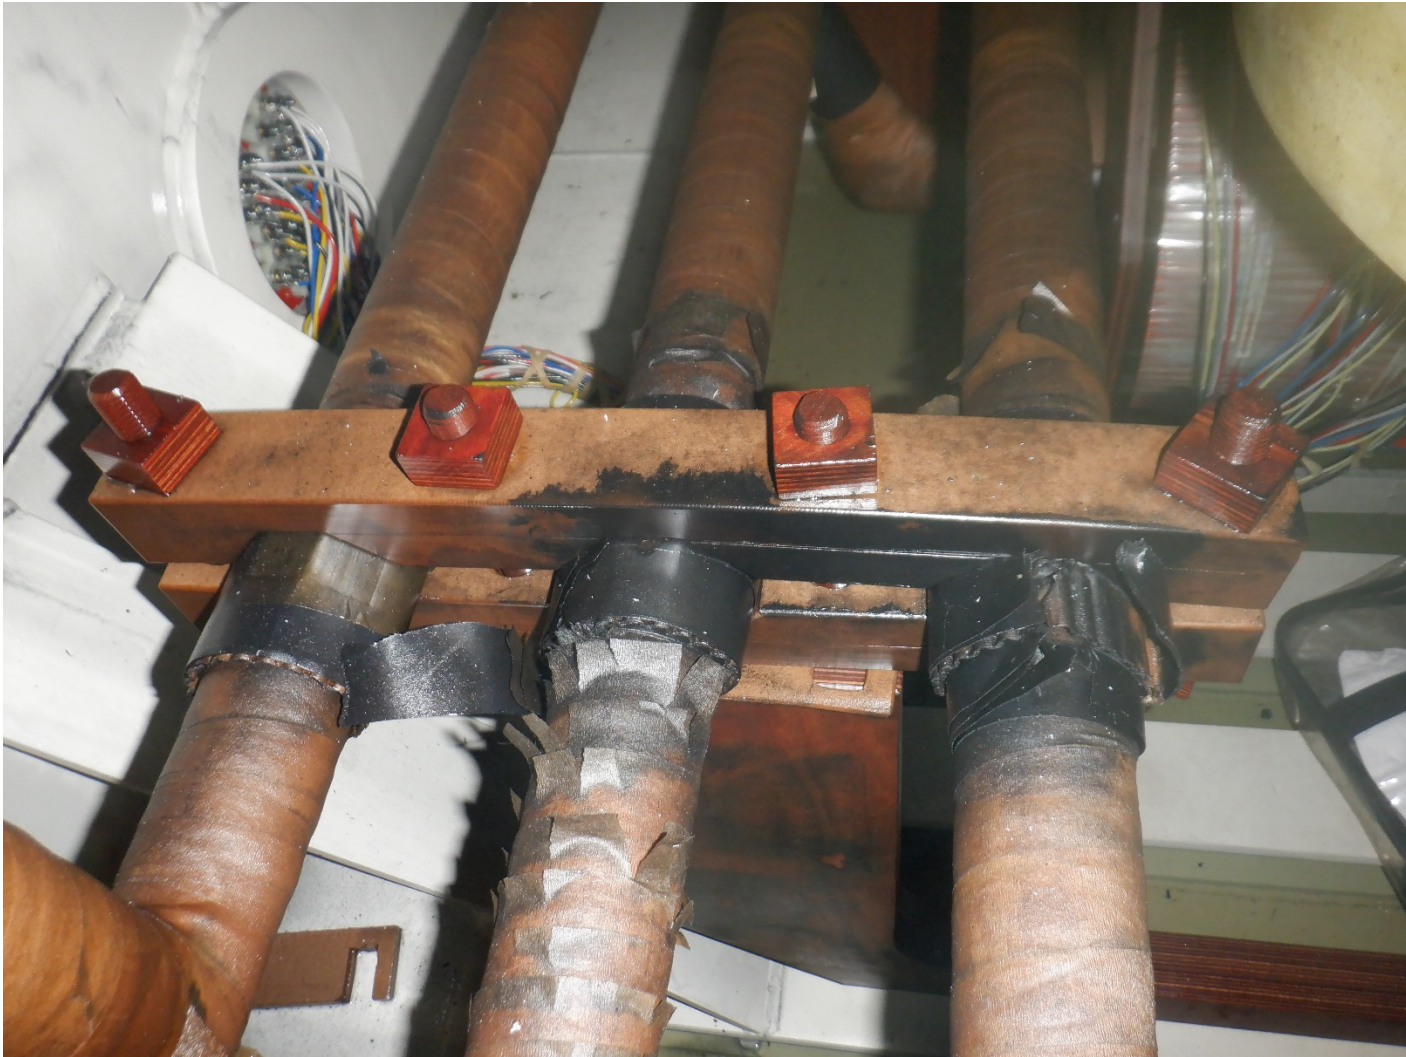
# Fault between the two phases

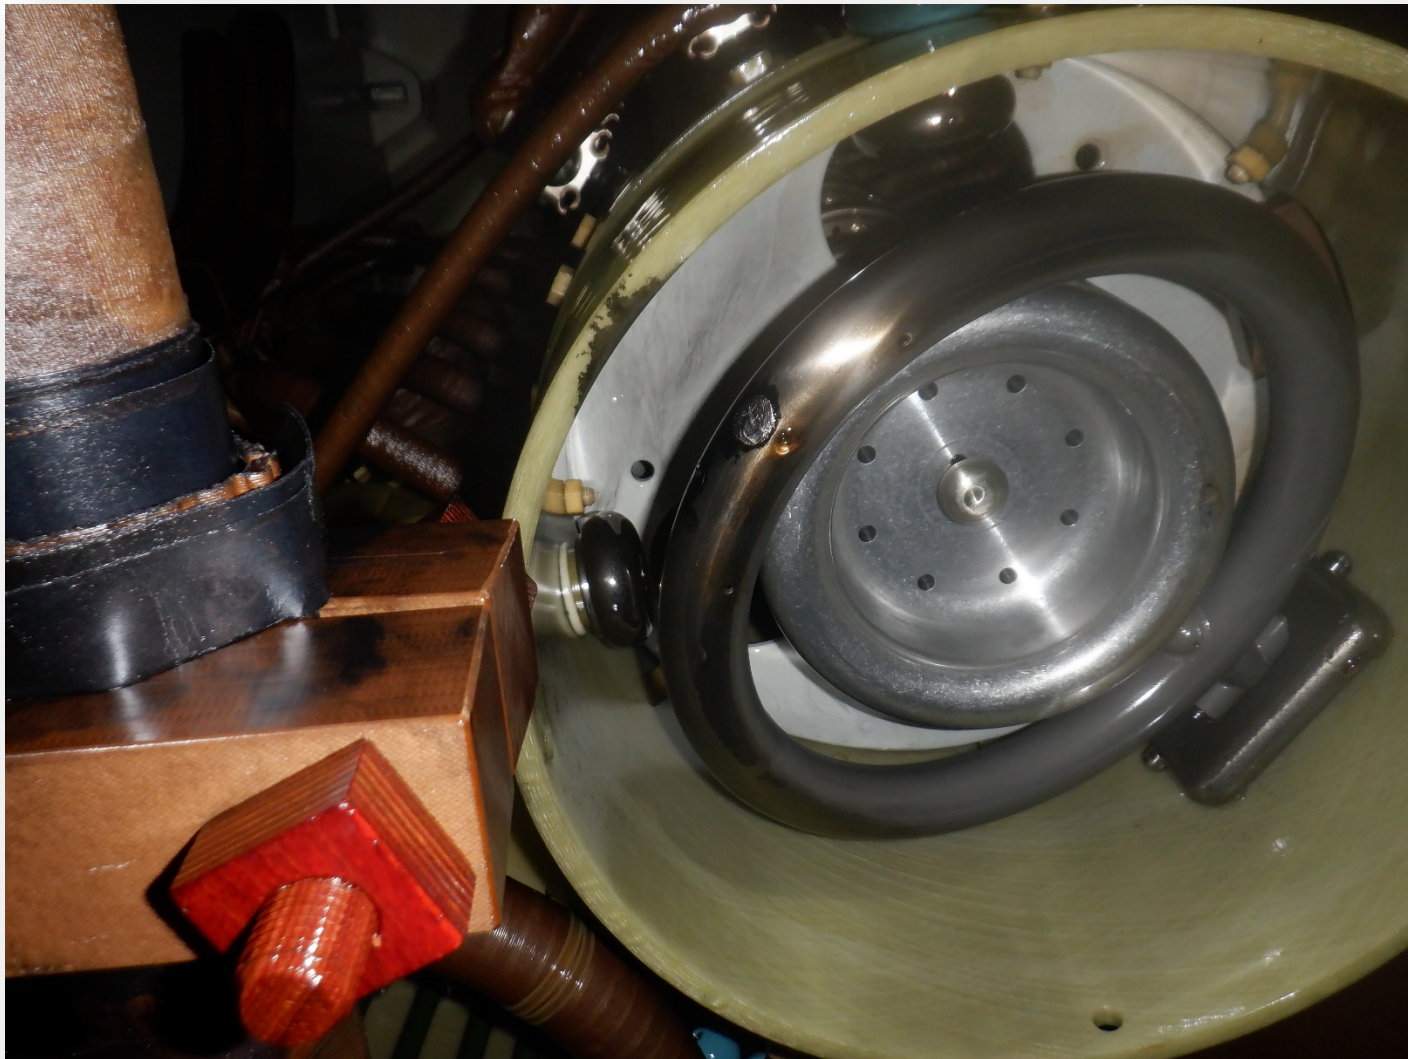
# Electrical fault flashed to corona ring

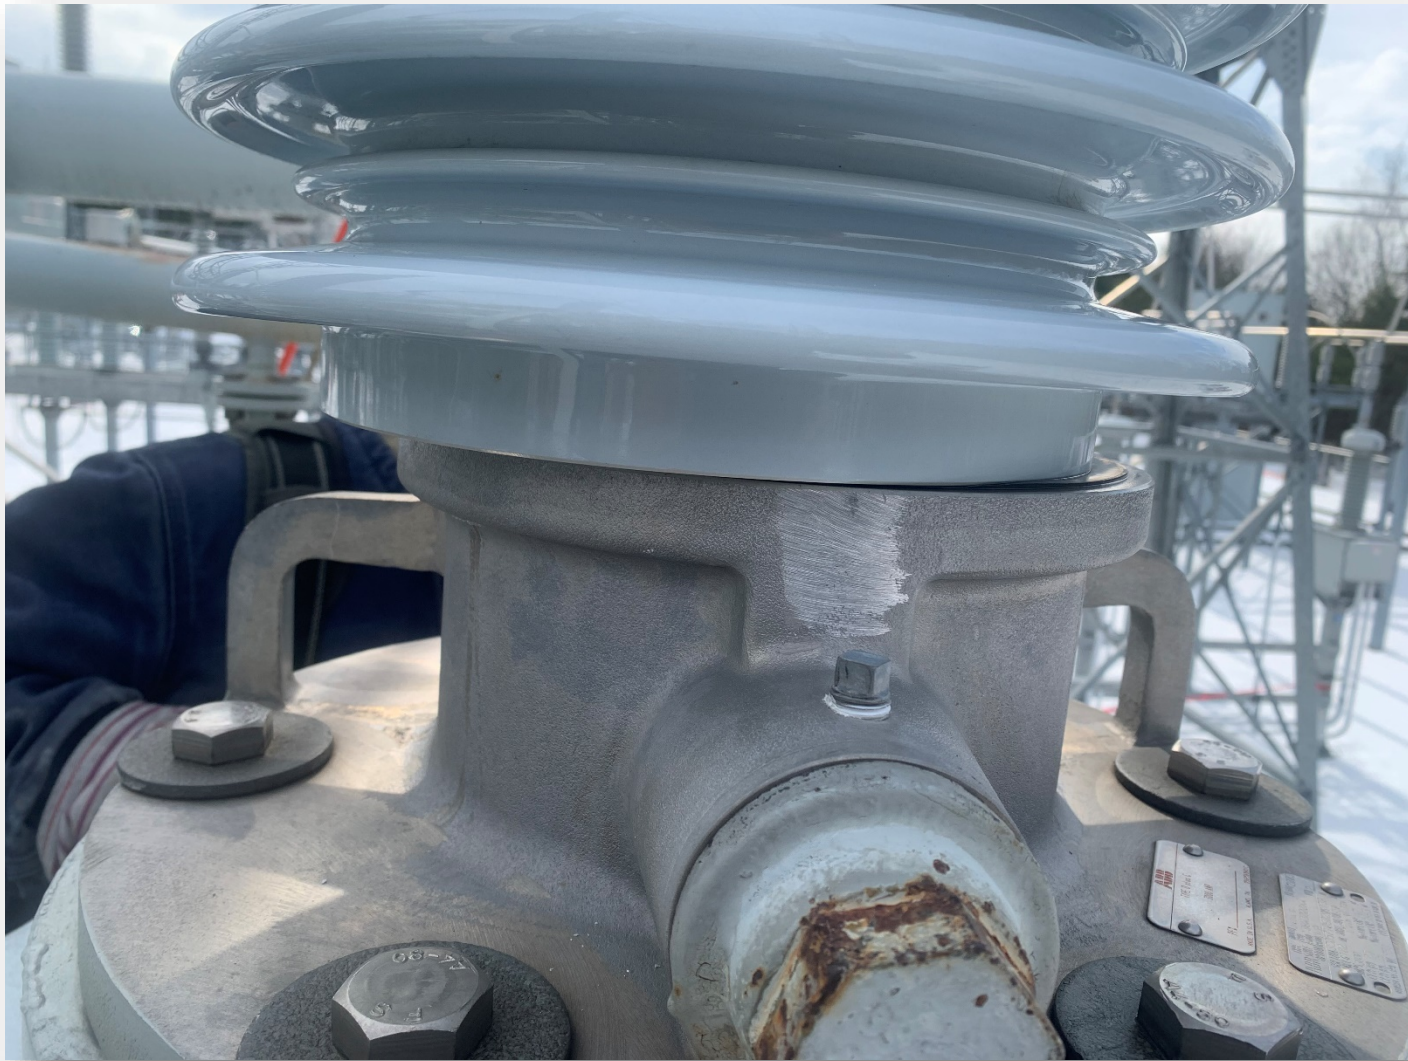
# Fault pressure shifted bushing
