# ARCHITECTURAL RECONNAISSANCE SURVEY FRANKLIN COUNTY LINE UPGRADE PROJECT

Franklin County, Vermont

December 22, 2023

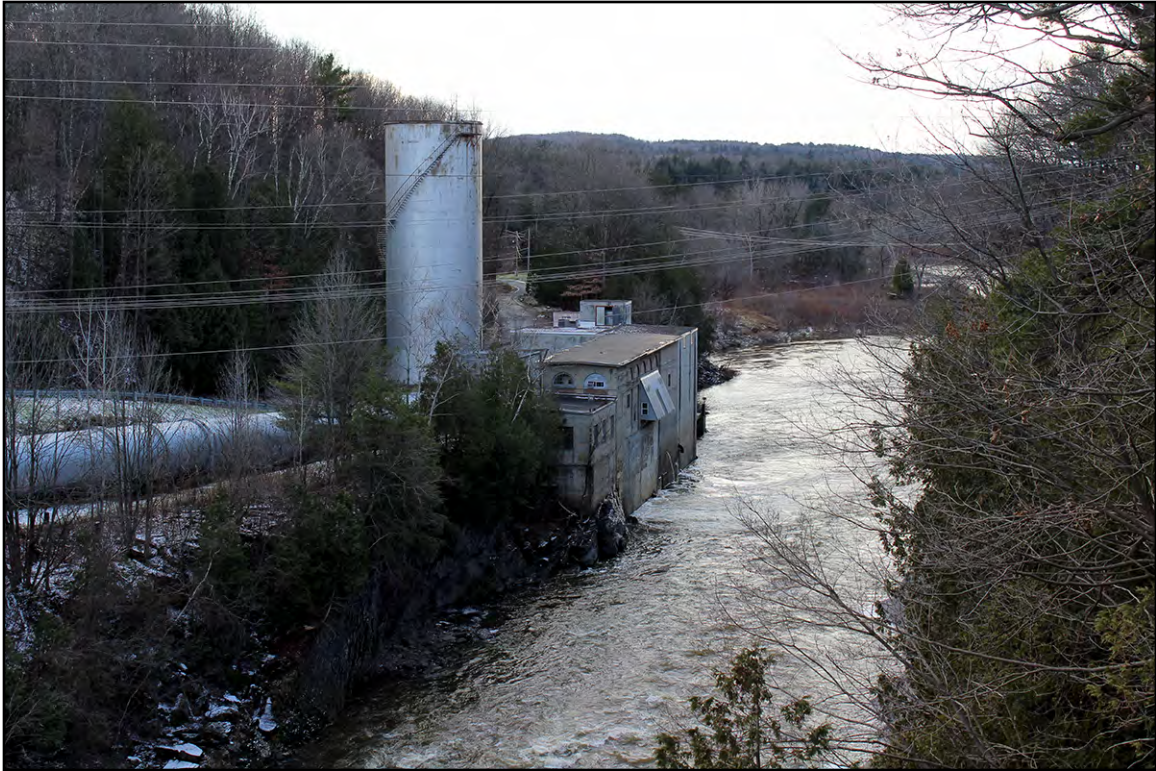
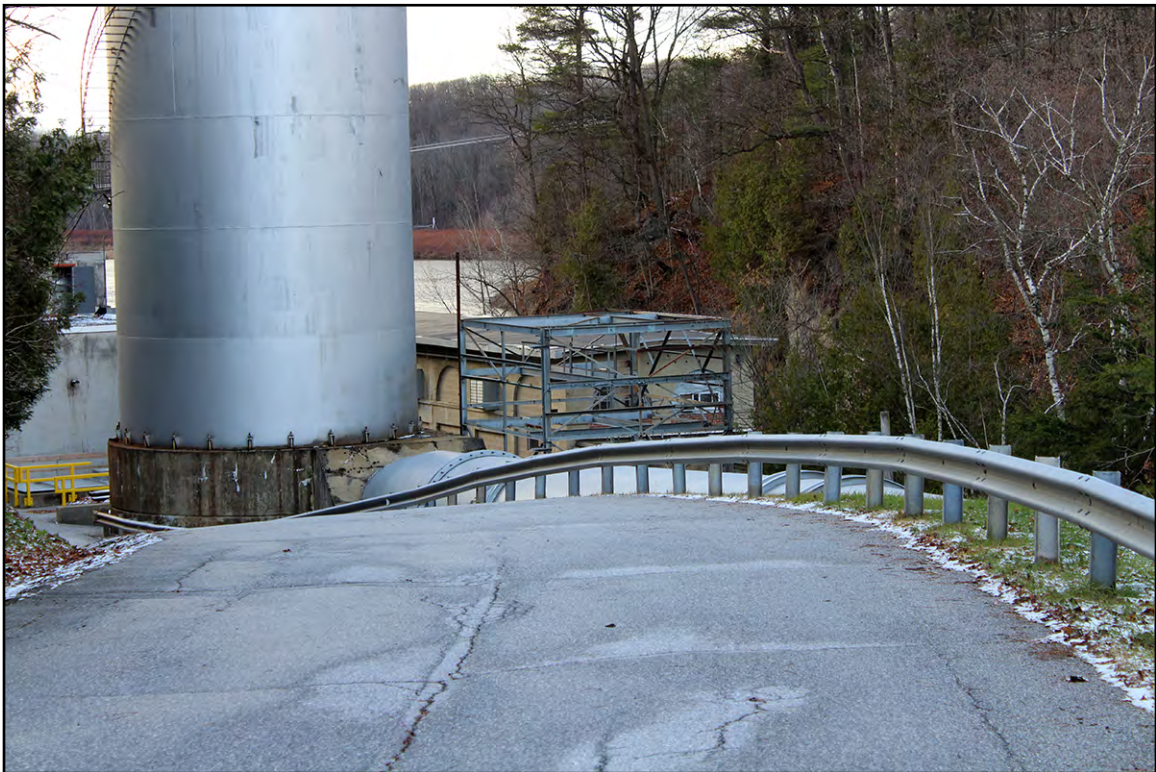
The circa 1920 Highgate Falls Power Plant is a three-story rectangular-plan reinforced-concrete hydroelectric power plant along the south bank of the Missisquoi River downstream from the Douglas & Jarvis Patent Parabolic Truss Iron Bridge and Highgate Falls. The main block of the structure has a shallow iron and concrete gable roof. Fenestration consists of recessed 19-light semi-circular windows atop 12-over-12 sashes, infilled on the north elevation along the river. Centered on this elevation is a cantilevered shed room sheathed in corrugated metal and two louvered windows. The plant is flanked on the west and east by flat-roofed wings, with the east end at a lower height. A bulkhead sits atop the west wing. The plant is powered by a 4,070-horsepower turbine driving a 2800kw generator in the west wing and two 1,340-horsepower vertical turbines powering two 900kw generators in the east. Located in the east wing are the control room and switching gear.

PLATE 2: Highgate Falls Power Plant, Baker Road Along the Missisquoi River, Looking Southwest

PLATE 3: Highgate Falls Power Plant, Baker Road Along the Missisquoi River, Looking Southwest

The parcel contains a circa 1915 cylindrical metal surge tank on a poured concrete foundation, a circa 1930 three-bay shed-roof garage, and a concrete dam 240 feet long and 25 feet high connected to a 200-foot-long gravity dam linking a 12-foot-diameter conduit penstock to the surge tank.

The power plant has remained in use since the VDHP (1982a) survey. A recent VDHP environmental review of the property found that the resource has lost much of its historic integrity as a result of twentieth-century alterations and that it is no longer eligible for SR/NRHP listing.

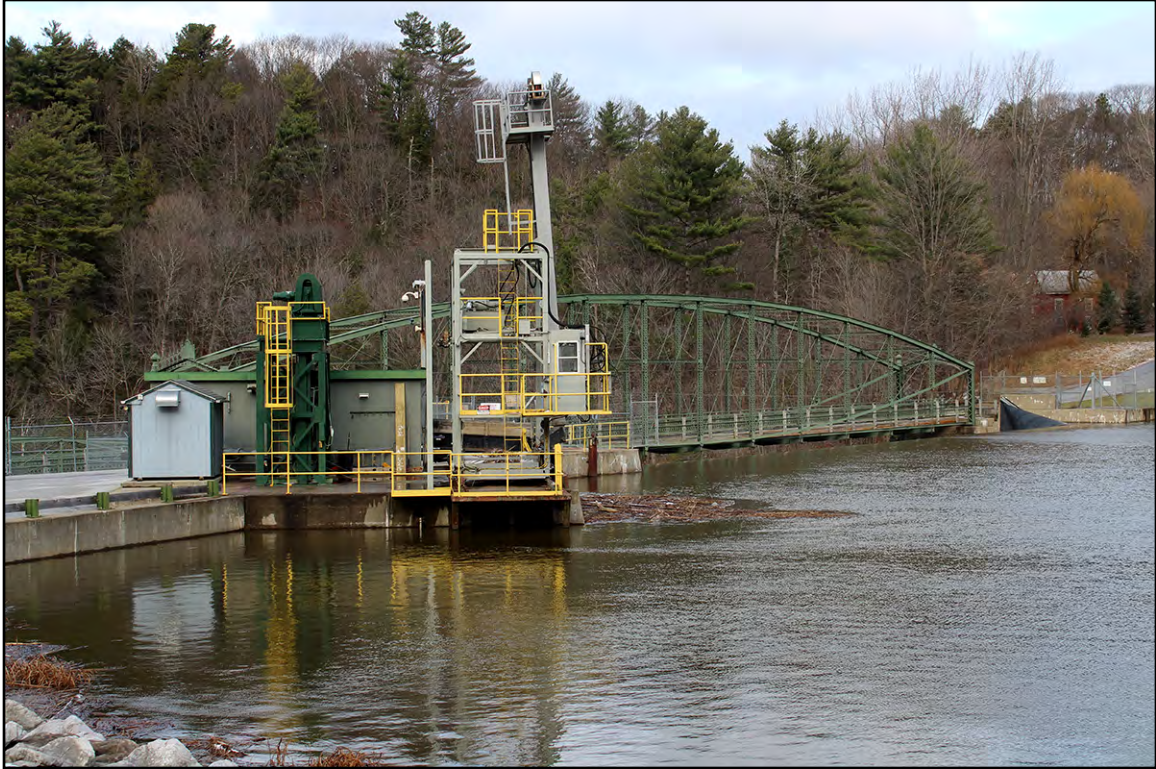
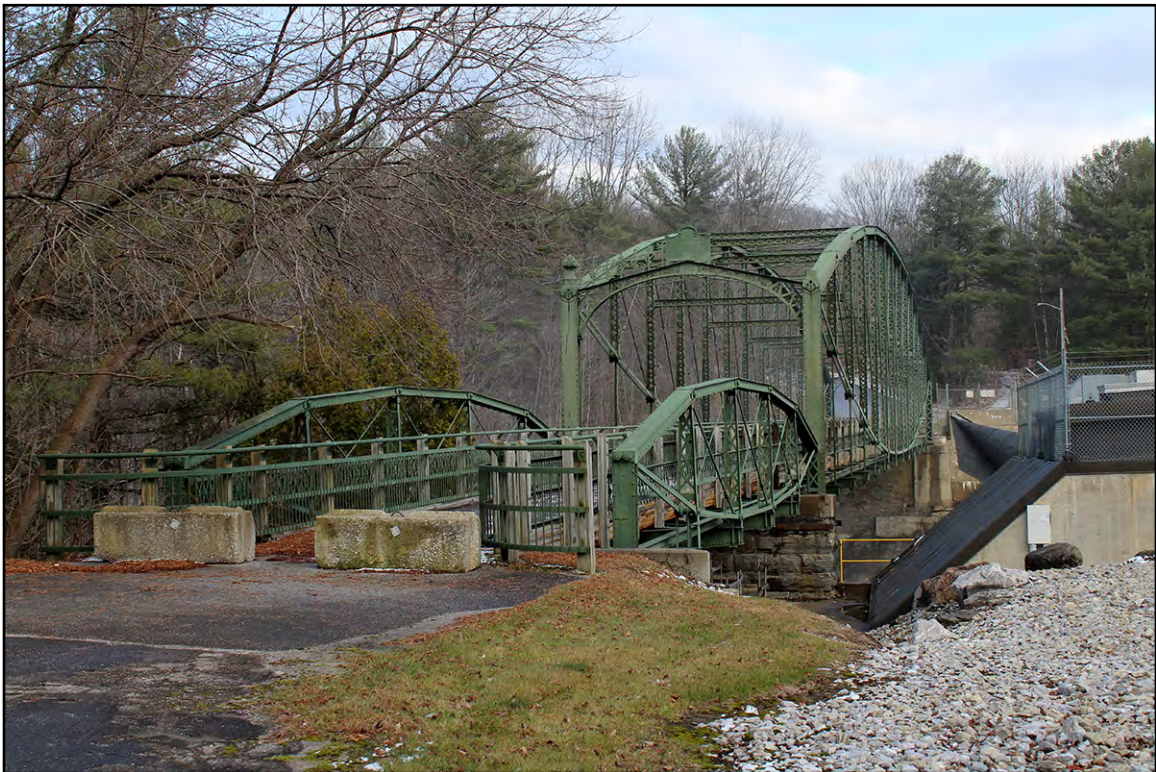
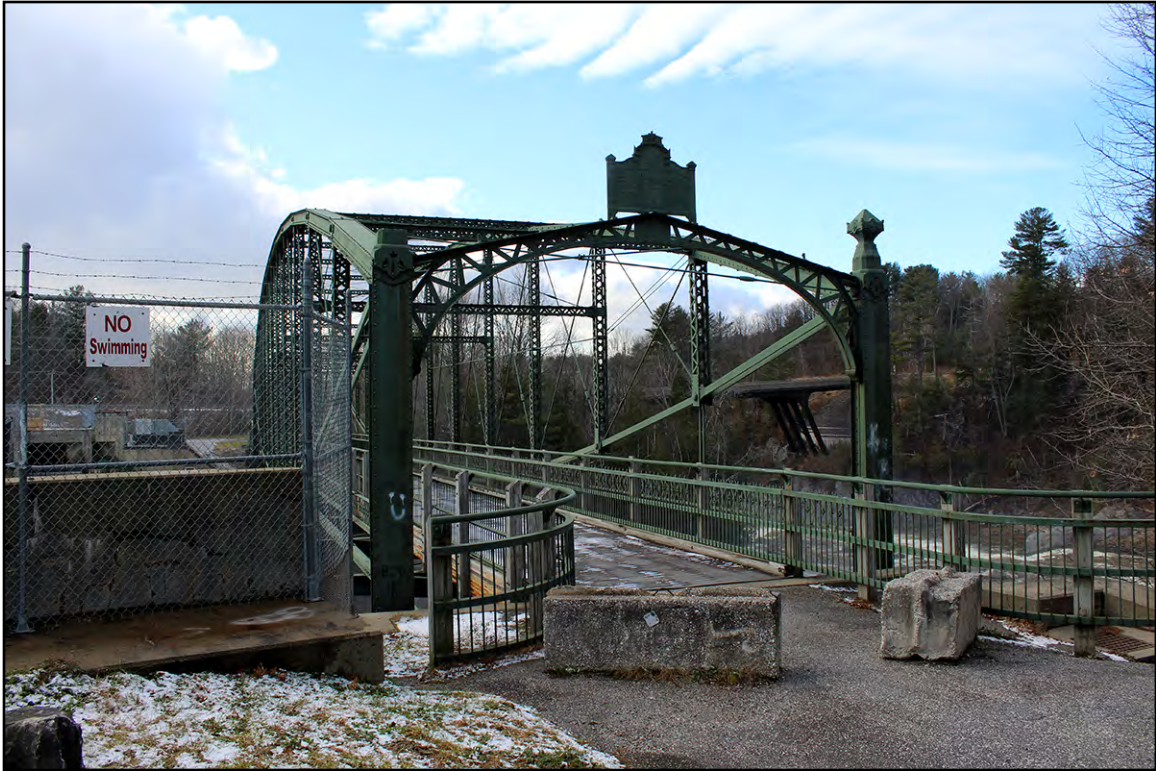
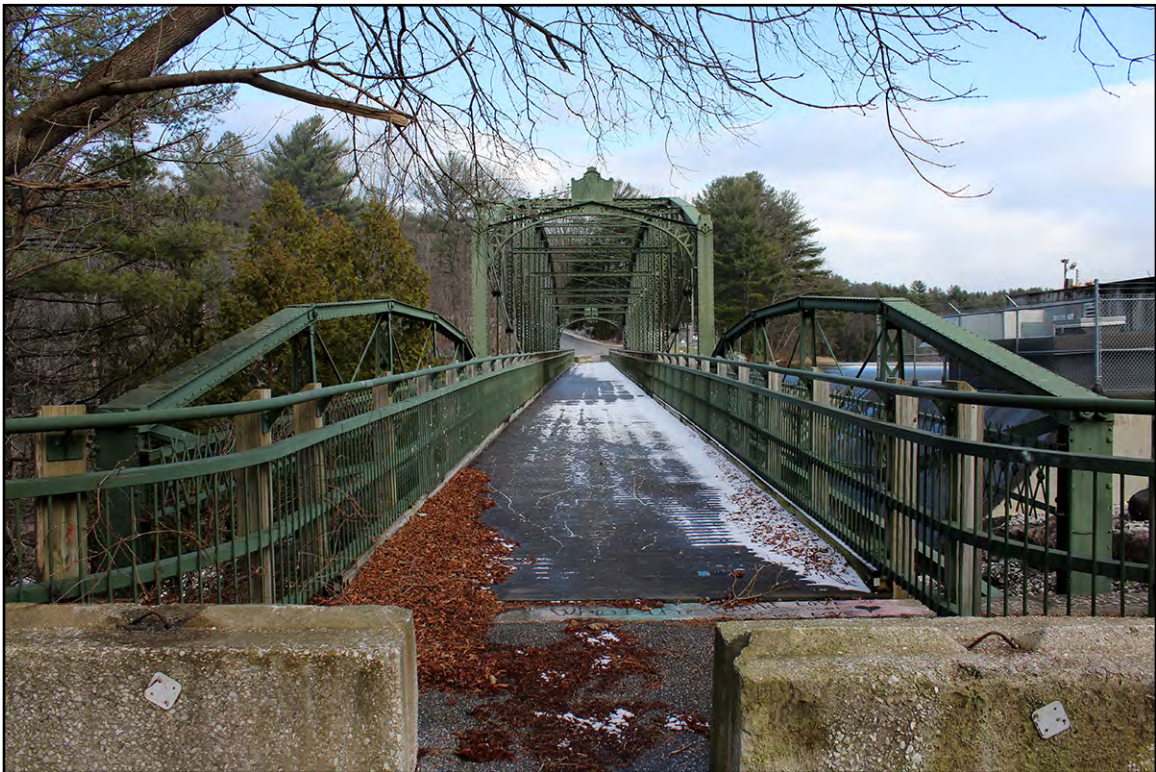
The substructure includes a wood-plank deck anchored by random ashlar and concrete abutments, and a rusticated stone pier with a concrete cap supporting the deck joint. The diagonal floorbeams are pin connected to correlative vertical trusses by rods. The deck is flanked by slotted guard rails reinforced by bolted tapered wood posts.

PLATE 4: Douglas & Jarvis Patent Parabolic Truss Iron Bridge, Crossing the Missisquoi River, Looking Northeast

PLATE 5: Douglas & Jarvis Patent Parabolic Truss Iron Bridge, Crossing the Missisquoi River, Looking East

PLATE 6: Douglas & Jarvis Patent Parabolic Truss Iron Bridge, Crossing the Missisquoi River, Looking West

PLATE 7: Douglas & Jarvis Patent Parabolic Truss Iron Bridge, Crossing the Missisquoi River, Looking East-Northeast

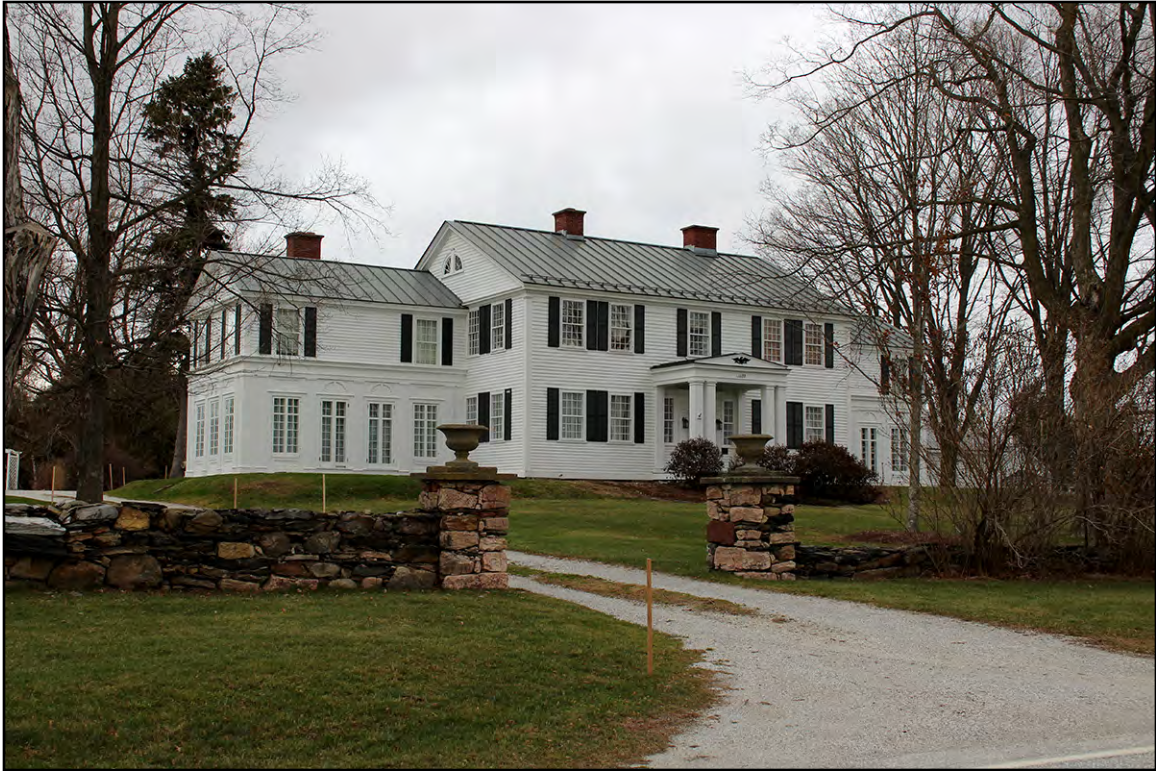
PLATE 8: Rockledge Farm, 2396 Highgate Road, Swanton, Looking Northwest

Built in 1799, the Rockledge Farm is anchored by a two-and-one-half-story Federal farmhouse that rests on a cut-stone foundation. The side-gable roof is covered in standing-seam metal and is pierced by paired interior brick chimneys. The symmetrical clapboarded five-bay main block has 12-over-12 double-hung sash windows. The top floor fenestration engages a denticulated cornice carried by corner pilasters with

molded capitals. The entrance is contained within fluted pilasters and six-by-six sidelights surmounted by a full entablature. A pedimented portico on full entablature supported by two pairs of square columns carried by fluted pilasters shelters the entrance. The quarter-round attic windows, likely added during circa 1918 renovations, sit within pedimented gables (Visser 1994). The rear elevation features a one-story clapboarded shed-roof addition.

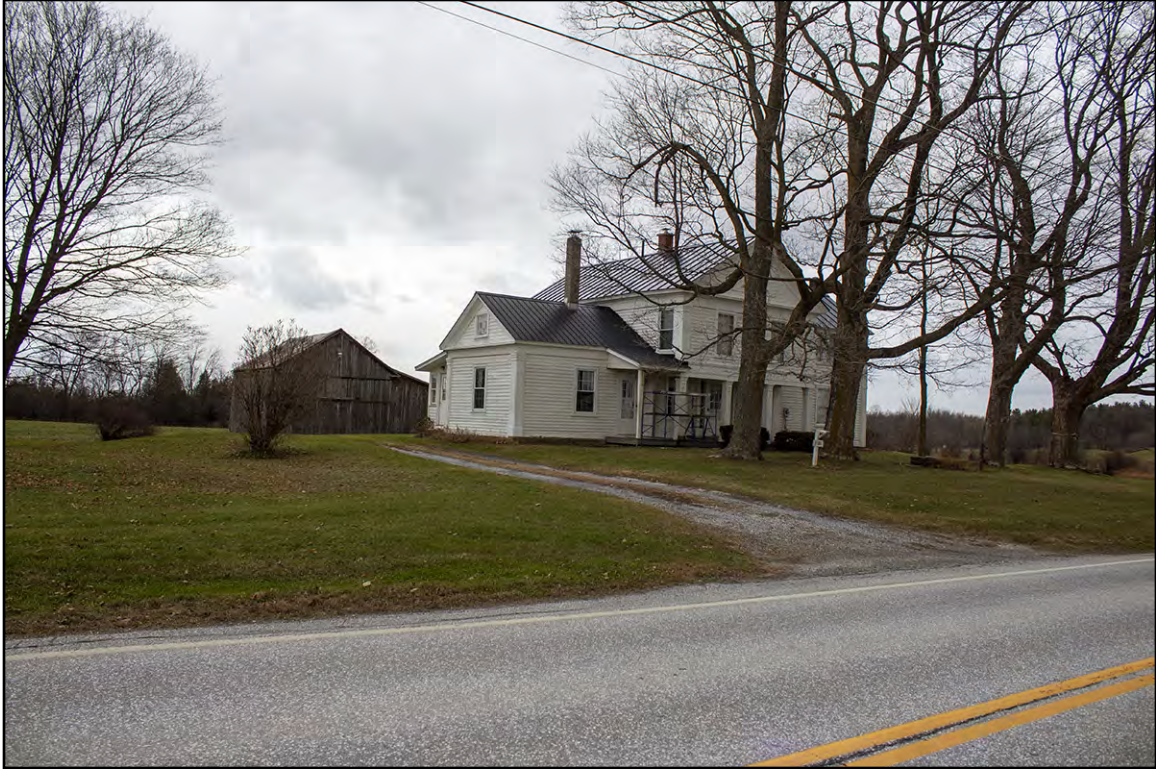
PLATE 12: Tarte House, 2384 Highgate Road, Swanton, Looking North

The circa 1835 Tarte House is a restrained Greek Revival farmhouse that stands two and one-half stories tall on a stone foundation. The temple-front residence with flanking wings is sheathed in clapboards and corner pilasters. The pedimented front-gable roof is covered in standing-seam metal and is pierced by a central ridgeline brick chimney. The pediment rests on plain entablature and has a flush weatherboard tympanum with a triangular attic vent. The symmetrical three-bay façade is lit by six-over-six double-hung sash windows in plain surrounds. The central entrance is a 12-light door flanked by sidelights contained in a simple trabeated frame. Four square columns with recessed paneling support the second-story overhang. The appearance of the wings largely mirrors the main unit. Both wings have cinderblock chimneys. The northeast wing has a second-story addition with paired one-over-one modern windows on the top floor. The first bay on the shorter southwest wing is occupied by a modern six-over-six window, and the second bay is opened by a multi-light door. The door is sheltered by a shed-roof extension on square posts. The shed-roof additions extend from the rear of the main unit and wings.

The Tarte House retains its overall historic integrity despite minor alterations. It may be re-evaluated during later projects. An updated Determination of Eligibility for the NRHP may be considered for any future projects that may affect the historic resource.

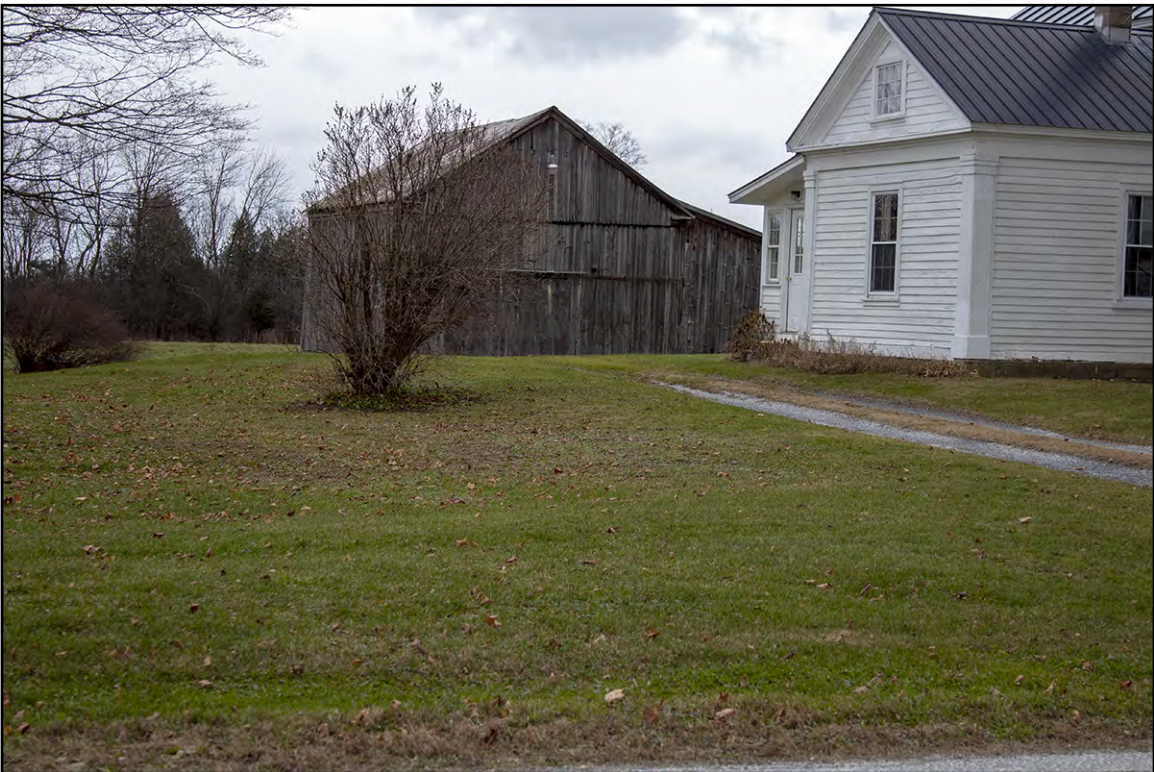
PLATE 15: Barn at Tarte House, 2384 Highgate Road, Swanton, Looking Northwest

The outbuildings include two wood-frame structures: a front-gable barn with a northeast elevation shed addition and a small two-bay shed.

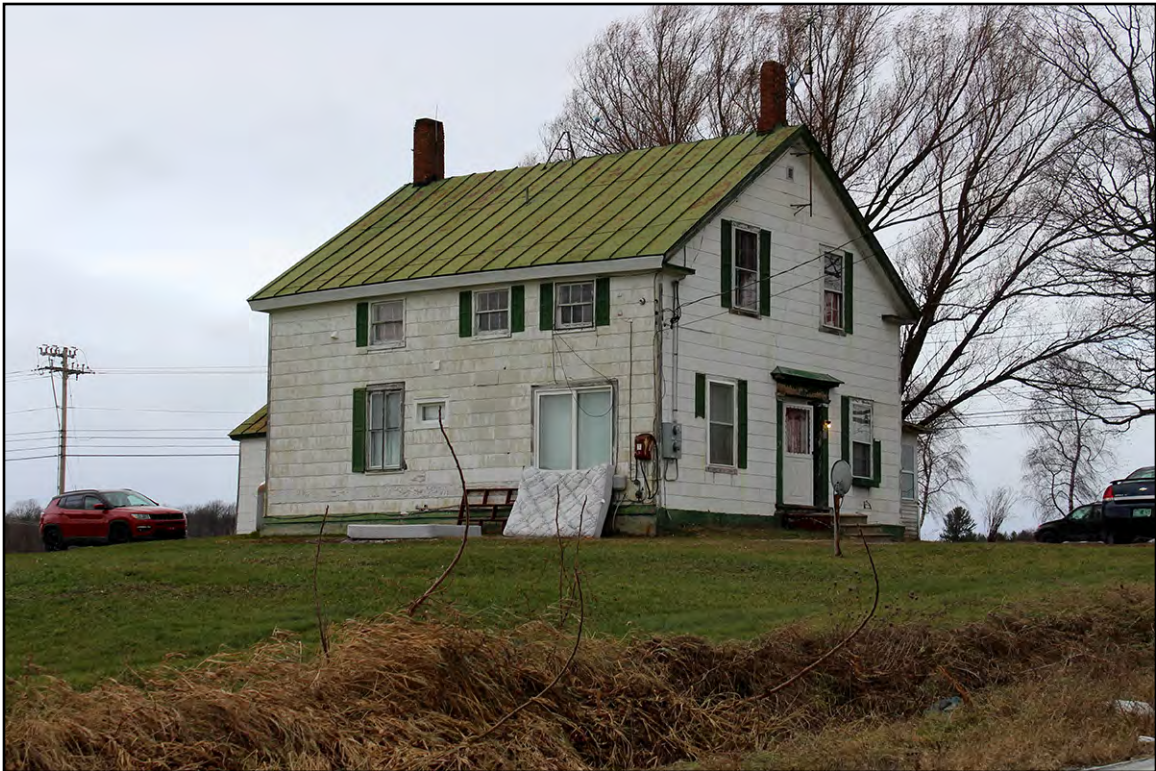
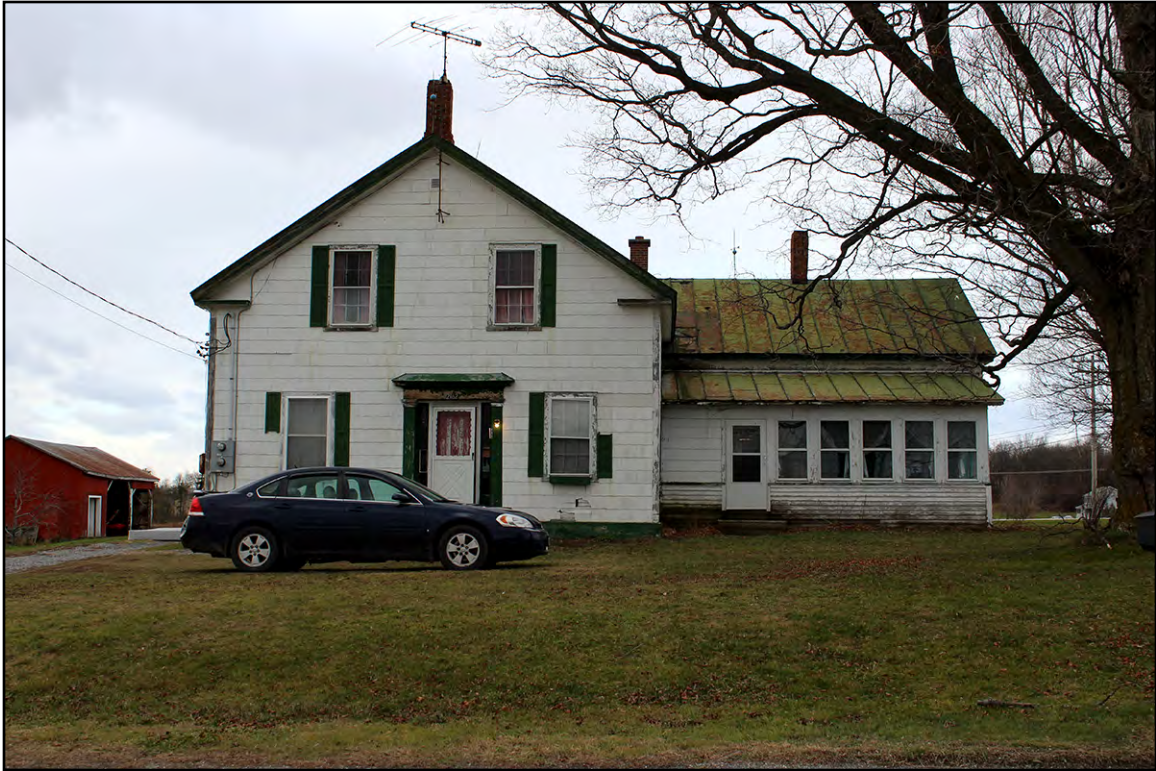
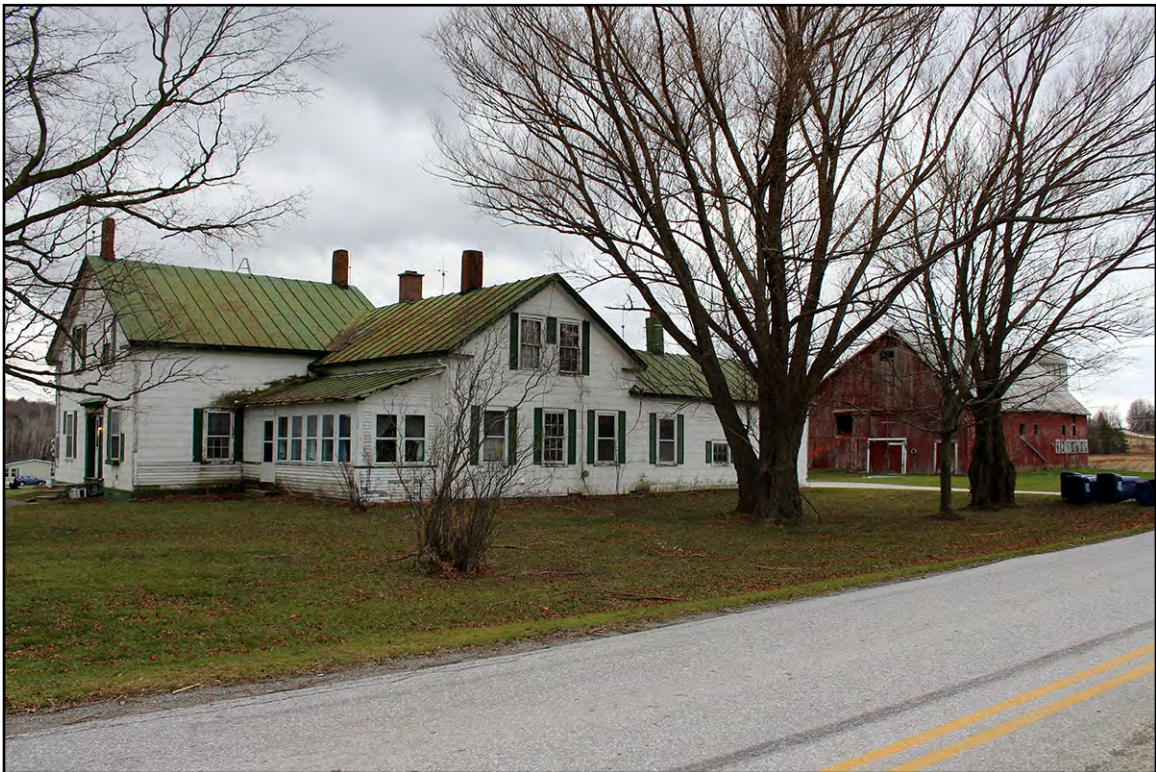
The circa 1835 dwelling on the Jennison-Hubbard Farm is a gable-front-and-wing farmhouse that stands one and one-half stories tall on a stone foundation. The residence has a roof covered in standing-seam metal with internal gable-end brick chimneys and molded cornice with returns. The exterior (including the wing) is clad in asbestos shingles. The fenestration consists of six-over-six double-hung sash windows primarily on the irregular three-bay façade. The first and third bays on the façade are lit by a modern one-over-one and five-over-five windows, respectively, and the first bay on the south elevation has by a modern one-over-one window. A row of three three-over-three attic windows extend just below the south eaves. The off-center entrance is flanked by sidelights and headed by an entablature surmounted on pilasters. A wing extending from the north elevation is pierced by two ridgeline brick chimneys. The gable-end bay configuration, fenestration, cornice returns, and cladding reflect those of the main unit. A full-width shed-roof enclosed porch sheathed in clapboards extends across the wing. An ell extends from the northwest corner of the wing.

Alterations to the property since the original survey (VDHP 1982b) are limited to some windows and the front door. The asbestos siding obscures much of the original material; however, the siding falls within the 50-year historic threshold. The Jennison-Hubbard Farm retains its overall historic integrity, and an updated Determination of Eligibility for the NRHP may be considered for any future projects that may affect the historic resource.

PLATE 17: Jennison-Hubbard Farm, 2162 Highgate Road, Swanton, Looking Northwest

PLATE 18: Jennison-Hubbard Farm, 2162 Highgate Road, Swanton, Looking West

PLATE 19: Jennison-Hubbard Farm and Barn, 2162 Highgate Road, Swanton, Looking Southwest

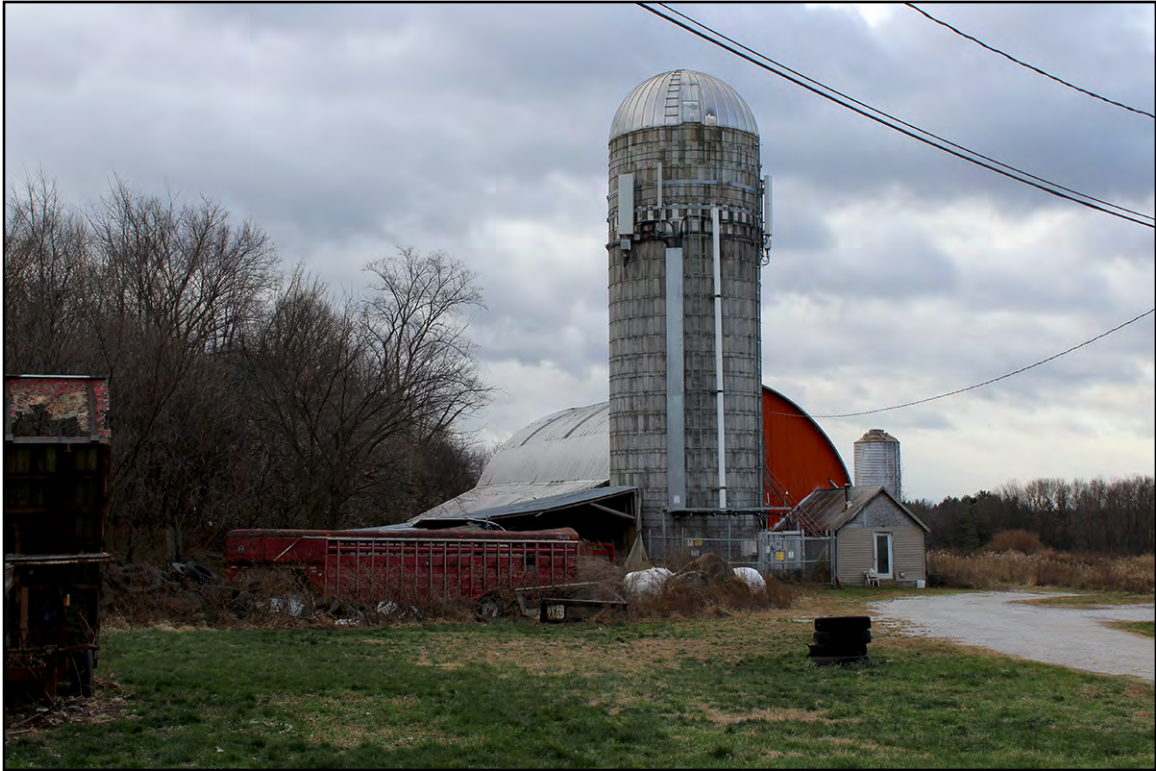
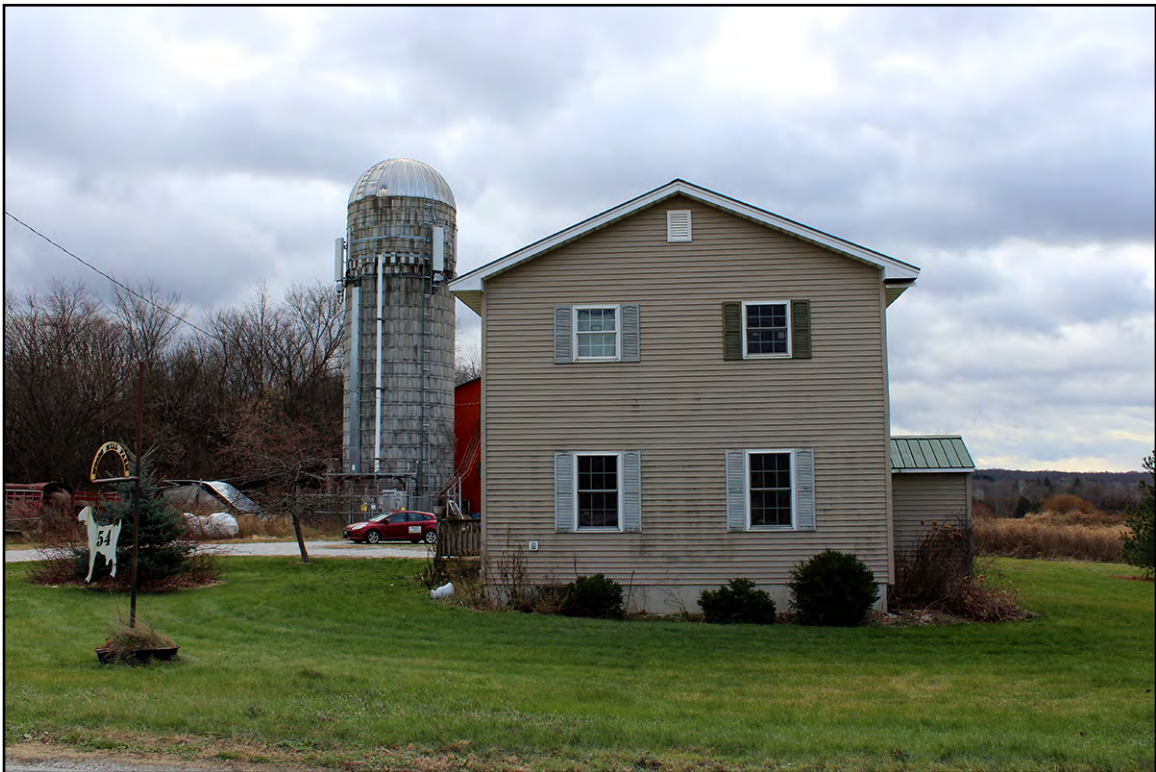
The circa 1950 Machia Silo and Barn are active outbuildings on a 141.1-acre working farm on the south side of Woods Hill Road. The silo is a concrete-stave subtype topped by a standing-seam metal dome. The exterior retains its chute and ladder and has been fitted with a telecommunications array. Adjacent to the silo is a ground-level stable barn with a curved corrugated-metal arch roof. The exterior has vertical metal panels imitating boards, a north gable hay loft, and a series of eave-side windows. A single-bay gabled milk house extends from the façade. Shed-roof additions are found on the east elevation and southwest corner. A short steel granary stands next to the barn and milk house.

The property has remained relatively unmodified since the original survey (VDHP 2009). In addition to the telecommunications antennas, which precipitated the survey, the cladding on the residence and the milk house cladding appear to have been replaced. As the historic integrity of the resource has been diminished since the 2009 environmental review, an updated Determination of Eligibility for the NRHP may be considered for any future projects that may affect the historic resource.

PLATE 24: Machia Silo and Barn, 54 Woods Hill Road, Swanton, Looking South

PLATE 25: Machia Silo and Barn and Residence, 54 Woods Hill Road, Swanton, Looking Southwest

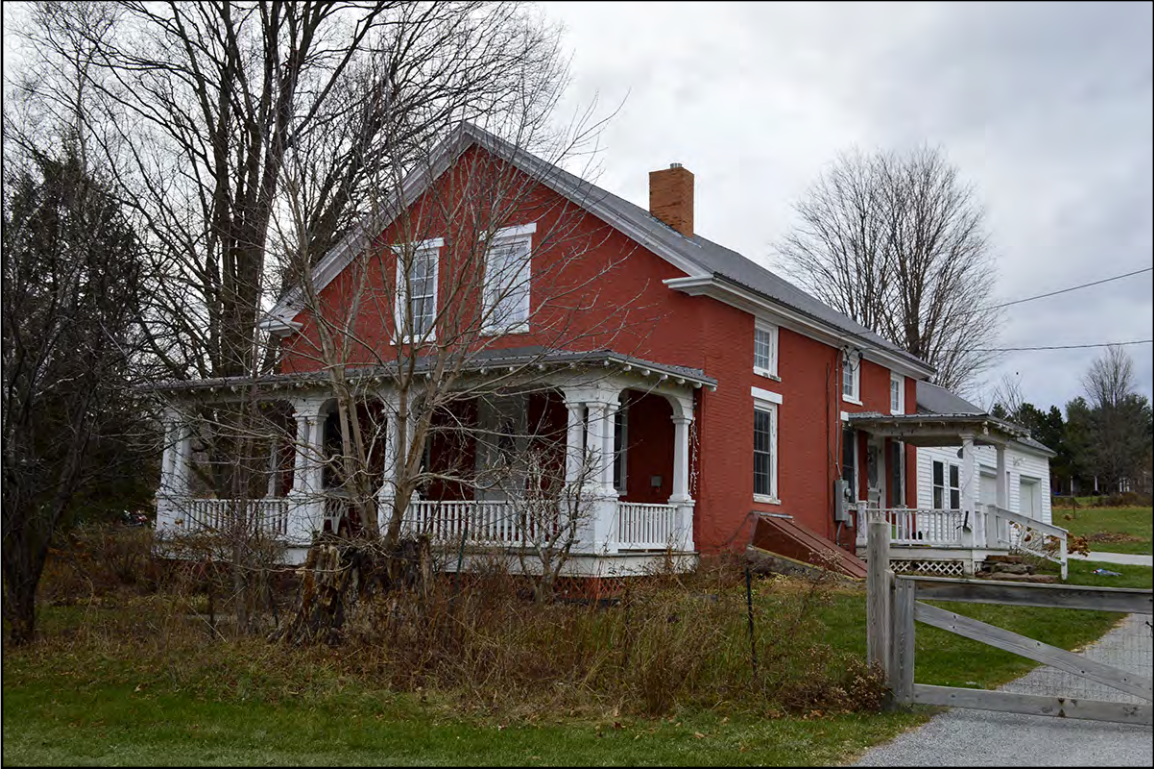
PLATE 27: McMahon House, 543 St. Albans Road, Swanton, Looking North

The circa 1840 front-gable McMahon House stands one-and-one-half stories tall on a stone foundation. The vernacular Greek Revival residence has a painted brick exterior and a corrugated-metal roof with a molded cornice and returns. An internal chimney rises from the south slope. The four-bay façade contains replacement six-over-six double-hung sash windows set within recessed wood surrounds and flat lintels. Small nine-light attic windows are located on the north and south elevations. The full-width façade porch has a hipped roof with exposed rafters surmounted on paired square columns. A smaller version of the front porch shelters the secondary south elevation entrance. The one-story rear ell has been converted into a two-bay garage. The house is partially obscured by evergreens and ornamental shrubs.

The house has been altered since the original survey (VDHP 1982b), notably the windows and porch railings. The replacement windows do not detract from the overall character as they adhere to Greek Revival light configurations with unaltered openings. The McMahon House retains its overall historic integrity, and an updated Determination of Eligibility for the NRHP may be considered for any future projects that may affect the historic resource.

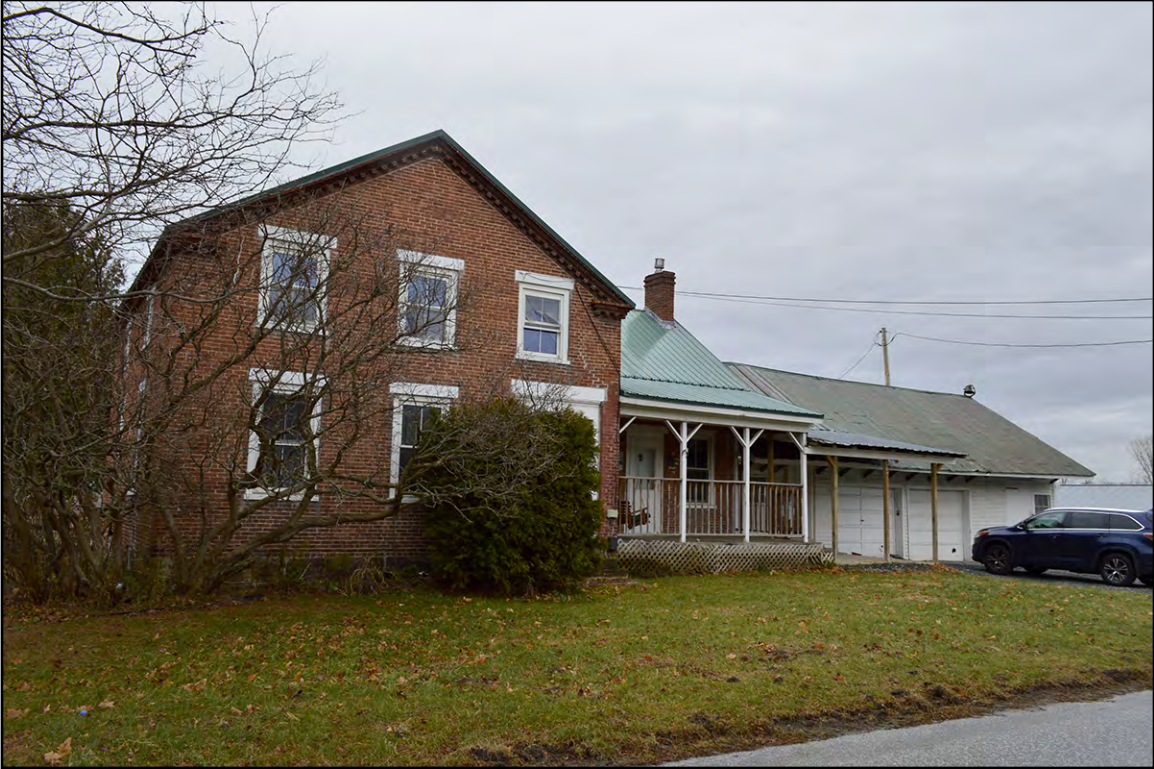
PLATE 29: Brooks-Larson Farm, 2331 Kellogg Road, St. Albans, Looking North

The Brooks-Larson Farm is anchored by a circa 1850 gable-front-and-wing vernacular Greek Revival house. Faced in common bond, the one-and-one-half-story house stands on a stone foundation. The corrugated-metal roof has a corbeled cornice with returns and is pierced by a corbeled internal chimney. The three-bay façade features two-over-two double-hung sash windows with plain lintels and lug sills. The slightly recessed side-hall entry is flanked by sidelights and topped by a lintel. The original three-bay wing on the

north elevation has a corbeled end chimney and a shed-roof porch supported by king posts with simple railings and lattice skirting. A long two-bay garage extends from the wing.

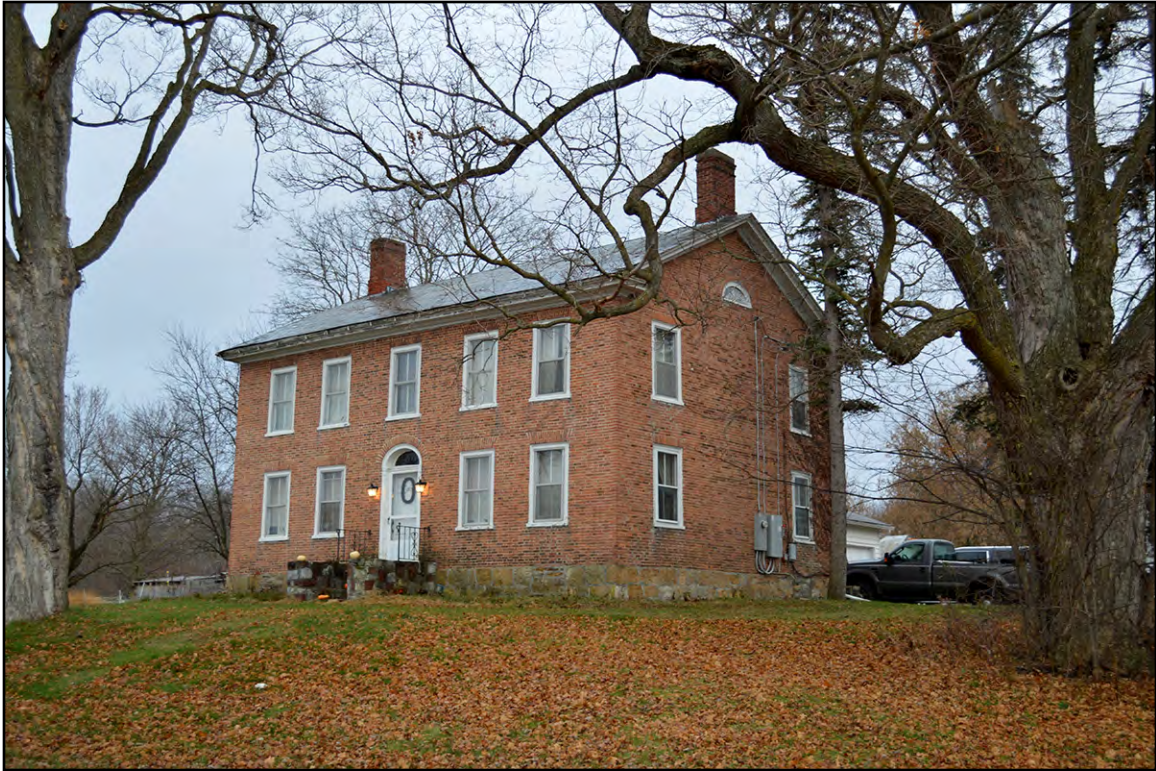
PLATE 31: Tullar-Dunsmore Farm, 2764 Kellogg Road, St. Albans, Looking Northeast

The Tullar-Dunsmore Farm is anchored by a circa 1815 Federal farmhouse. This massed side-gable residence stands two and one-half stories on a stone foundation. The roof is covered in slate and has two interior end chimneys. The gently molded cornice has returns and runs atop the second-story windows. The brick exterior is faced in Flemish bond on the façade and American bond on the gable ends. The symmetrical five-bay façade contains two-over-two double-hung sash windows topped by flat brick splayed lintels. Additional fenestration includes two-light semi-elliptical attic windows at both gables. The central entrance is a recessed paneled door surmounted by a segmental arch fanlight with radiating muntins; the stone steps were added circa 1950 (VDHP 1985). The one-story rear ell with an integrated garage is slightly offset from the northeast corner.

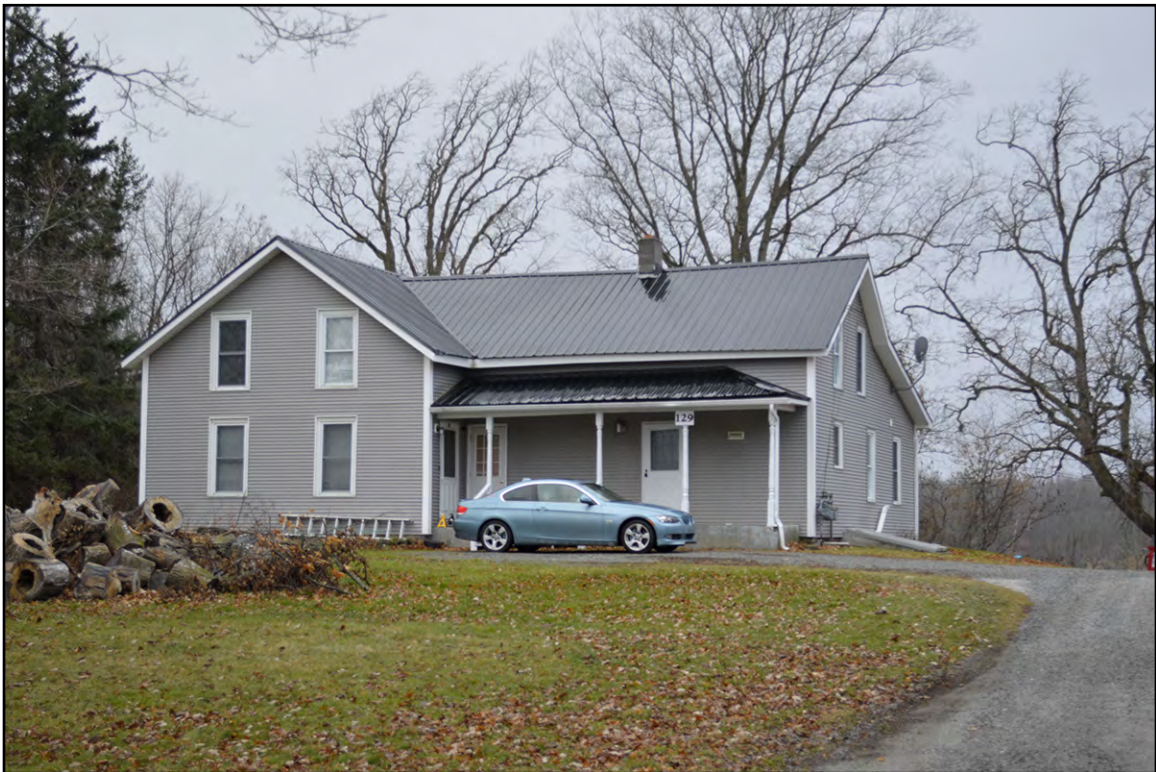
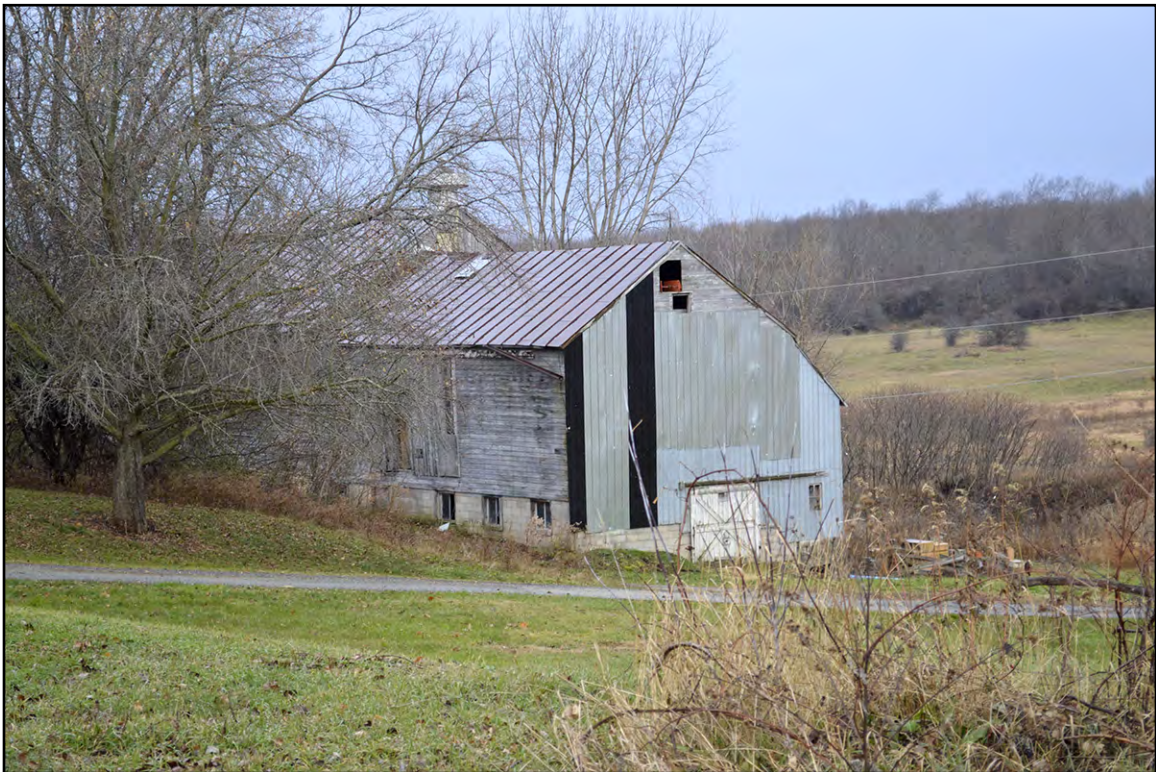
The Brigham-Lareau Farm is anchored by a circa 1870 gable-front-and-wing house set back from Brigham Road. The one-and-one-half-story house has a corrugated-metal roof, replacement one-over-one windows, an aluminum siding exterior, and a rear ell. A hipped-roof porch on turned posts extends across the wing. Shed-roof additions are located on the rear elevation and the ell's south elevation.

PLATE 34: Brigham-Lareau Farm, 129 Brigham Road, St. Albans, Looking West

PLATE 36: Brigham-Lareau Farm Barn, 129 Brigham Road, St. Albans, Looking Southwest

The property has been extensively altered since the VDHP (1985) survey. The house's fabric and stylistic elements have been replaced by modern materials and no longer convey any association as a mid-nineteenth-century rural farmhouse. Furthermore, the outbuildings are obscured from the Public ROW by buildings and vegetation. As the historic integrity of the farmstead has been diminished since the 1985 survey, an updated Determination of Eligibility may be considered for any future projects that may affect the historic resource.

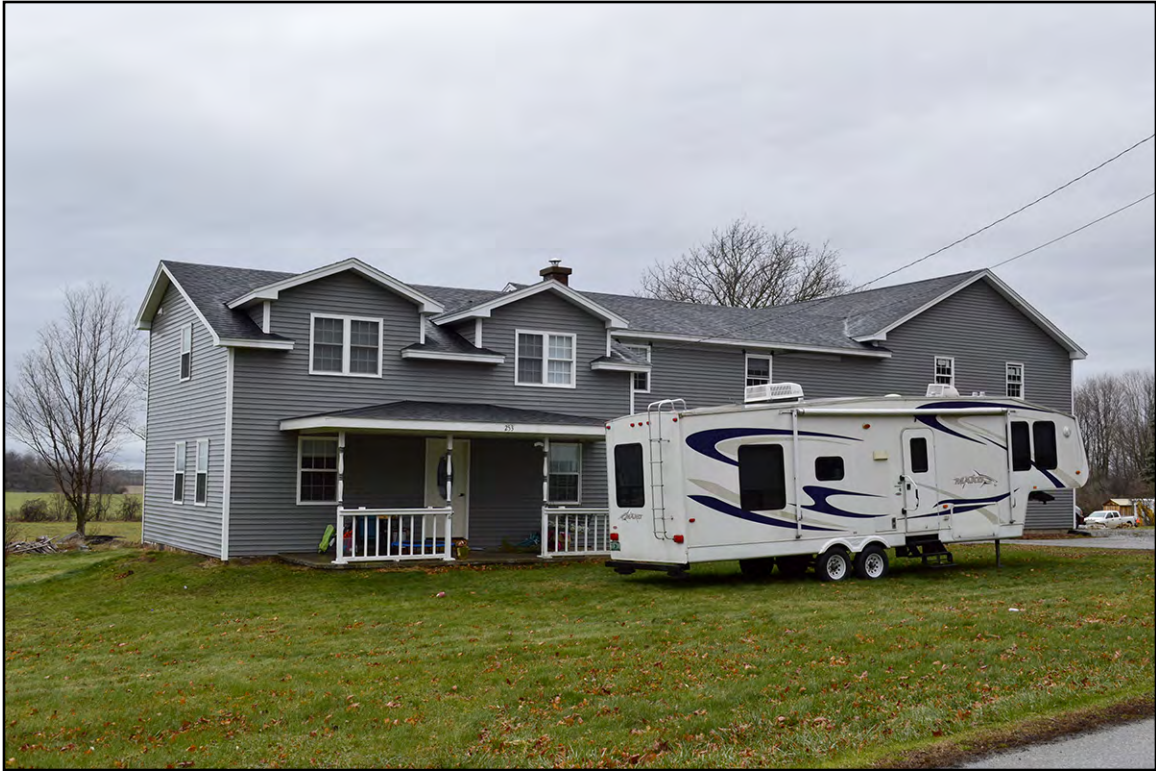
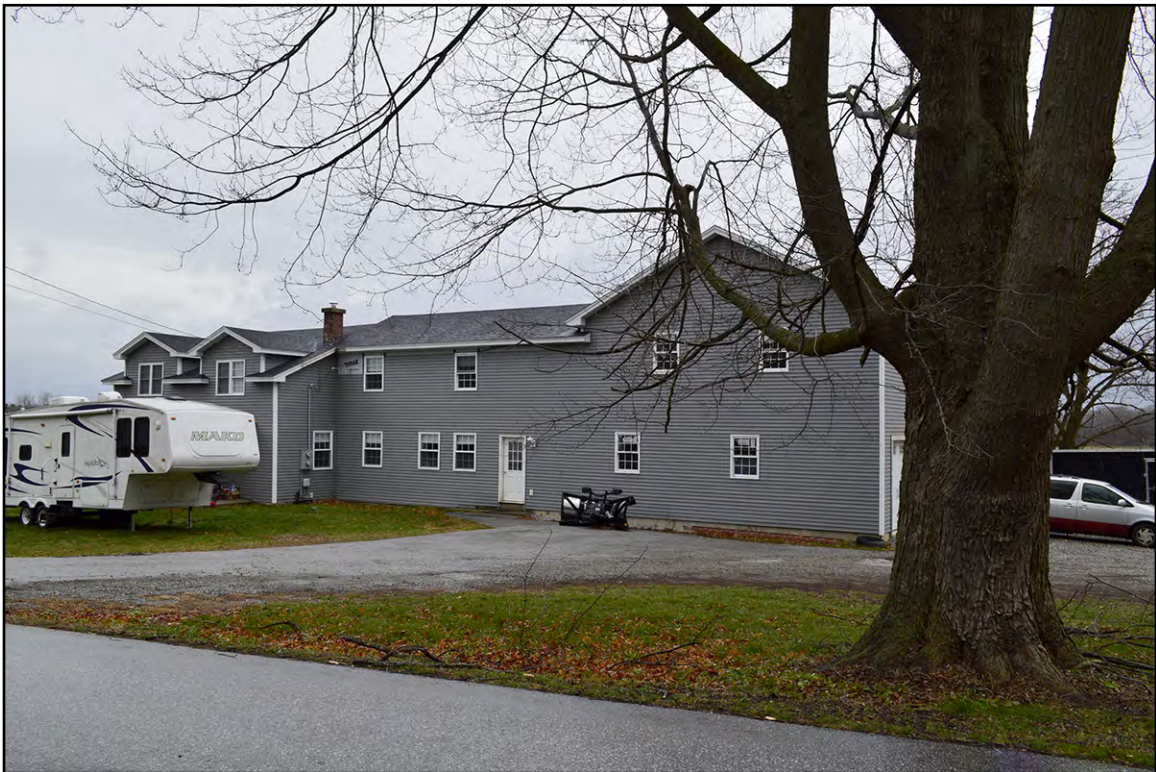
The circa 1835 Old Wright House stands one and one-half stories tall on a stone foundation. The residence has an asymmetrical side-gable roof covered in asphalt shingles, an internal brick chimney, modern six-over-six windows, and aluminum siding. A hipped-roof porch on turned spindles protects the three-bay main unit façade. A two-story cross-gable wing on the north elevation features the same exterior materials and fenestration of the main block, albeit with window openings with slightly different dimensions. The front-gable portion includes a two-bay garage. A hipped hood shelters the garage doors and the central recessed entry.

The house has been drastically modified since the initial evaluation (VDHP 1985). These changes consist of an altered roof; replacement windows, doors, and siding; a façade porch; and second-floor and garage additions on the wing. As the historic integrity of the property has been diminished since the 1985 survey, an updated Determination of Eligibility may be considered for any future projects that may affect the historic resource.

PLATE 37: Old Wright House, 255 Kellogg Road, St. Albans, Looking Northwest

PLATE 38: Old Wright House, 255 Kellogg Road, St. Albans, Looking Southwest
