# ARCHITECTURAL RECONNAISSANCE SURVEY FRANKLIN COUNTY LINE UPGRADE PROJECT

Franklin County, Vermont

December 22, 2023

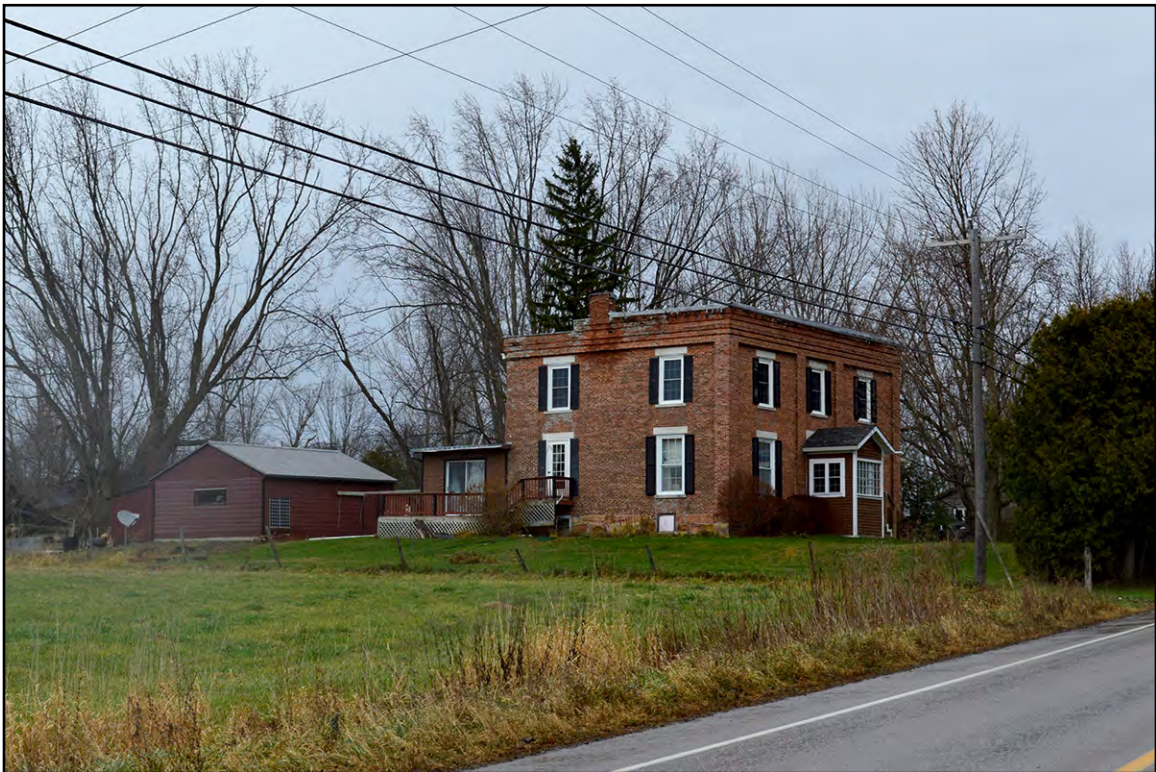
The Old Pelkey Farm is anchored by a circa 1845 two-story square-plan tempered Greek Revival house faced in common bond on a stone foundation. The parapeted roof has two internal brick chimneys, on the east and west elevations. A corbeled frieze partitions brick plasters on the corners and the three-bay façade. The pilaster grouping creates unequal bays opened by modern six-over-six double-hung sash windows with flat lintels and lug sills. The cellar windows are boarded and align with each bay. The central entrance is sheltered by a clapboarded gabled vestibule with a large 28-light window. A hipped-roof porch with short tapered columns and a clapboarded apron protects the east elevation entrance. The one-story rear addition has a shed roof, shingled exterior, sliding glass doors, and a wood deck.

The alterations since the original evaluation (VDHP 1985) consist of replacement windows and cladding on both porches. The windows honor Greek Revival light configurations, and the modern cladding does not detract from the house's peculiar composition. The Old Pelkey Farm retains its overall historic integrity, and an updated Determination of Eligibility for the NRHP may be considered for any future projects that may affect the historic resource.

PLATE 40: Old Pelkey Farm, 447 Lake Road, St. Albans, Looking East-Northeast

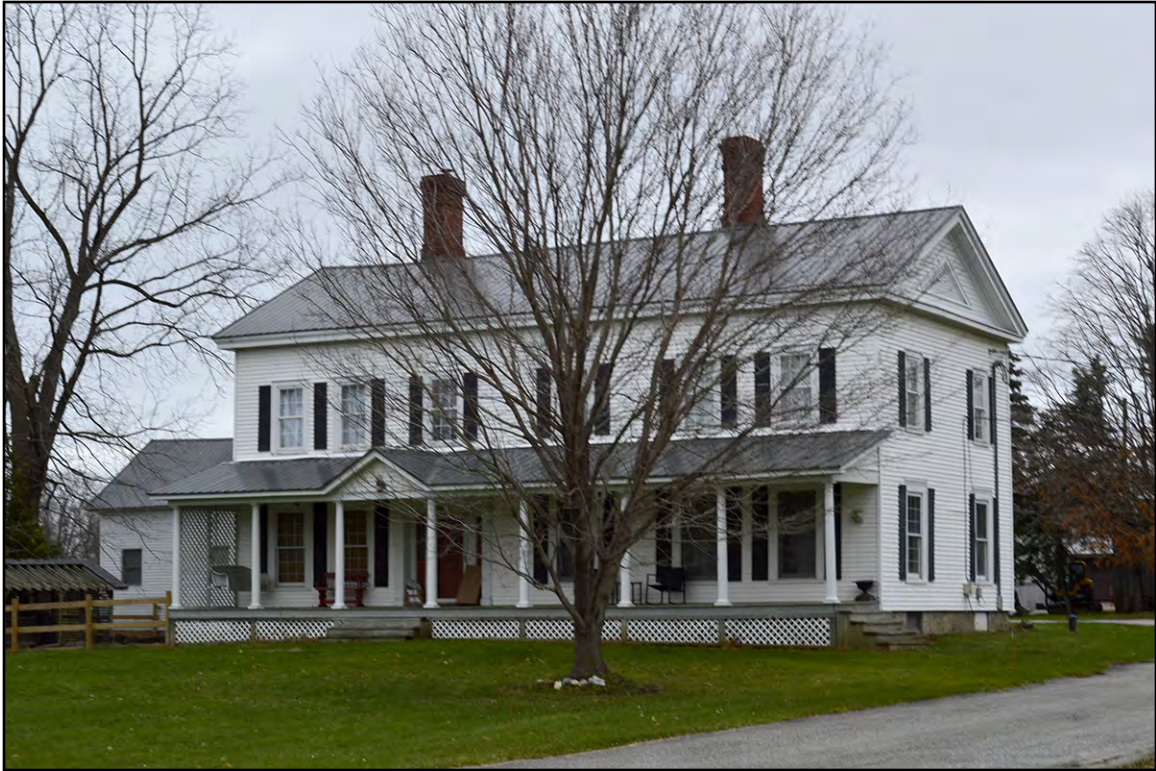
PLATE 43: Burton-Guay-Boissoneault Farm, 549 Lake Road, St. Albans, Looking Northwest

The farmstead is associated with the Burton family, a prominent, prosperous agricultural and commercial shipping family in the St. Albans region throughout the nineteenth century. However, the house has been further modified since the original survey (VDHP 1985). These changes include the façade porch, front entry, and sidelights, although the replacement windows adhere to the six-over-six Greek Revival sash configurations and the lintels are intact. Furthermore, the outbuildings are not associated with nineteenth-century agricultural practices and have been recently altered or constricted, specifically the grain bins. The Burton-Guay-Boissoneault Farm only retains a moderate amount of historic integrity, and an updated

Determination of Eligibility for the NRHP may be considered for any future projects that may affect the historic resource.

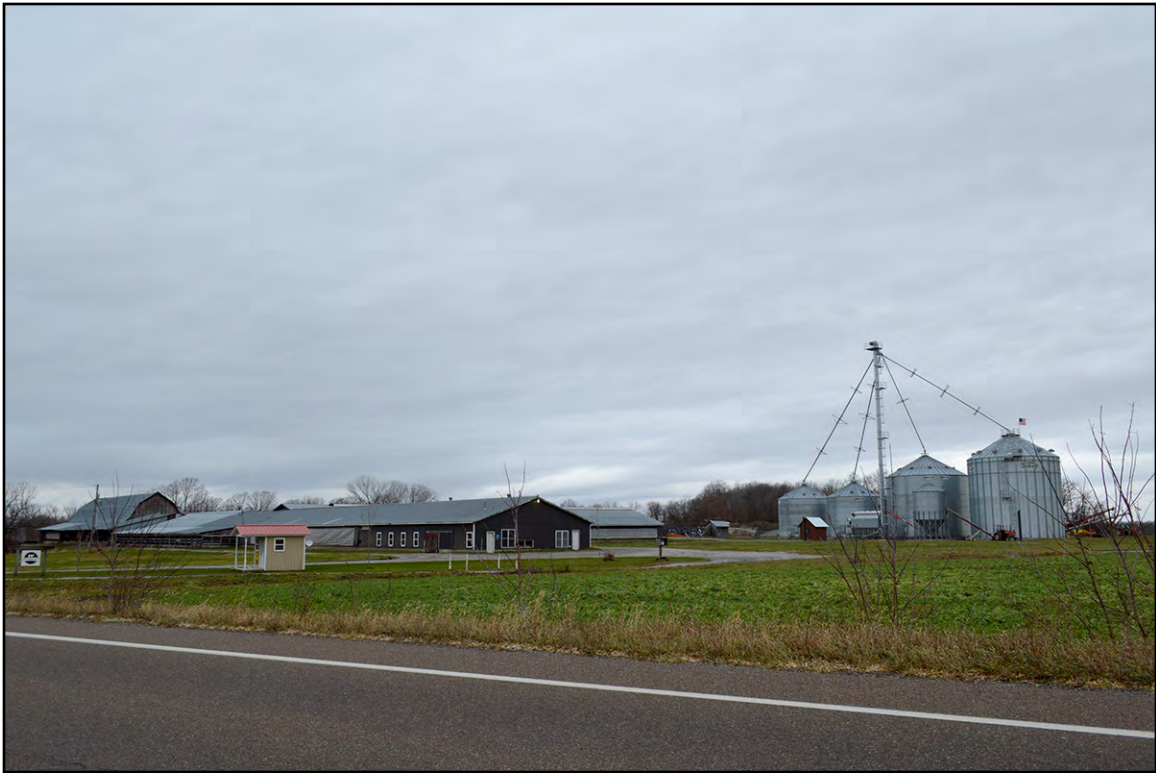
PLATE 45: Outbuildings at Burton-Guay-Boissoneault Farm, 549 Lake Road, St. Albans, Looking Northwest

The large parcel contains several outbuildings. The largest is a circa 1965 ground-stable barn sheathed in vertical boards and capped by a metal gambrel roof. The barn has been extended by a gabled T-plan cattle stall and a rear ell with a rounded metal roof. Behind this addition are five metal grain bins of graduating heights. Additional outbuildings include a circa 1920 wood-frame barn and various circa 1960 barns and sheds sheathed in novelty siding. A cattle pond is behind the cattle stalls and flanked by the rear additions.

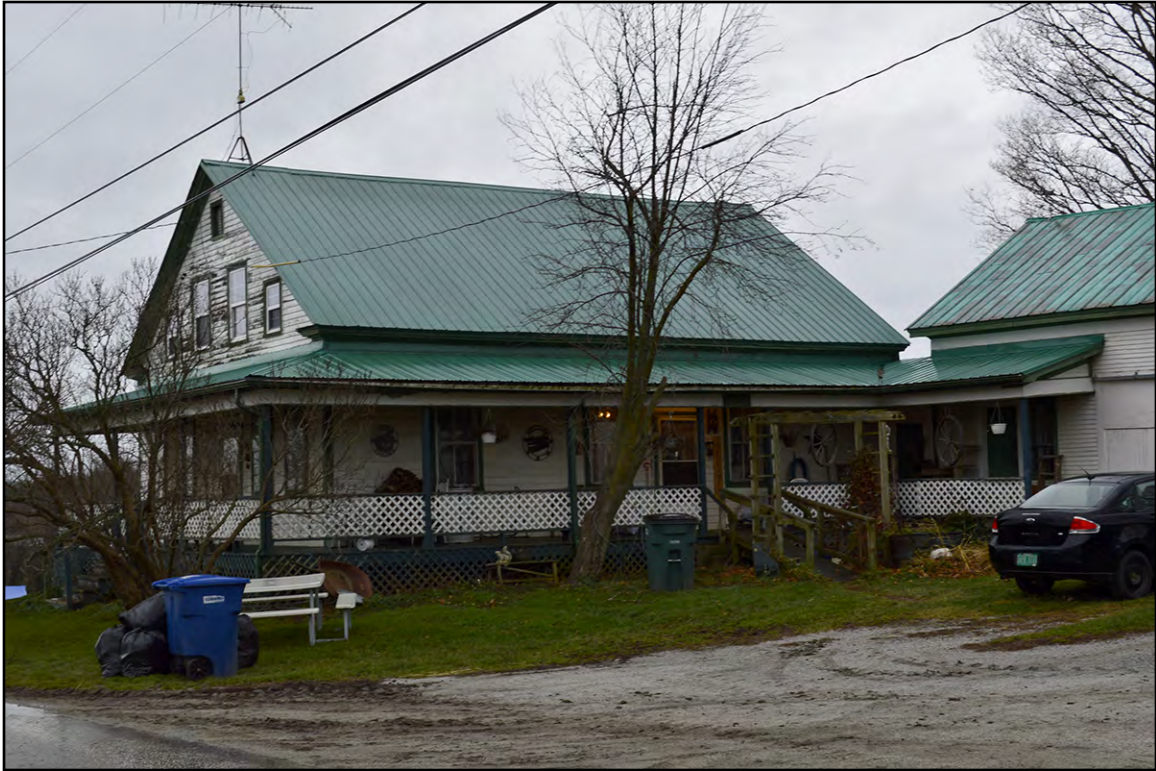
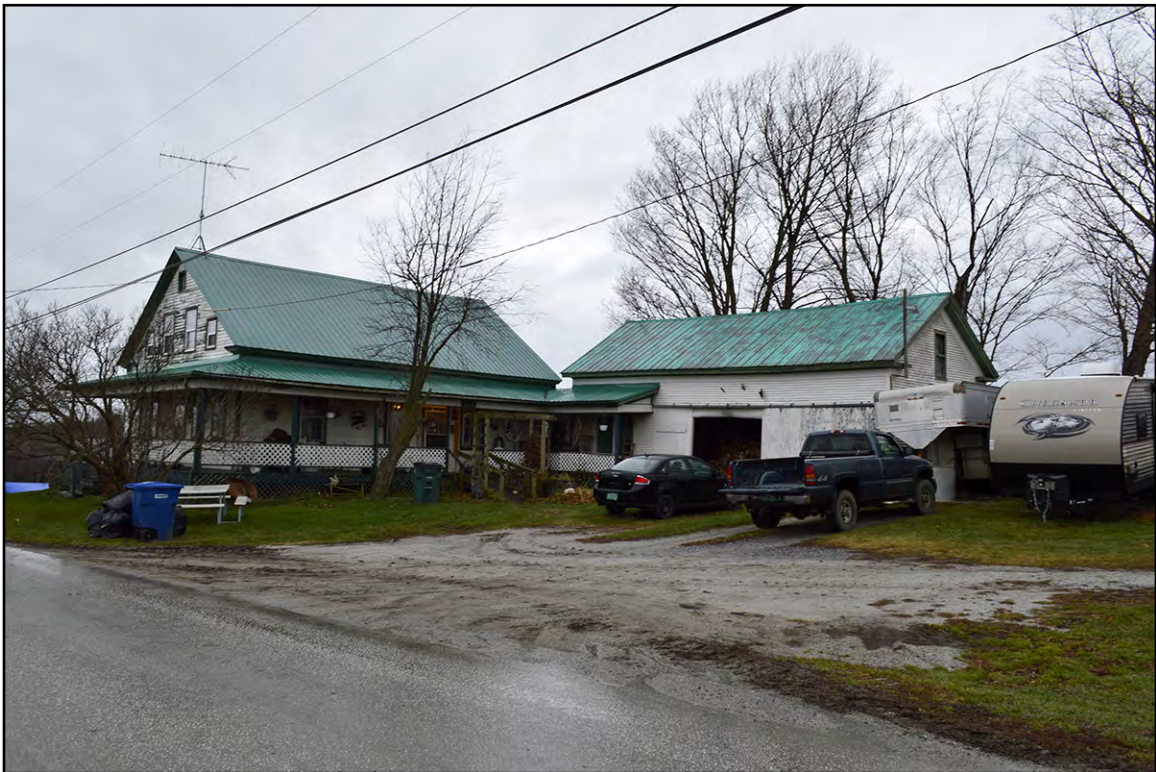
The circa 1815 Connors-Cameron House stands one and one-half stories tall on a stone foundation. The front-gable house has a standing-seam metal roof with boxed eaves and cornice returns. The off-center entrance is flanked on either side with two windows. Above, two full-size gable-end windows are flanked by smaller windows, all of which have been updated with modern six-over-six and four-over-four replacements, respectively, since the time of the property's listing in the SRHP. The dwelling is clad in wood siding. A twentieth-century porch with lattice railing wraps around the front (east) elevation to the north side. The porch then turns again to the north to connect to the attached carriage barn. The side-gable carriage barn has cornice returns like the main house, with a sliding wood barn door, which was not apparent at the time of the VDHP (1985) survey.

Changes to the house since the VDHP (1985) survey include replacement windows, and a new lattice porch railing. These changes do not seriously compromise the dwelling's historic integrity, nor do they diminish the property's significance as one of the earliest surviving farmsteads in the area. The Connors-Cameron House retains its overall historic integrity, and an updated Determination of Eligibility for the NRHP may be considered for any future projects that may affect the historic resource.

PLATE 46: Connors-Cameron House, 1715 Bronson Road, St. Albans, Looking Southwest

PLATE 47: Connors-Cameron House and Barn, 1715 Bronson Road, St. Albans, Looking Southwest

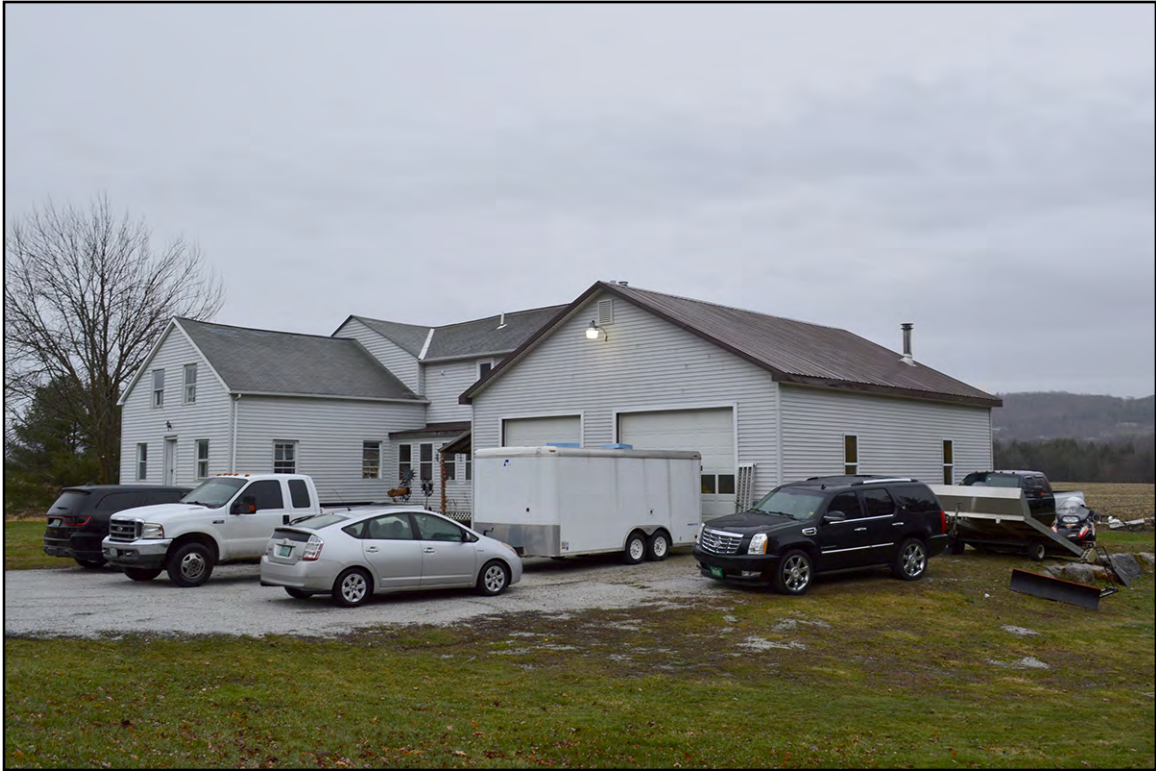
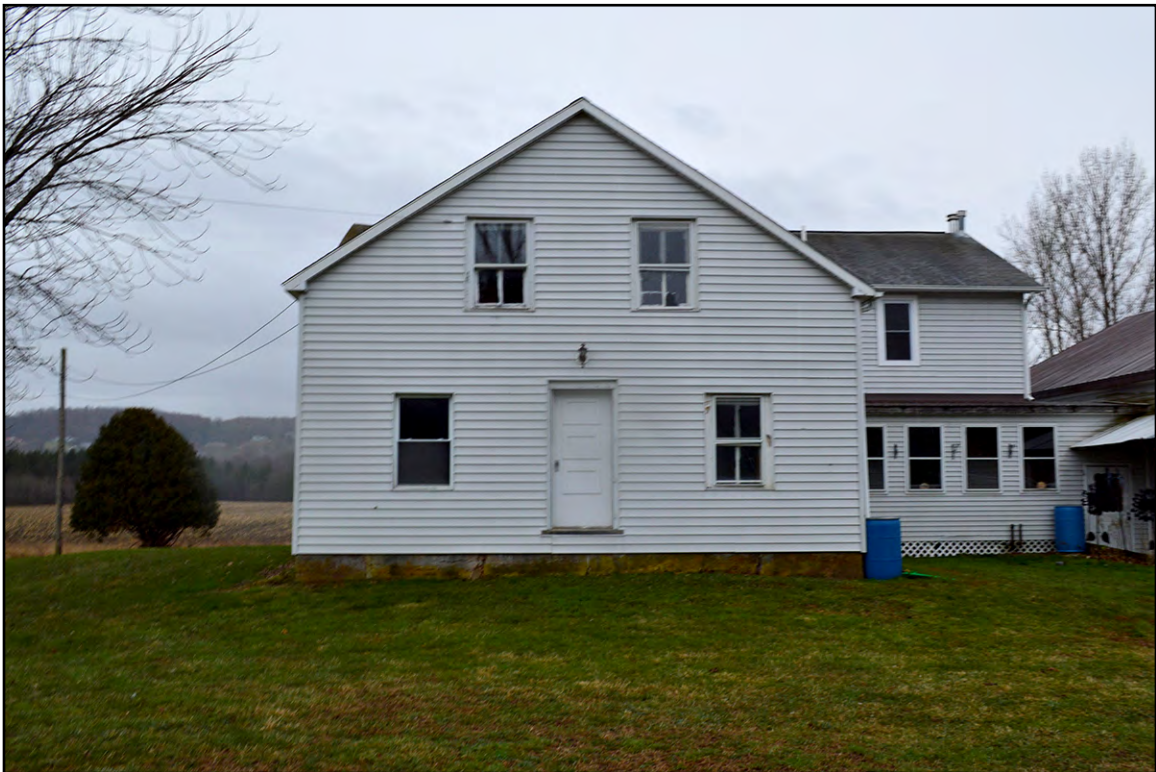
The alterations since the VDHP (1985) survey involve the replacement windows and the faux doorway surround. The latter component is historically, architecturally, and geographically incompatible. The style of doorway is unique to the region for which it is named, nearly 150 miles to the southeast, and is a Georgian feature, a style that predates the house by 70 years, both of which are only extant in southern Vermont. Additional changes to property include modern windows and outbuildings, notably the Quonset hut. A recent VDHP environmental review of the property found that the resource has lost much of its historic integrity owing to twentieth-century alterations and that it is no longer eligible for SR/NRHP listing.

PLATE 52: Smith-Stevens House, 742 Bronson Road, St. Albans, Looking East-Northeast

PLATE 53: Smith-Stevens House, 742 Bronson Road, St. Albans, Looking Southeast

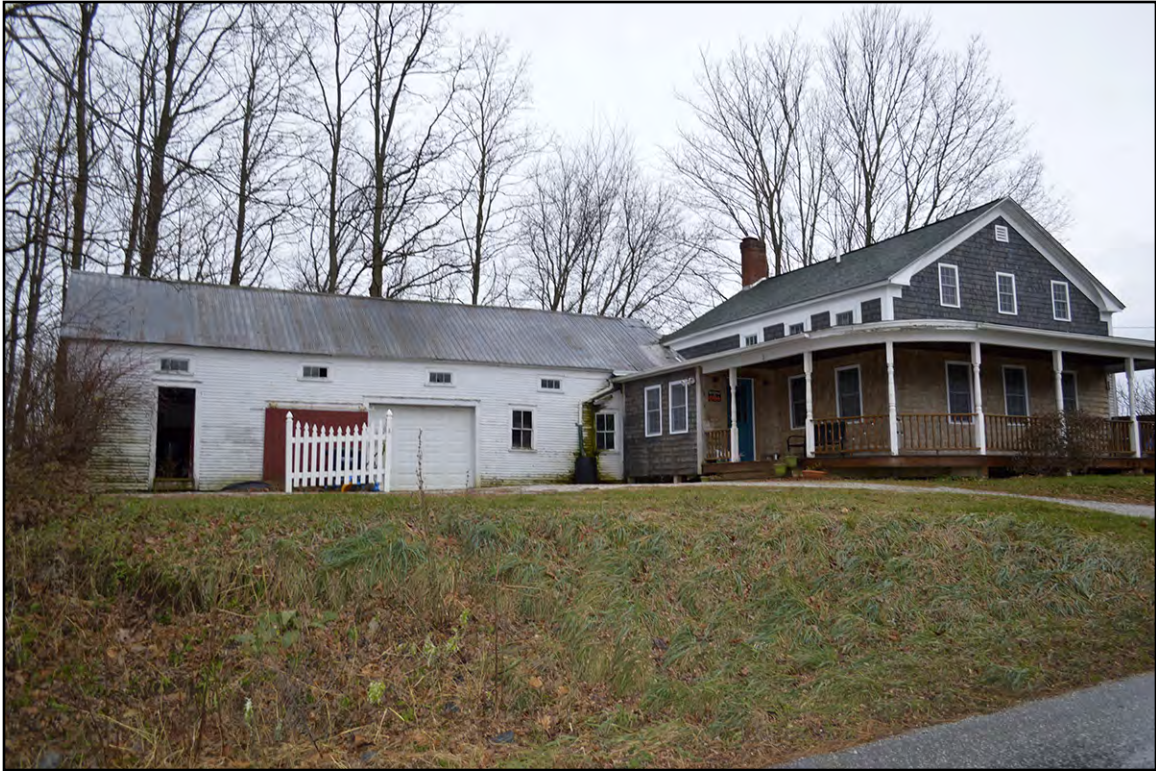
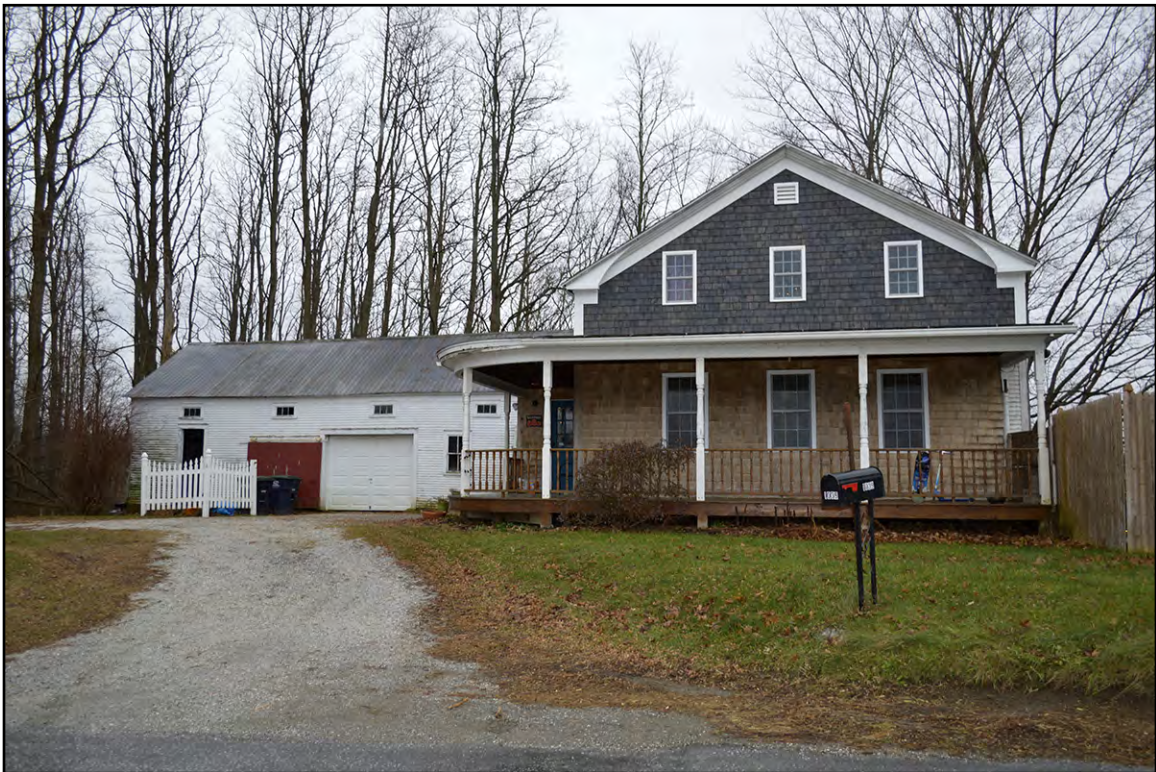
The circa 1865 Meigs-Armstrong House is a front-gable residence that stands one and one-half stories tall on a stone foundation. The dwelling's Statement of Significance in the VDHP (1980) survey notes its curved L-shaped metal-tiled roof porch with spindle work valance and railing: "This sound vernacular building has a very unusual and beautiful curve porch exhibiting masterful carpentry work. There are none like it in Georgia and probably very few in the region." Since then the valance has been removed and the railing replaced, and like the house's main roof, the porch roof is now covered with asphalt shingles. The house's central entrance has been removed, and an enclosed foyer built under the porch. Originally clapboarded, the house is now clad in novelty wood-shingle siding. All of the windows have also been replaced, and the cornice return eaves have been altered. The interior end brick chimney at the rear of the house remains, but the others have been removed.

A large side-gable attached carriage barn is located at the southeast corner of the dwelling. The barn is five bays wide with clapboard siding and metal roofing. Part of the sliding barn door entrance has been replaced with a modern steel garage door, but the rest of the fenestration appears to remain intact with two-over-two double-hung wood windows on the main level and three-light kneewall windows.

PLATE 59: Meigs-Armstrong House, 1039 Mill River Road, Georgia, Looking Southwest

PLATE 60: Meigs-Armstrong House, 1039 Mill River Road, Georgia, Looking South

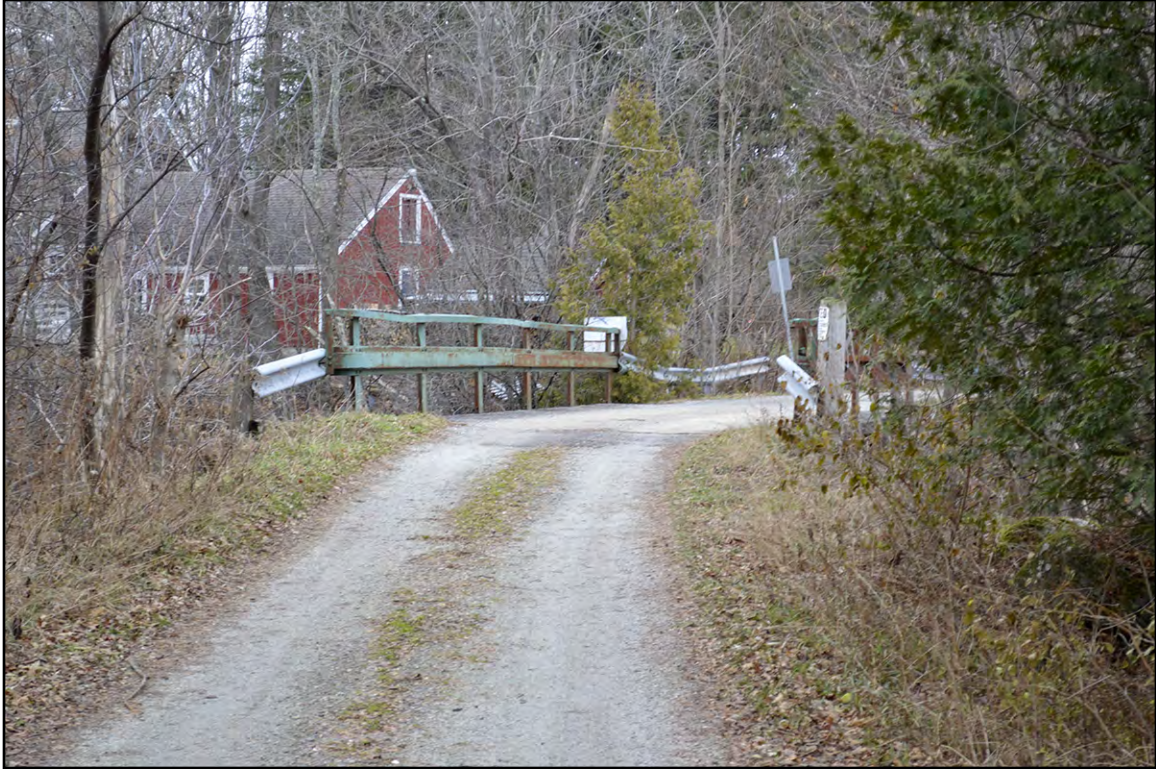
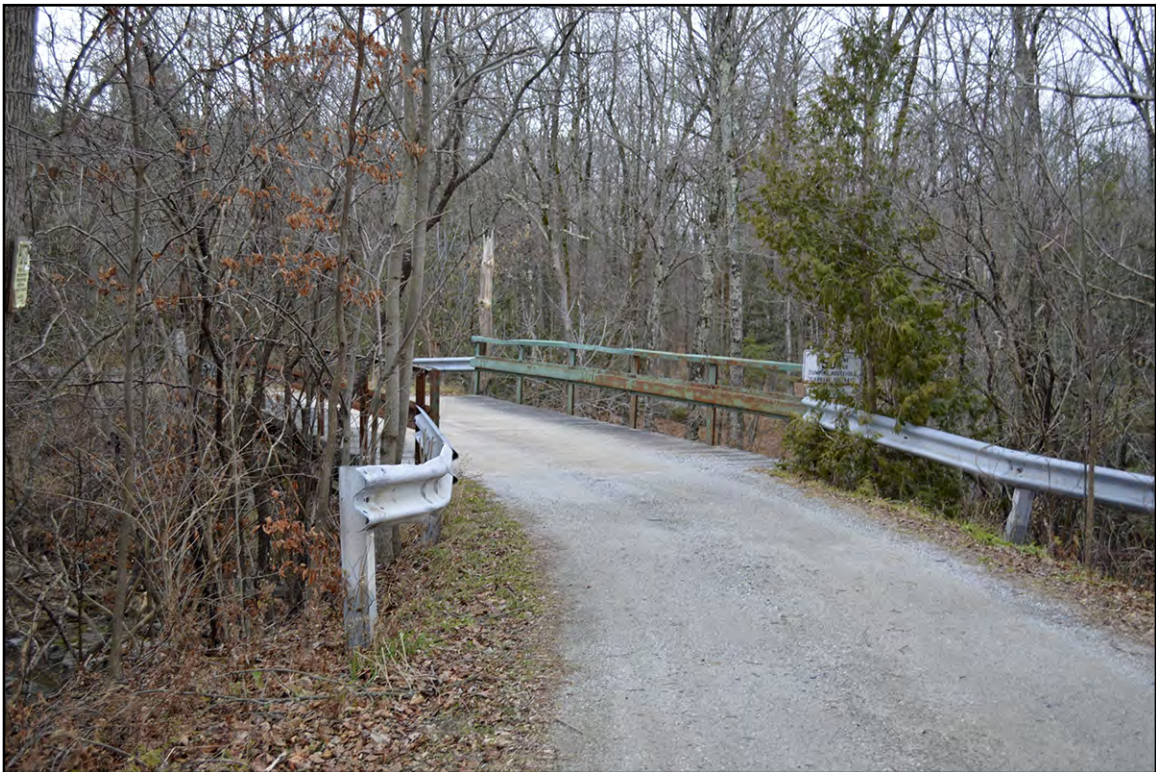
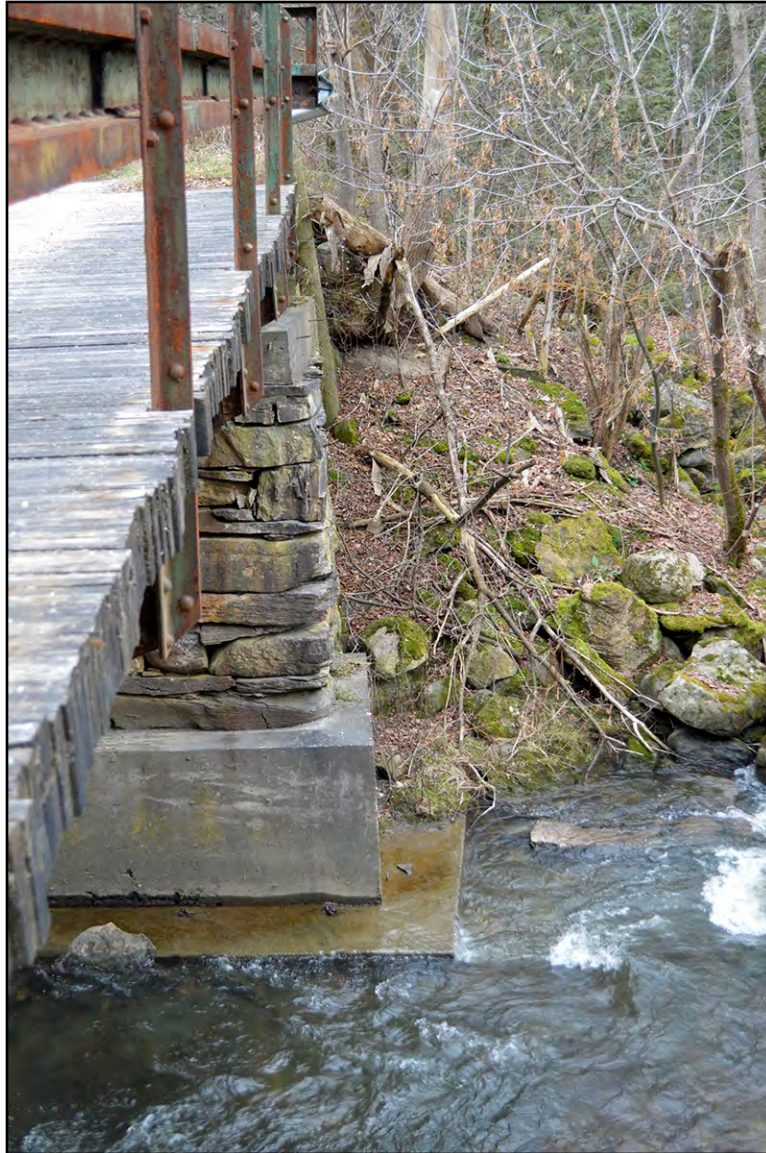
The 1906 pony truss bridge is located on Falls Road, spanning the Mill River. The steel guardrails have a top chord with vertical posts and a center rail. The rolled I-section floorbeams are covered with a wood-plank deck surface. The stacked rubble abutments appear to have been recently repaired with concrete patching and a poured concrete base on the south abutment.

Changes to the bridge since the VDHP (1985) evaluation include the removal of the diagonal eye bars and inclined end posts and replacement with modern steel guardrails, as well as concrete patching of the abutments. The bridge is significant as a transitional type, using the standard Pratt truss type but also pinned connections, which by that date had fallen out of use in favor of welded connections. As the historic integrity of the structure has been diminished since the 1980 survey, an updated Determination of Eligibility may be considered for any future projects that may affect the historic resource.

PLATE 61: Pony Truss Bridge, Falls Road over Mill River, Georgia, Looking North

PLATE 62: Pony Truss Bridge, Falls Road over Mill River, Georgia, Looking West-Southwest

PLATE 63: South Abutment of Pony Truss Bridge, Falls Road over Mill River, Georgia, Looking Southwest

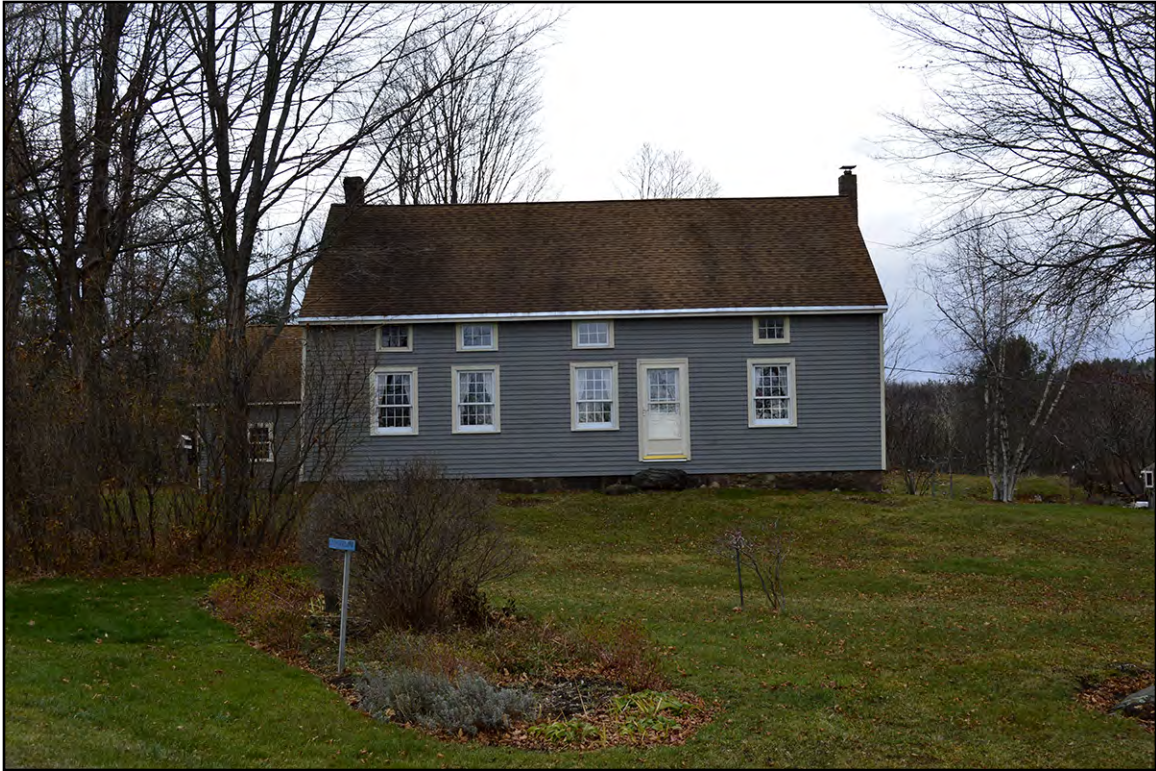
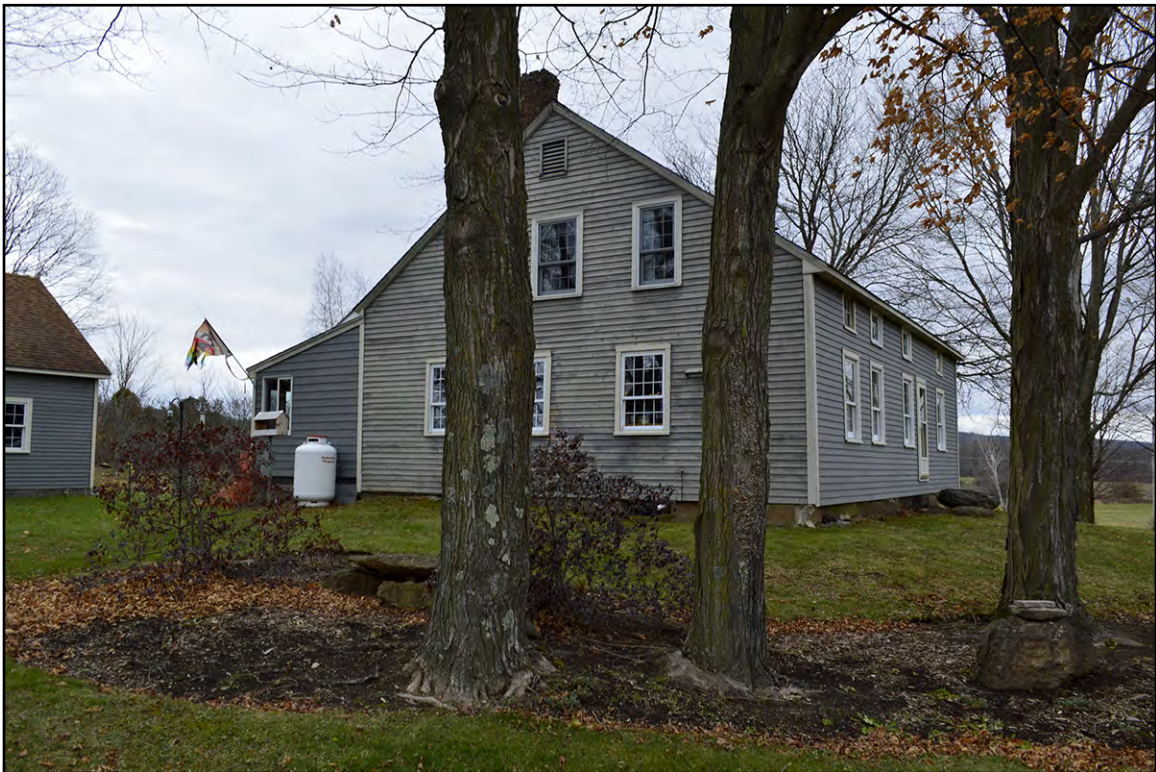
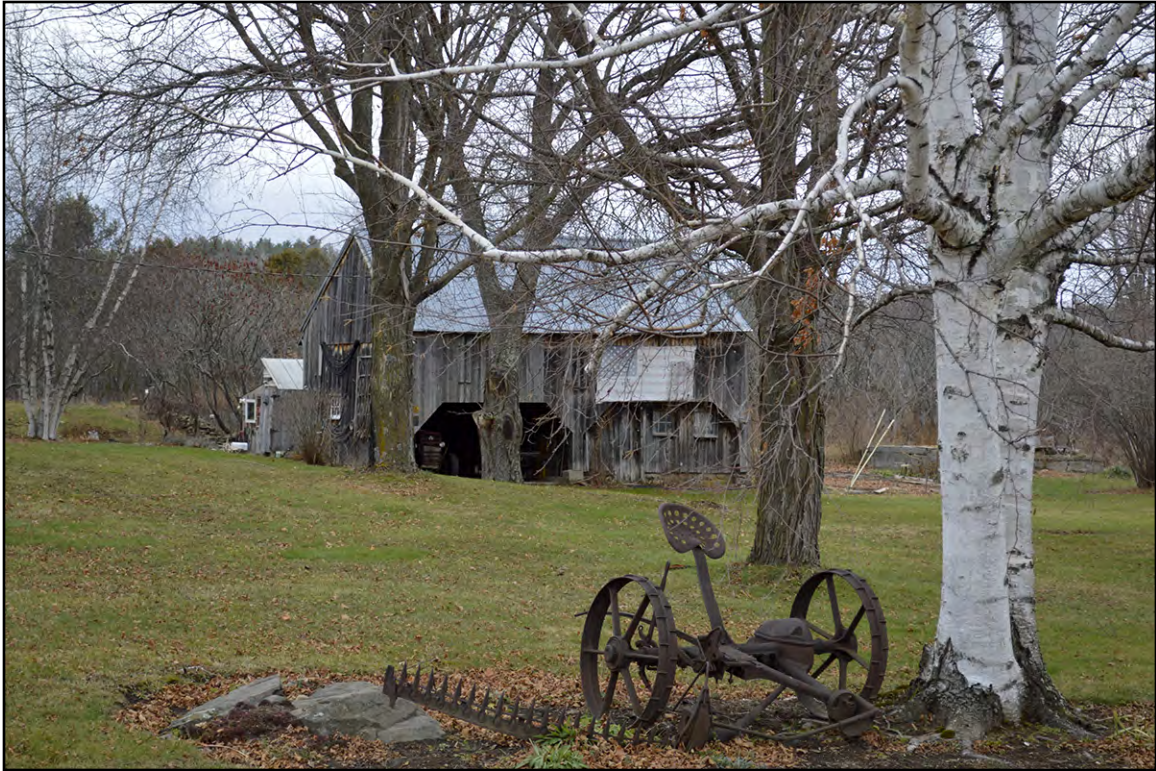
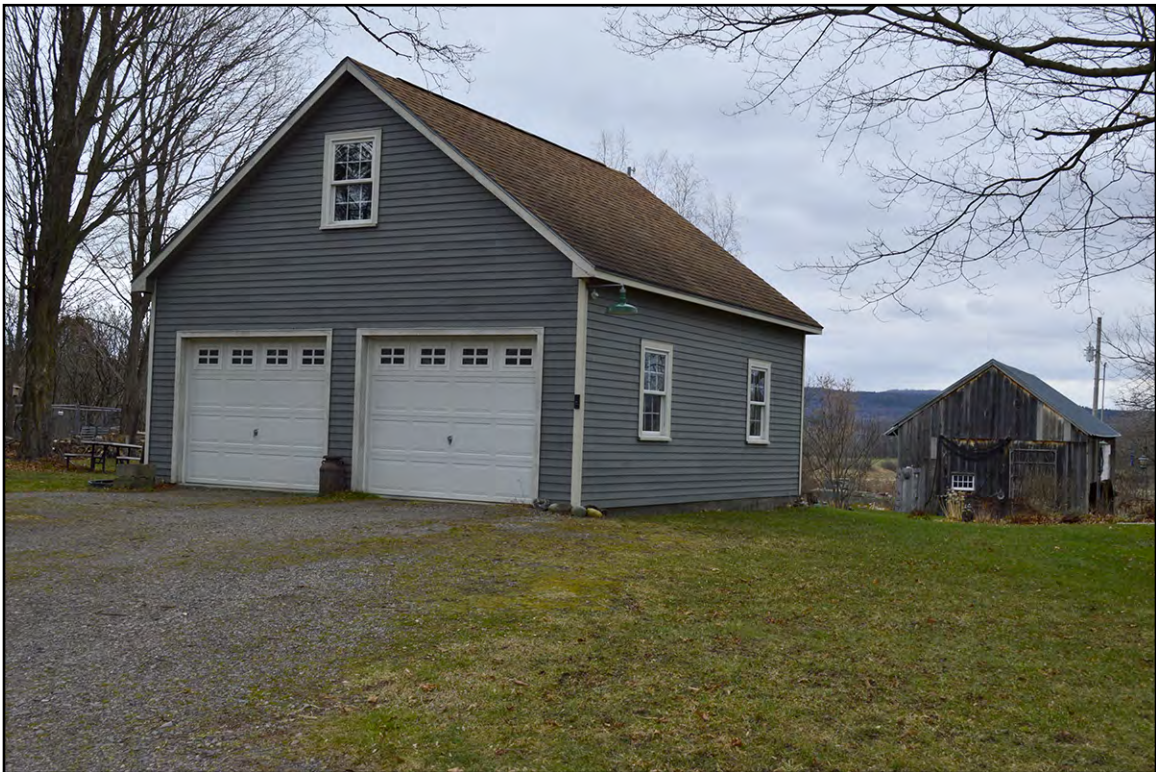
The circa 1788 Reuben Evarts House is a massed side-gable residence that stands one and one-half stories high on a stone foundation. The utilitarian house has an asphalt-shingle gable roof with opposing gable end corbelled brick and cinderblock chimneys. The clapboarded asymmetrical five-bay façade has 12-over-eight double-hung sash windows. Thin cornerboards carry a molded cornice. Each window has a

PLATE 64: Reuben Evarts House, 2143 Polly Hubbard Road, Georgia, Looking North

PLATE 65: Reuben Evarts House, 2143 Polly Hubbard Road, Georgia, Looking East

PLATE 66: Barn at Reuben Evarts House, 2143 Polly Hubbard Road, Georgia, Looking Northwest

PLATE 67: Garage and Shed at Reuben Evarts House, 2143 Polly Hubbard Road, Georgia, Looking East

corresponding six-light attic awning. The first-floor gable end windows are modern replacements with light configurations mirroring the façade fenestration. On the second story, the first and third bay windows are nine-over-six double-hung sashes. The windows and off-center primary entrance are framed in plain wood surrounds. A shed-roof addition is located on the rear façade.

Changes to the property since the VDHP (1980) survey are consist of a replacement front door and second-story windows on the west gable end. The Reuben Evarts House retains its overall historic integrity, and an updated Determination of Eligibility for the NRHP may be considered for any future projects that may affect the historic resource.

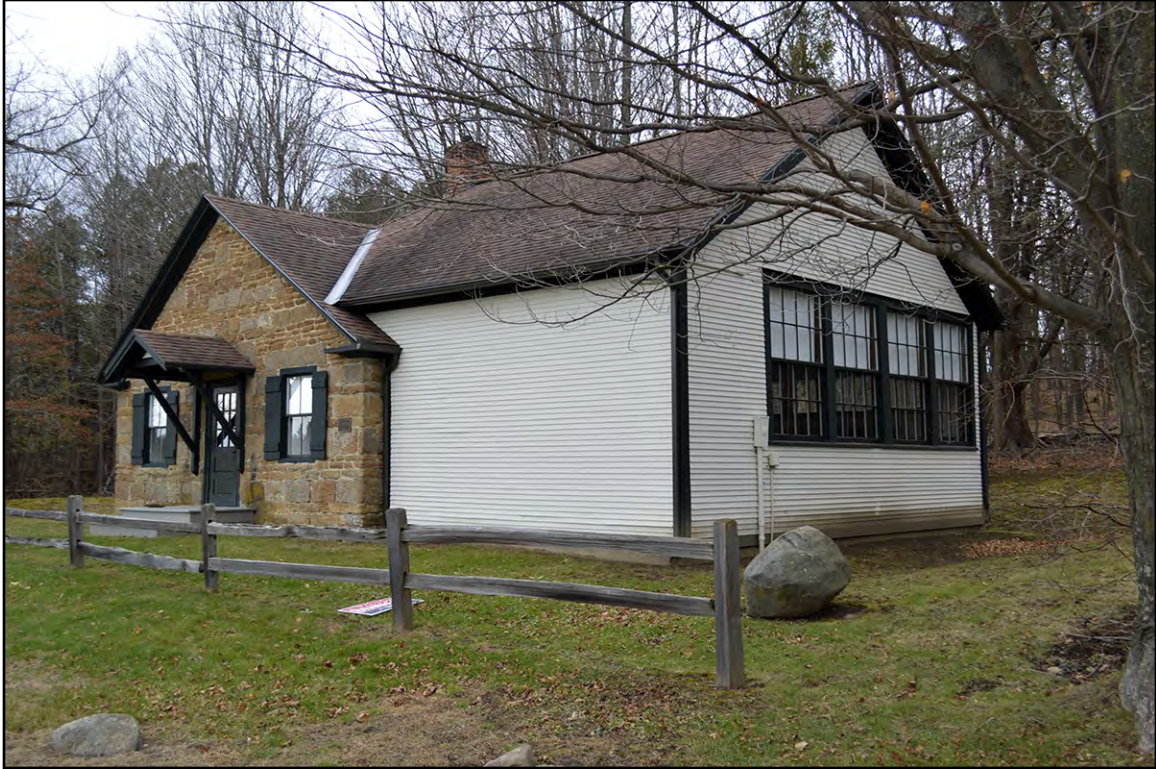
Built in 1843, the District No. 2 School is a vernacular Greek Revival one-room schoolhouse, currently operating as a repository for the school's historical documents and as an interpretive nature center (VDHP 1980). The one-story building is built with locally quarried dolomite limestone of alternating sizes and courses, including small gap-filling chips and stones known as galleting. The foundation consists of large stones. The front-gable roof is covered in asphalt shingles and has a molded cornice with returns. The symmetrical three-bay façade has two-over-two double-hung sash windows in painted wood surrounds flanking a divided six-light paneled door. The windows are headed by large elongated rectangular cut-stone lintels. The door is sheltered by a gabled hood supported by triangular braces. A clapboarded one-story ell added in 1931 extends from the east elevation. The exterior is framed by corner and edge boards. This section rests on a concrete foundation and is covered by a hipped roof covered in asphalt shingles with a brick chimney rising from where the slope descends from the ridgeline. The east and north elevations are lit by ribbons of eight-over-eight and two-over-two double-hung sash windows, respectively.

At the time of the VDHP (1980) evaluation, the window openings were boarded, and the wood trimmings have since been painted, but otherwise the building has been untouched. The field fence has been replaced by the post and rail fence and stone edging. The 1931 addition is well within the 50-year historic threshold and is sympathetic to the main unit. The schoolhouse is an excellent example of a rural one-room schoolhouse with good integrity; however, an updated Determination of Eligibility for the NRHP may be considered for any future projects that may affect the historic resource.

PLATE 68: District No. 2 School, 2442 Polly Hubbard Road, Georgia, Looking Northwest

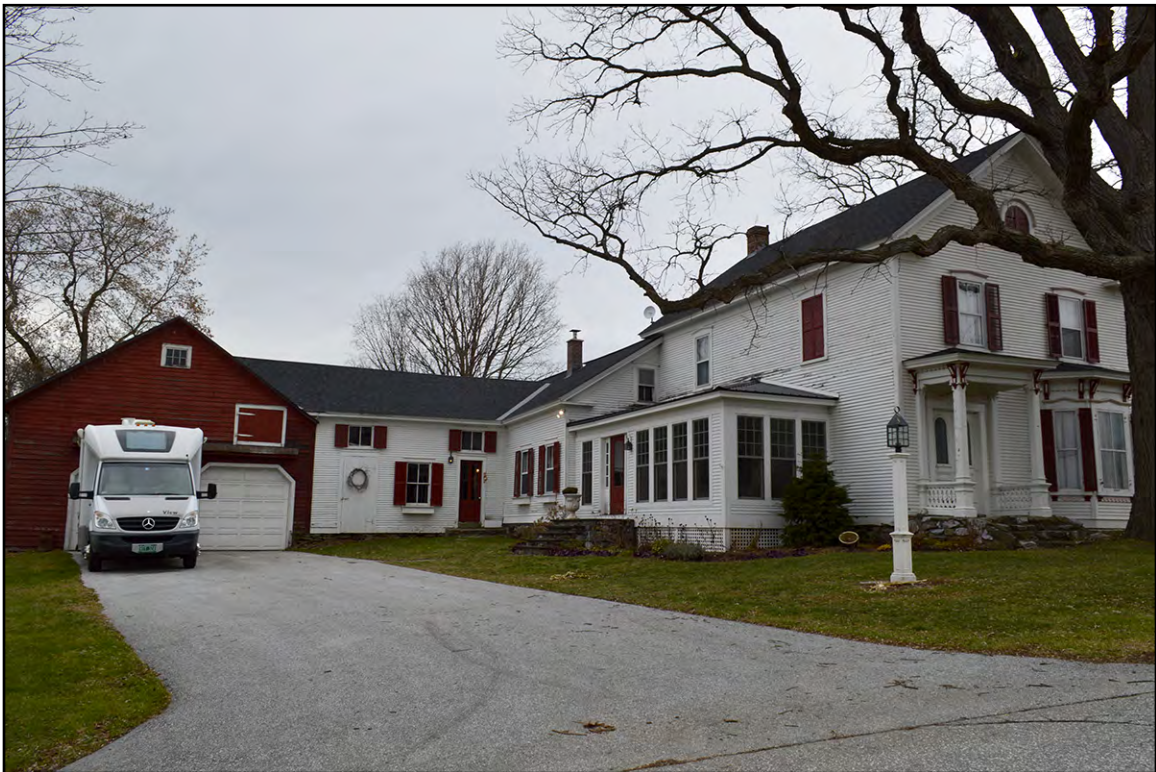
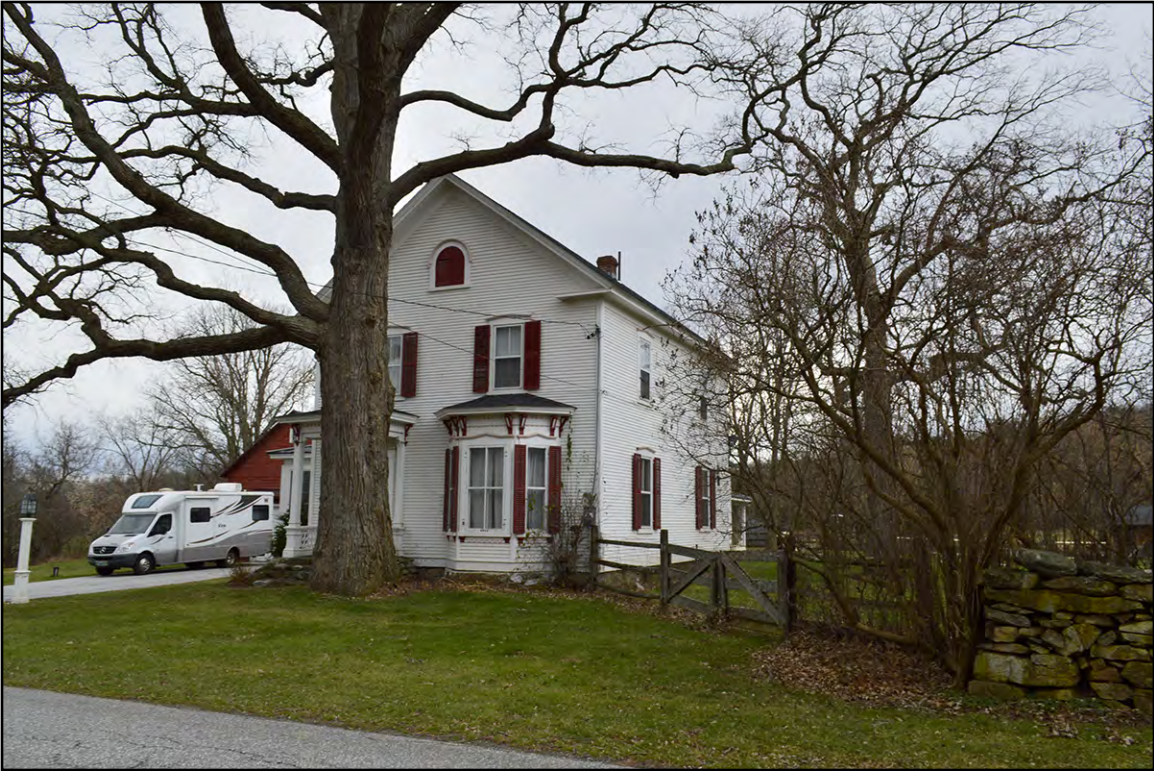
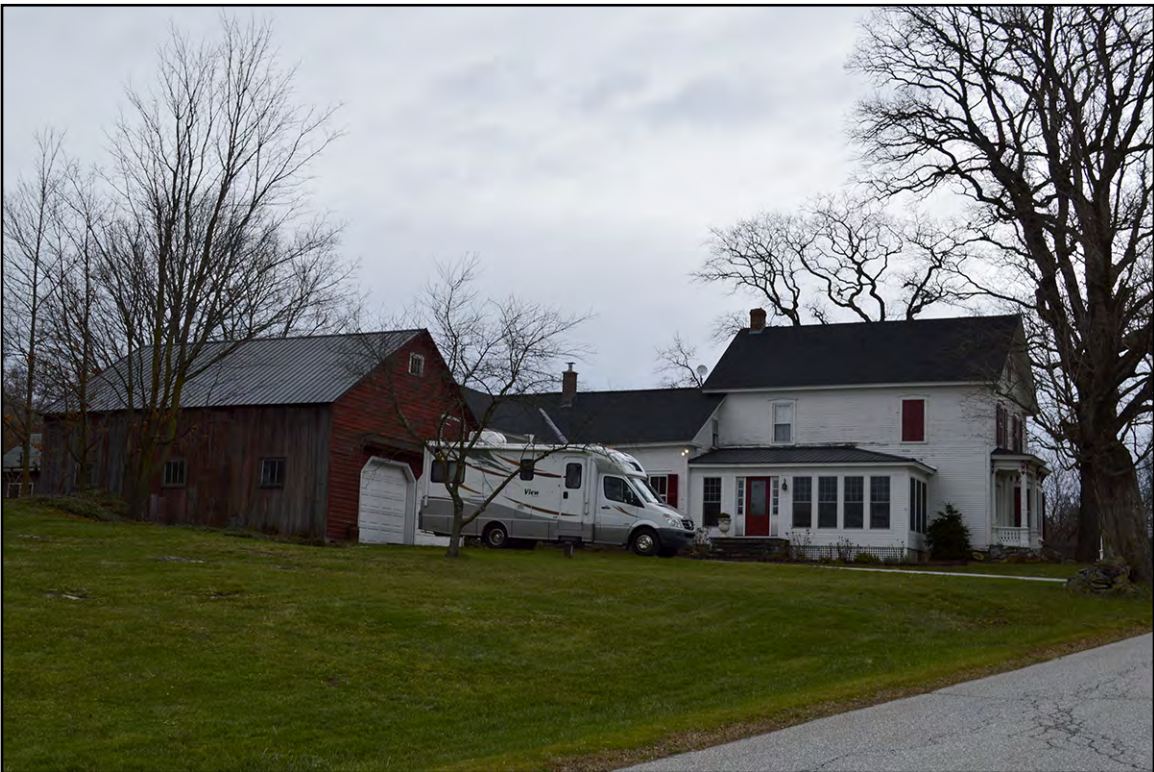
The original one-and-one-half-story dwelling was constructed circa 1830, and the large two-story front-gable east addition was constructed circa 1870 (VDHP 1980). The original dwelling was incorporated into a wing-and ell, and the portion that is now an attached garage was originally a cow barn. The main block of the house rests on a stone foundation and is clad with clapboard siding. The windows appear to be mostly two-over-two double-hung wood sash, with a three-part bay window in the north bay of the main block. The roof is covered with standing-seam metal and features cornice returns. The bay window and the hipped-roof portico have bracketed eaves and dentil moldings. The front entrance consists of a double-leaf paneled

PLATE 69: Hurlburt-Buchdahl, 1973 Polly Hubbard Road, Georgia, Looking Northwest

PLATE 70: Hurlburt-Buchdahl, 1973 Polly Hubbard Road, Georgia, Looking Southwest

PLATE 71: Hurlburt-Buchdahl, 1973 Polly Hubbard Road, Georgia, Looking Northwest

door with arched lights under a pedimented surround. An enclosed porch with modern vinyl windows spans the main block's south elevation. The large hay barn was located across the street but recently burned down.

The house maintains good historic and architectural integrity; the alterations are limited to replacement sunporch windows and garage doors on the carriage barn. Its Italianate embellishments are intact, and the house continues to function agriculturally. The Hurlburt-Buchdahl House retains its overall historic integrity, and an updated Determination of Eligibility for the NRHP may be considered for any future projects that may affect the historic resource.
