# ARCHITECTURAL RECONNAISSANCE SURVEY FRANKLIN COUNTY LINE UPGRADE PROJECT

Franklin County, Vermont

December 22, 2023

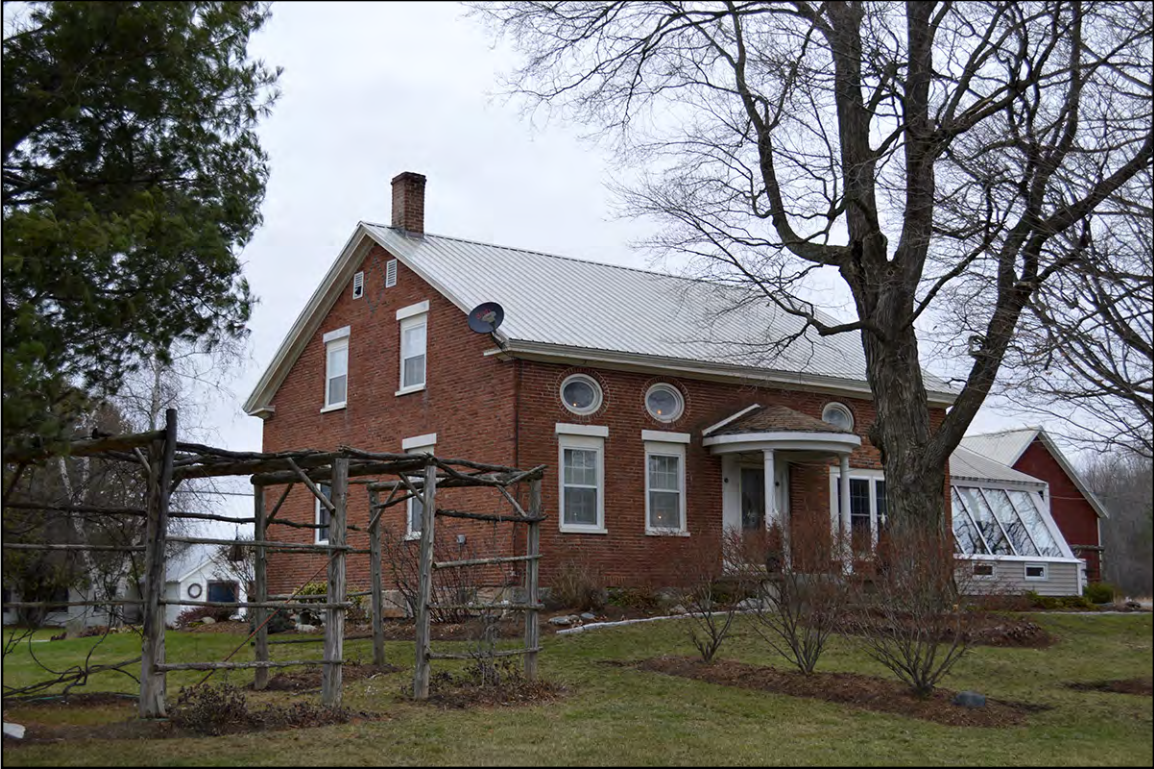
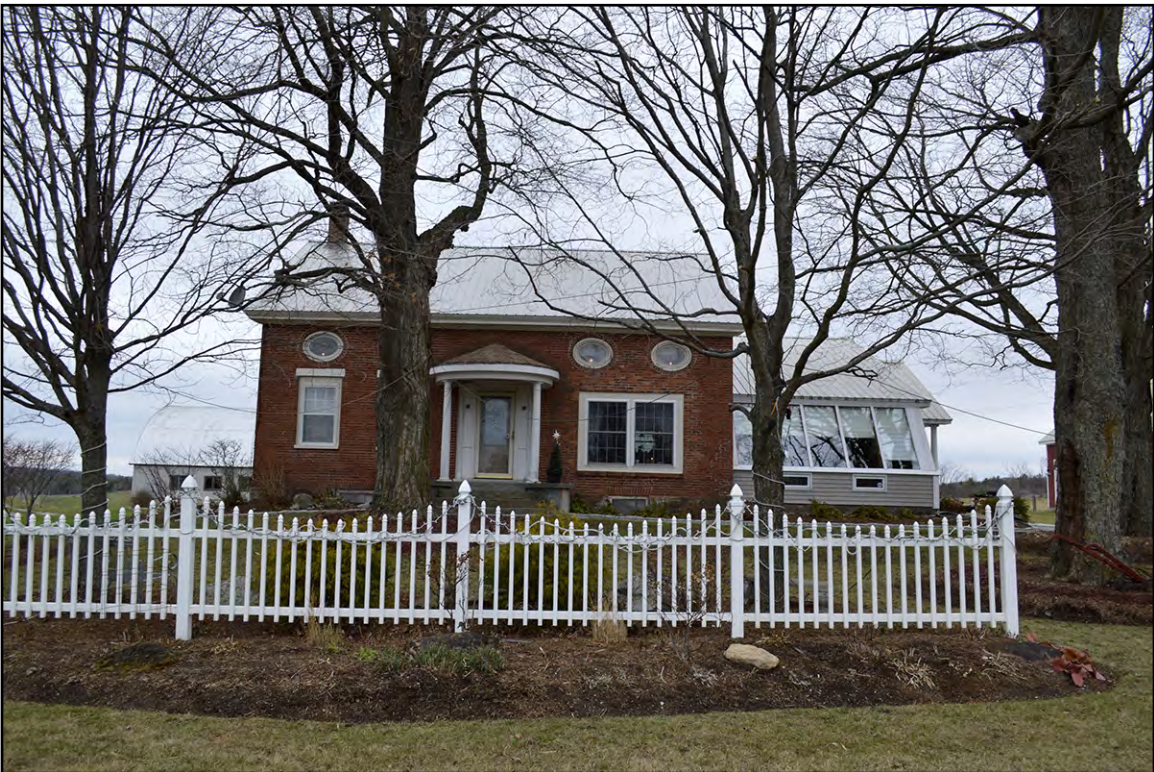
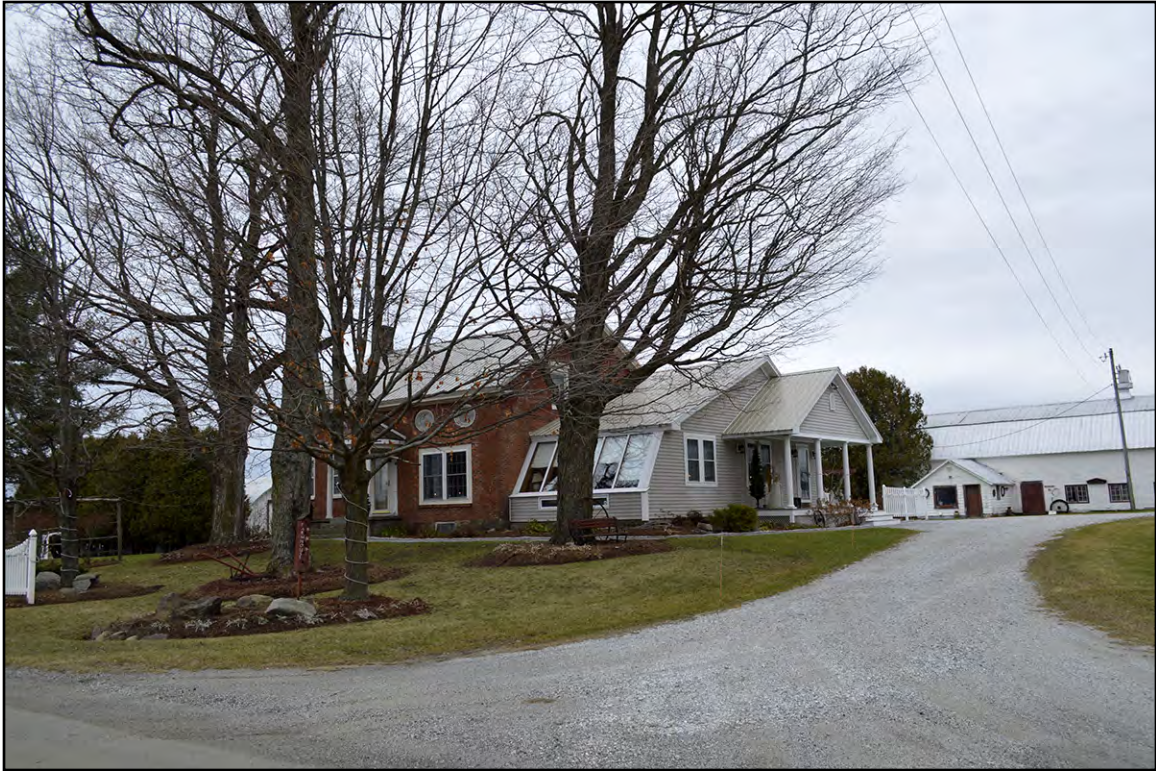
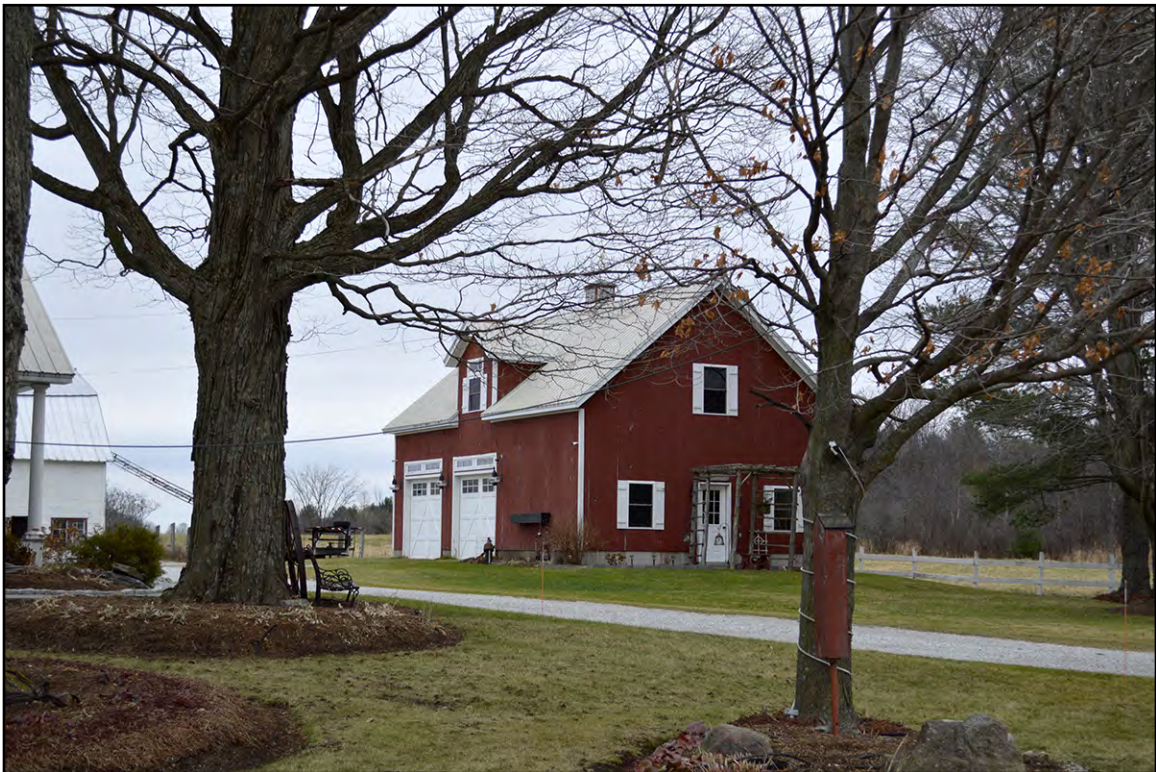
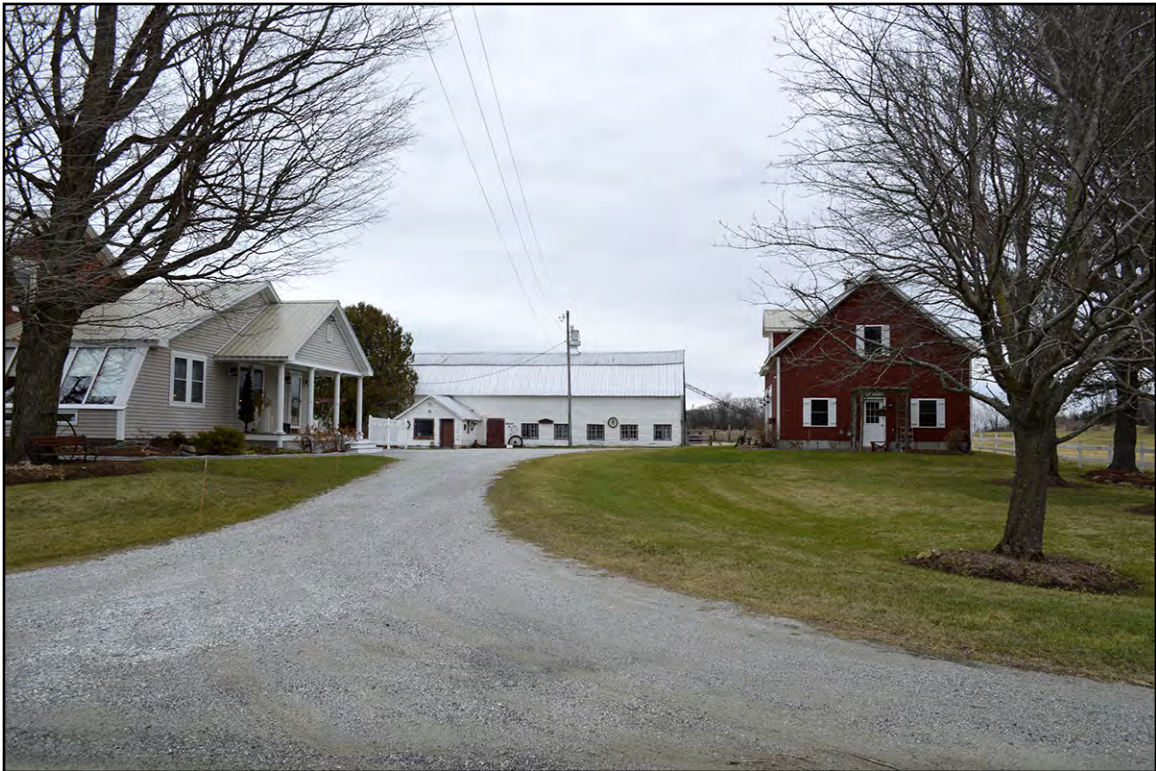
The property at 854 Pattee Hill Road consists of a 108.8-acre parcel with a residence, a carriage house, a machine shed, and a barn. Constructed circa 1840, the brick one-and-one-half story Greek Revival house is five bays wide with a central entrance under a modern semi-circular portico. The house rests on a coursed cut-stone foundation. Most of the window openings have flat stone sills and lintels and have been infilled with modern vinyl double-hung sash with faux muntins. The east window on the first level, which was made into a large picture window in the mid-twentieth century, was recently replaced with paired double-hung window units. Four bullseye kneewall windows are located on the front (south) elevation under the side-gable roof with boxed eaves and cornice returns. An interior end brick chimney is located on the west side of the roof, which is clad in standing-seam metal. At the northeast corner of the house is a one-story addition that was originally a summer kitchen, but it has been altered with vinyl siding, a modern front-gable porch, and a sloping front window wall.

The property's historic and architectural integrity have been severely compromised by replacement windows, including an altered opening on the southeast corner, a modern portico, a recent, large, incompatible addition on the north elevation, replacement windows on the carriage house, and the Quonset shed. The property has been further altered since the initial evaluation, including smaller replacement windows, a newer portico, and extensive alterations to the summer kitchen. The carriage house has also been altered with modern windows and doors. As the historic integrity of the structure has been diminished since the 1980 survey, an updated Determination of Eligibility may be considered for any future projects that may affect the historic resource.

PLATE 72: Parent Farm, 854 Pattee Hill Road, Georgia, Looking Northeast

PLATE 73: Parent Farm, 854 Pattee Hill Road, Georgia, Looking North-Northeast

PLATE 74: Parent Farm, 854 Pattee Hill Road, Georgia, Looking Northwest

PLATE 75: Carriage House, Parent Farm, 854 Pattee Hill Road, Georgia, Looking Northeast

PLATE 76: Barn and Carriage House at Parent Farm, 854 Pattee Hill Road, Georgia, Looking North

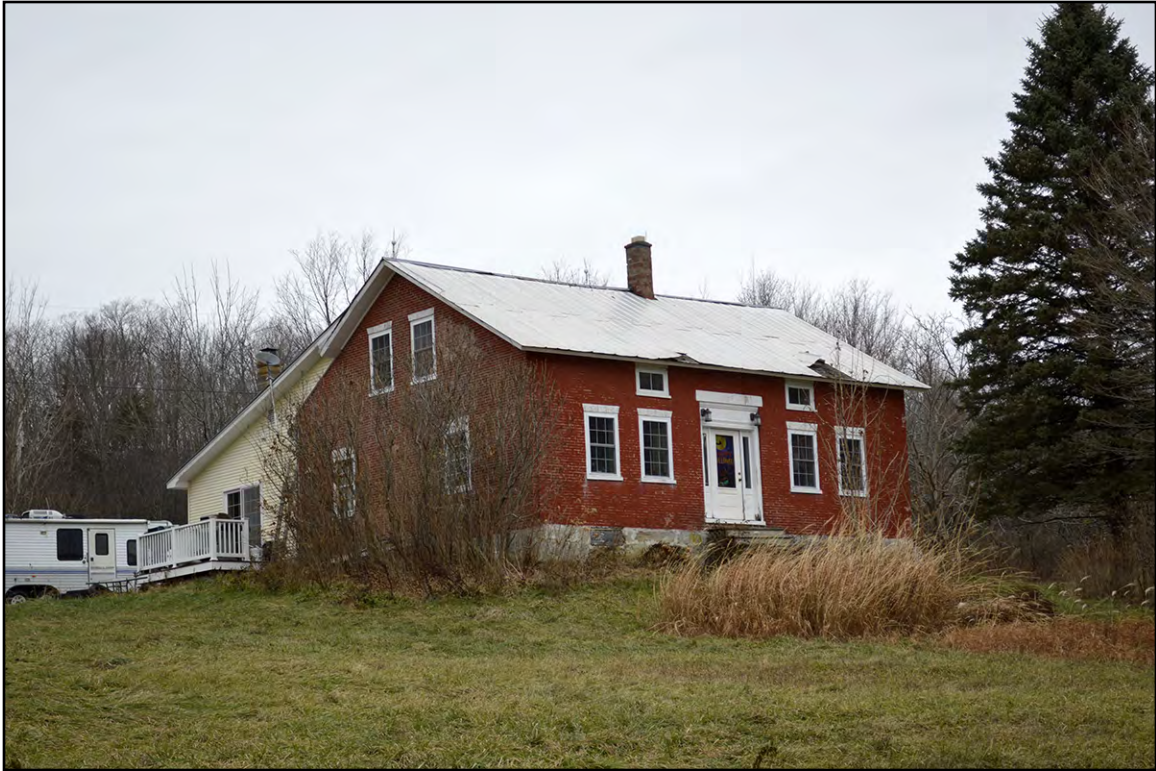
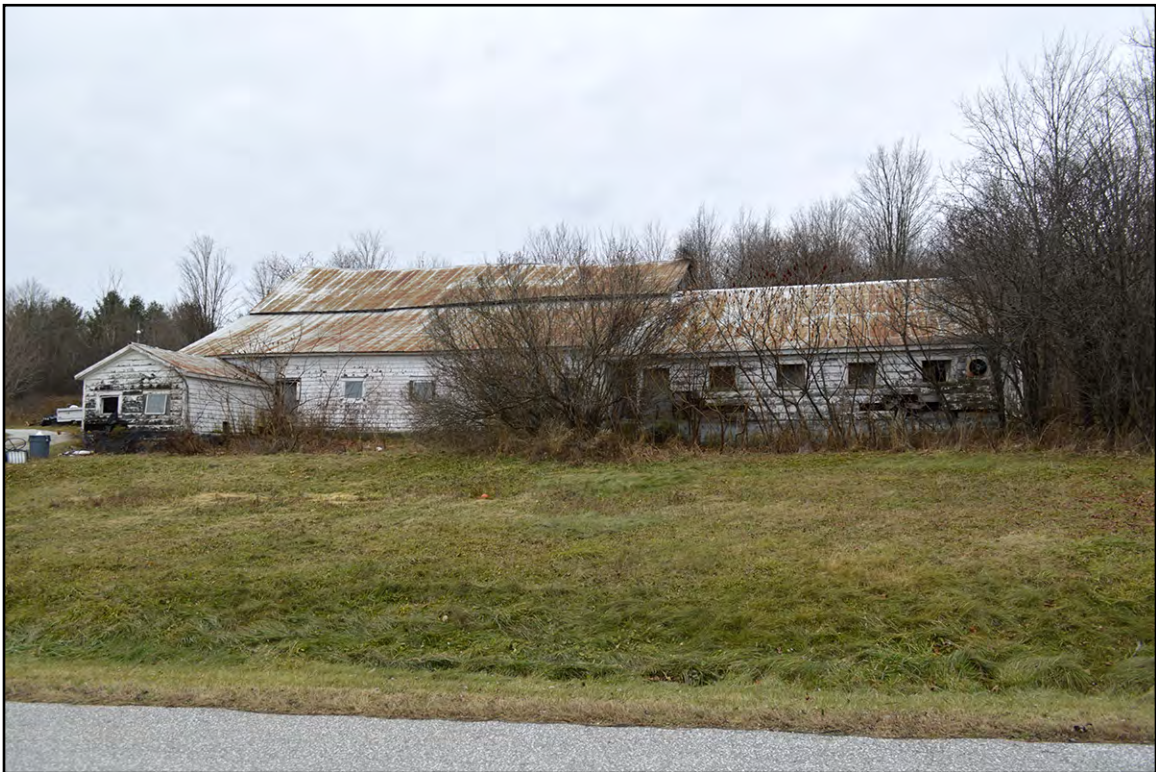
The Cota House / Dinsmore Homestead consists of a one-and-one-half-story side-gable Classic Cottage on a parged stone foundation, originally constructed in the early nineteenth century. The brick-veneered plank

PLATE 77: Cota House/Dinsmore Homestead, 717 Georgia Middle Road, Georgia, Looking Northwest

PLATE 78: Barn at Cota House/Dinsmore Homestead, 717 Georgia Middle Road, Georgia, Looking West

building has a central entrance with sidelights and a replacement door under a stone lintel. The entrance is flanked by two main-level windows (modern replacements) under flat arch brick lintels. Two kneewall windows are tucked under the open eaves. The standing-seam metal roof sheathing is damaged in several places, revealing wood shingles beneath. An interior brick chimney pierces the roof ridgeline. A vinyl-sided rear ell projects from the southwest corner of the dwelling.

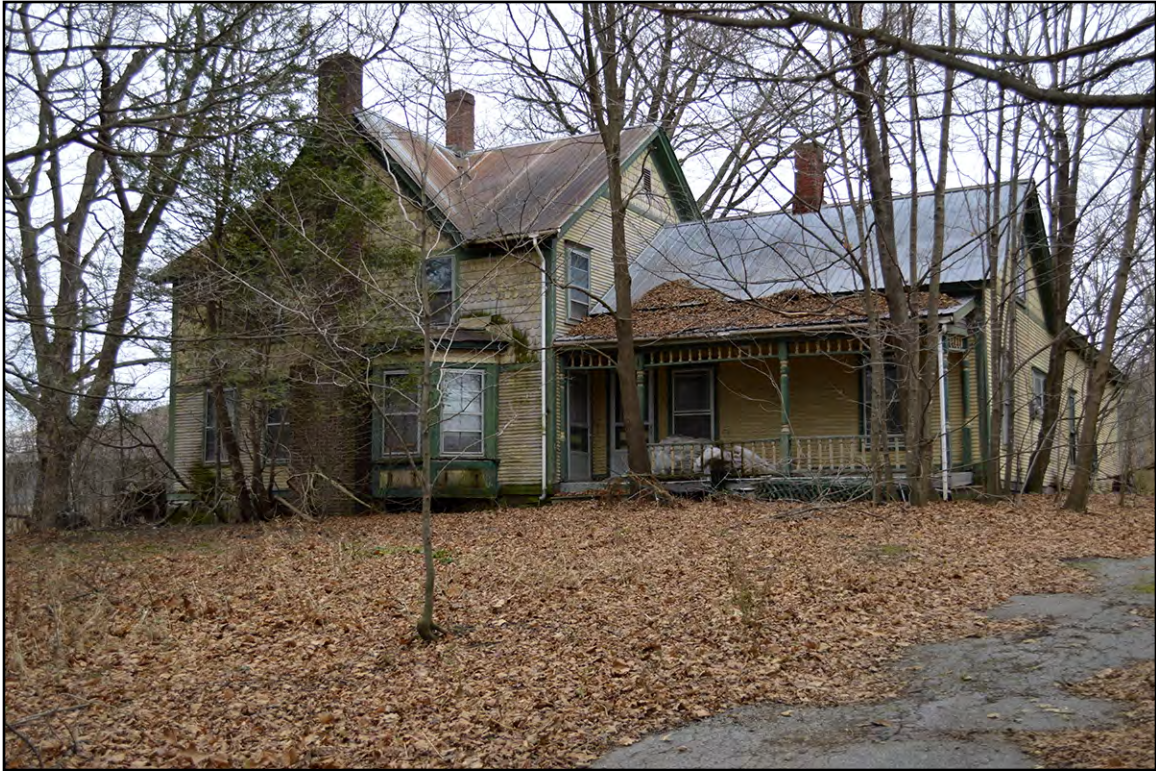
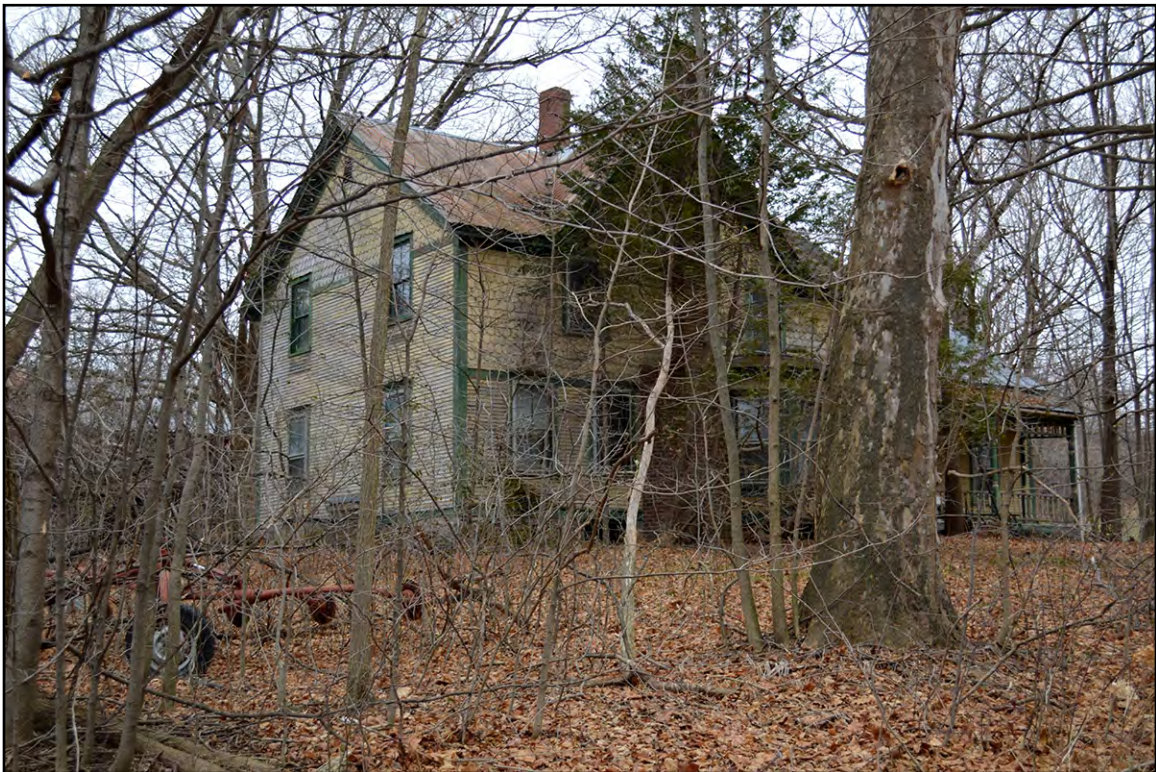
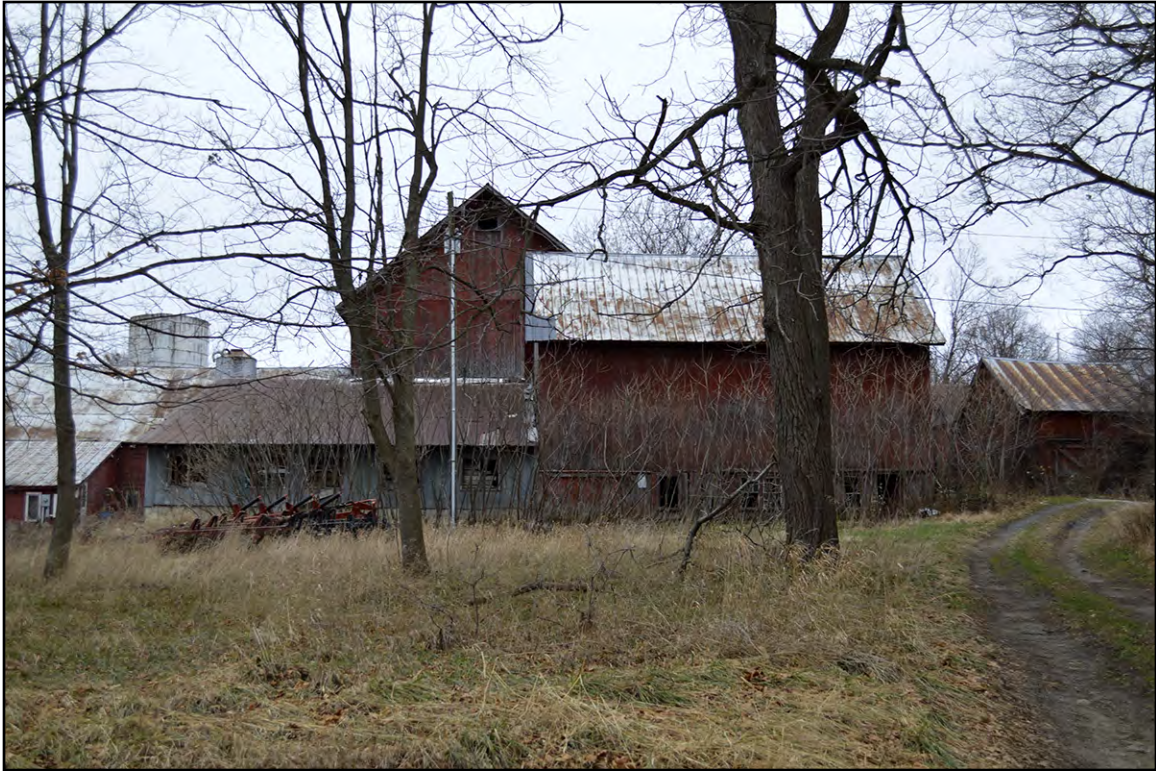
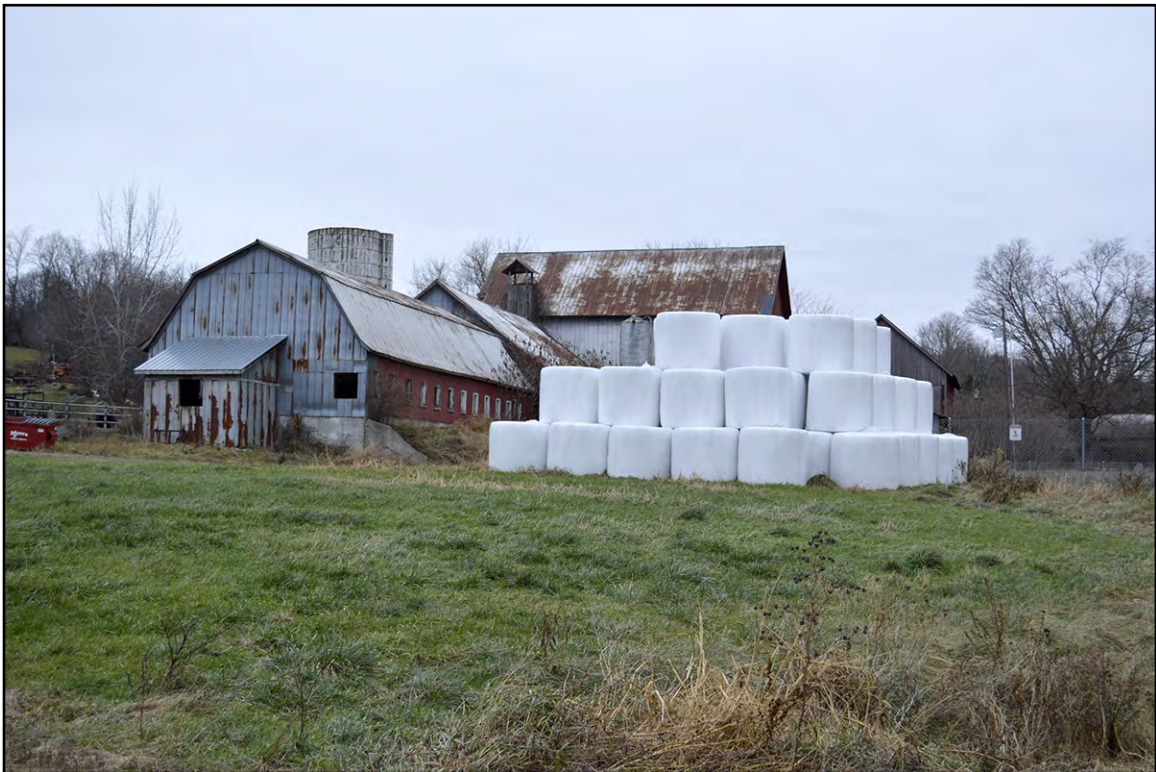
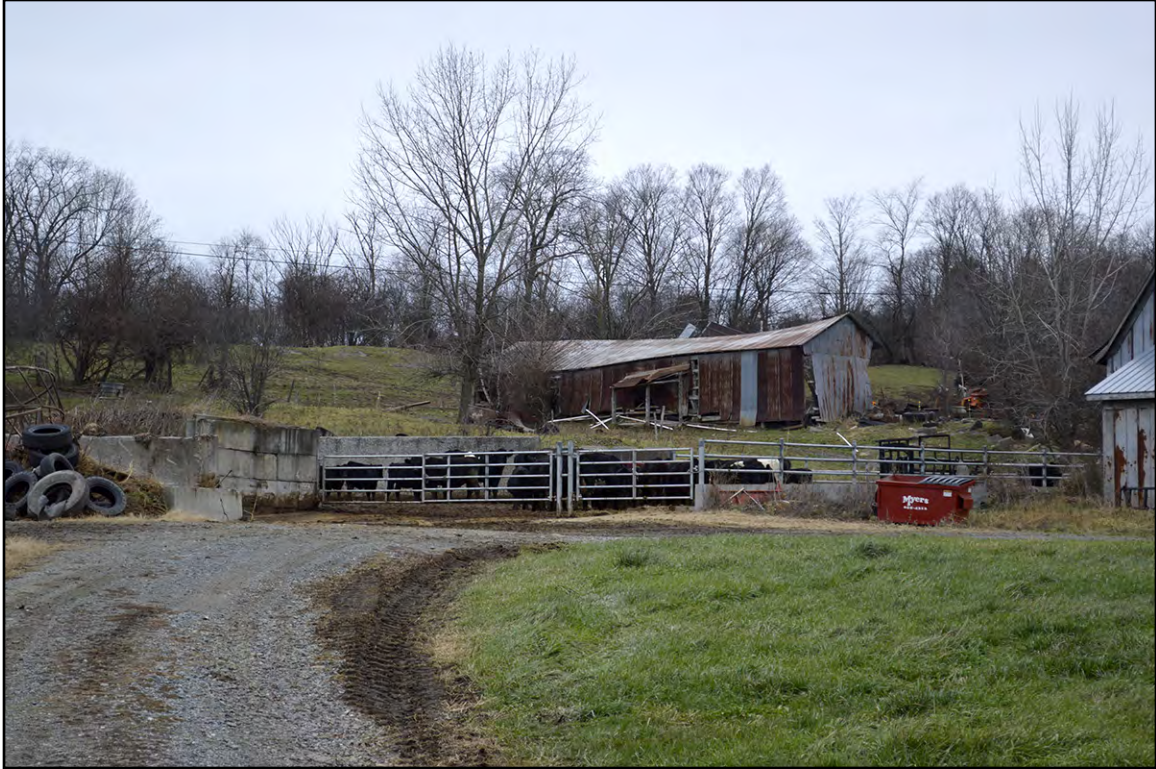
The property at 586 Plains Road consists of a 344-acre parcel with a residence, two barns, and several agricultural buildings. The original one-story dwelling was constructed circa 1820, and the large two-story cross-gable south addition was constructed circa 1890 (VDHP 1980). The original dwelling was incorporated into a wing and ell, and a Queen Anne-style porch with turned posts and spindles was added to the front. The house rests on a stone foundation and is clad with clapboard siding with imbricated wood shingles on the upper level. The windows appear to be mostly two-over-two double-hung wood sash, with a three-part bay window in the north bay of the main block. The roof is covered with standing-seam metal. Central interior corbeled cap brick chimneys are located in the two-story block, the wing, and the rear ell. An exterior brick chimney was added to the east elevation in the 1970s.

PLATE 79: Sabin-Nye House, 586 Plains Road, Georgia, Looking West

PLATE 80: Sabin-Nye House, 586 Plains Road, Georgia, Looking North-Northwest

PLATE 81: Barns at Sabin-Nye House, 586 Plains Road, Georgia, Looking West

PLATE 82: Barns at Sabin-Nye House, 586 Plains Road, Georgia, Looking Northwest

PLATE 83: Cattle Pen and Barn at Sabin-Nye House, 586 Plains Road, Georgia, Looking Northwest

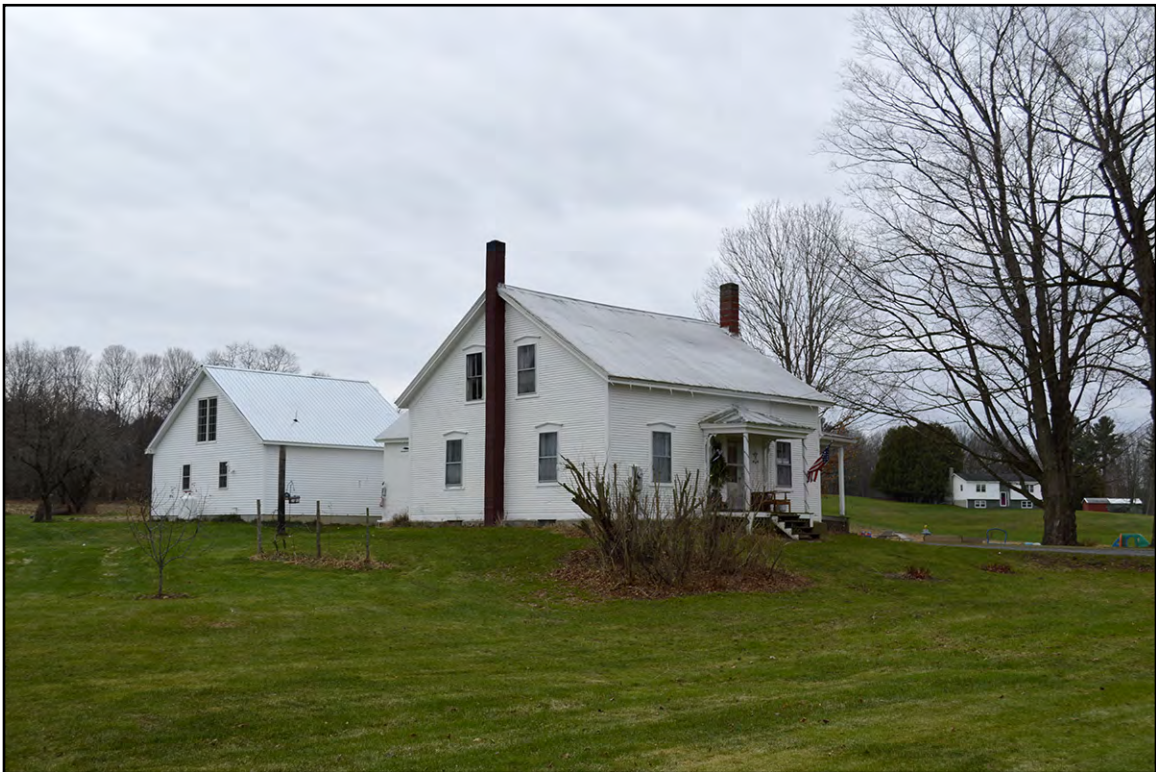
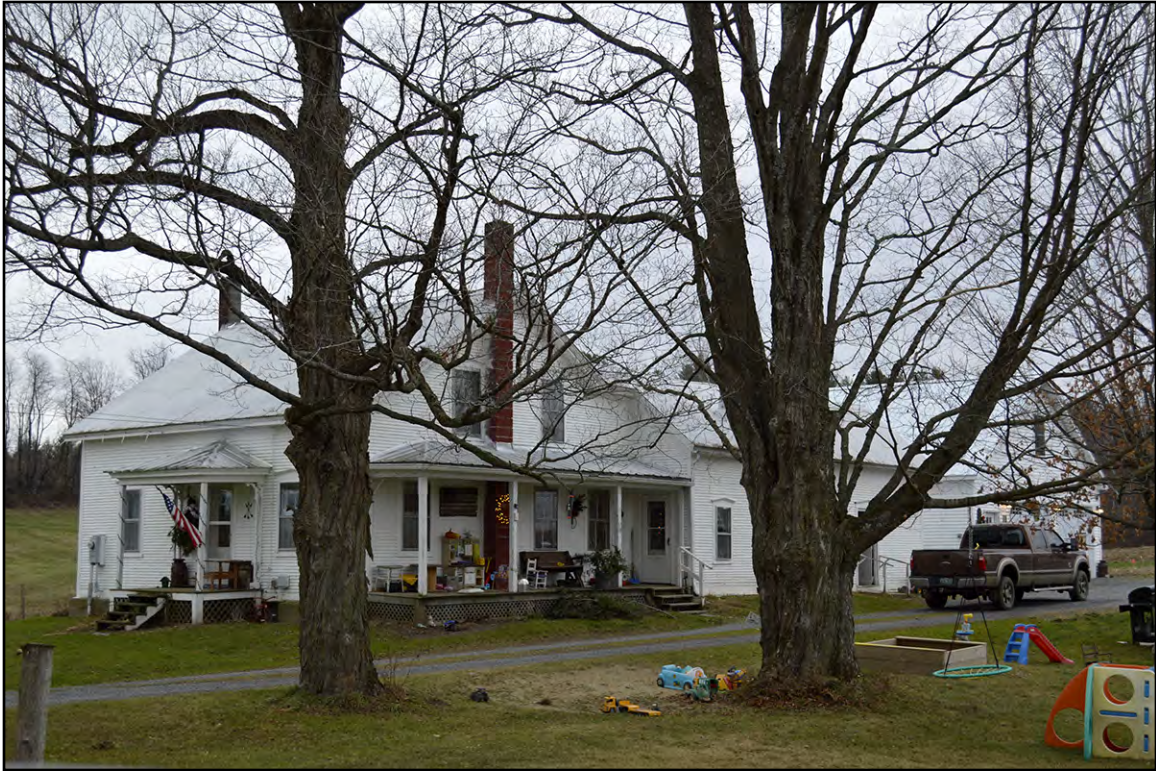
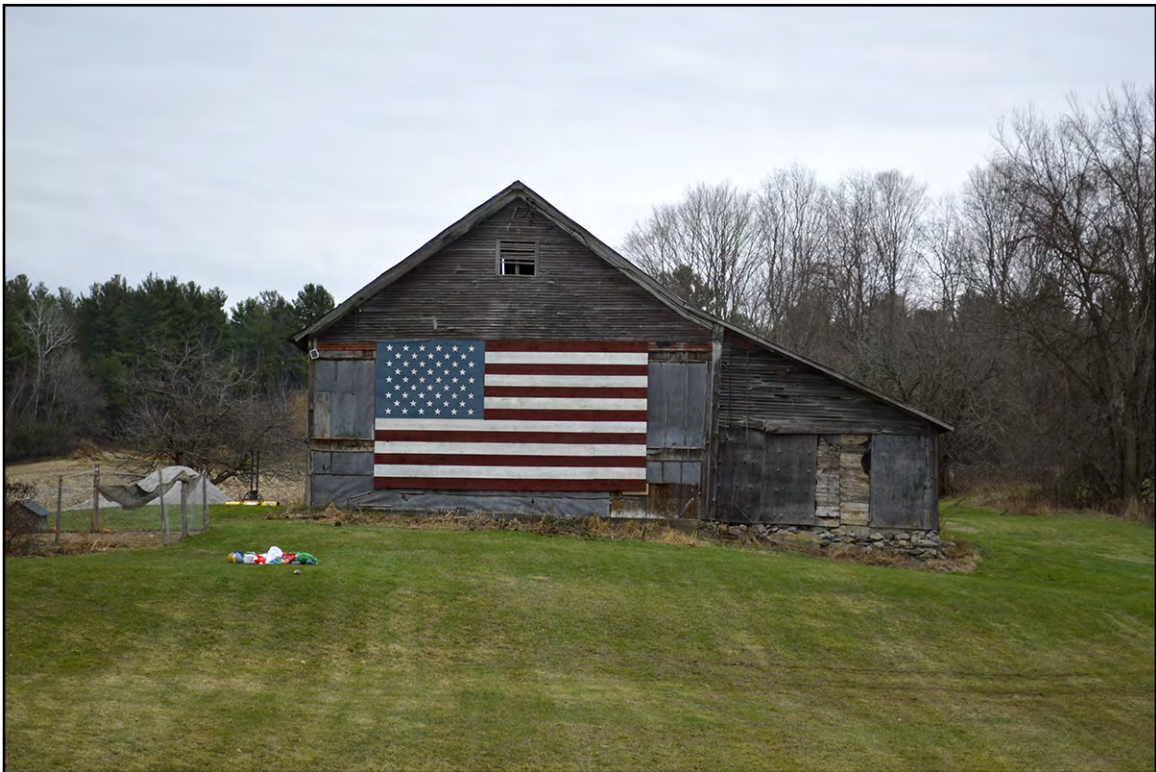
The Dutton-Wimble House consists of a one-and-one-half-story side-gable Classic Cottage on a stone and concrete foundation, constructed circa 1870. The clapboard-sided building has a central entrance with a replacement door under a hipped-roof one-bay porch with square posts and inch boards with brackets. The entrance is flanked by two main-level windows (modern replacements) under pitched lintel boards. A hipped side porch shelters a separate entrance into the rear ell, which appears to be original. The roof is clad in corrugated metal, with two twentieth-century exterior end concrete-block chimneys interrupting either side of the gable end eaves.

PLATE 84: Dutton-Wimble House, 976 Sodom Road, Georgia, Looking Southeast

PLATE 85: Dutton-Wimble House, 976 Sodom Road, Georgia, Looking Northeast

PLATE 86: Barn at Dutton-Wimble House, 976 Sodom Road, Georgia, Looking East-Southeast

A late nineteenth-century gable roof barn is located southeast of the house, with a cow stall added in 1964. A large modern one-and-one-half-story garage with a poured concrete foundation has been recently constructed behind (east of) the dwelling.
