SECTION 248 NATURAL RESOURCES REPORT

VELCO Sandbar Station Smartvalve Project – Natural Resources Report

Town of Milton, Vermont.

May 27, 2025

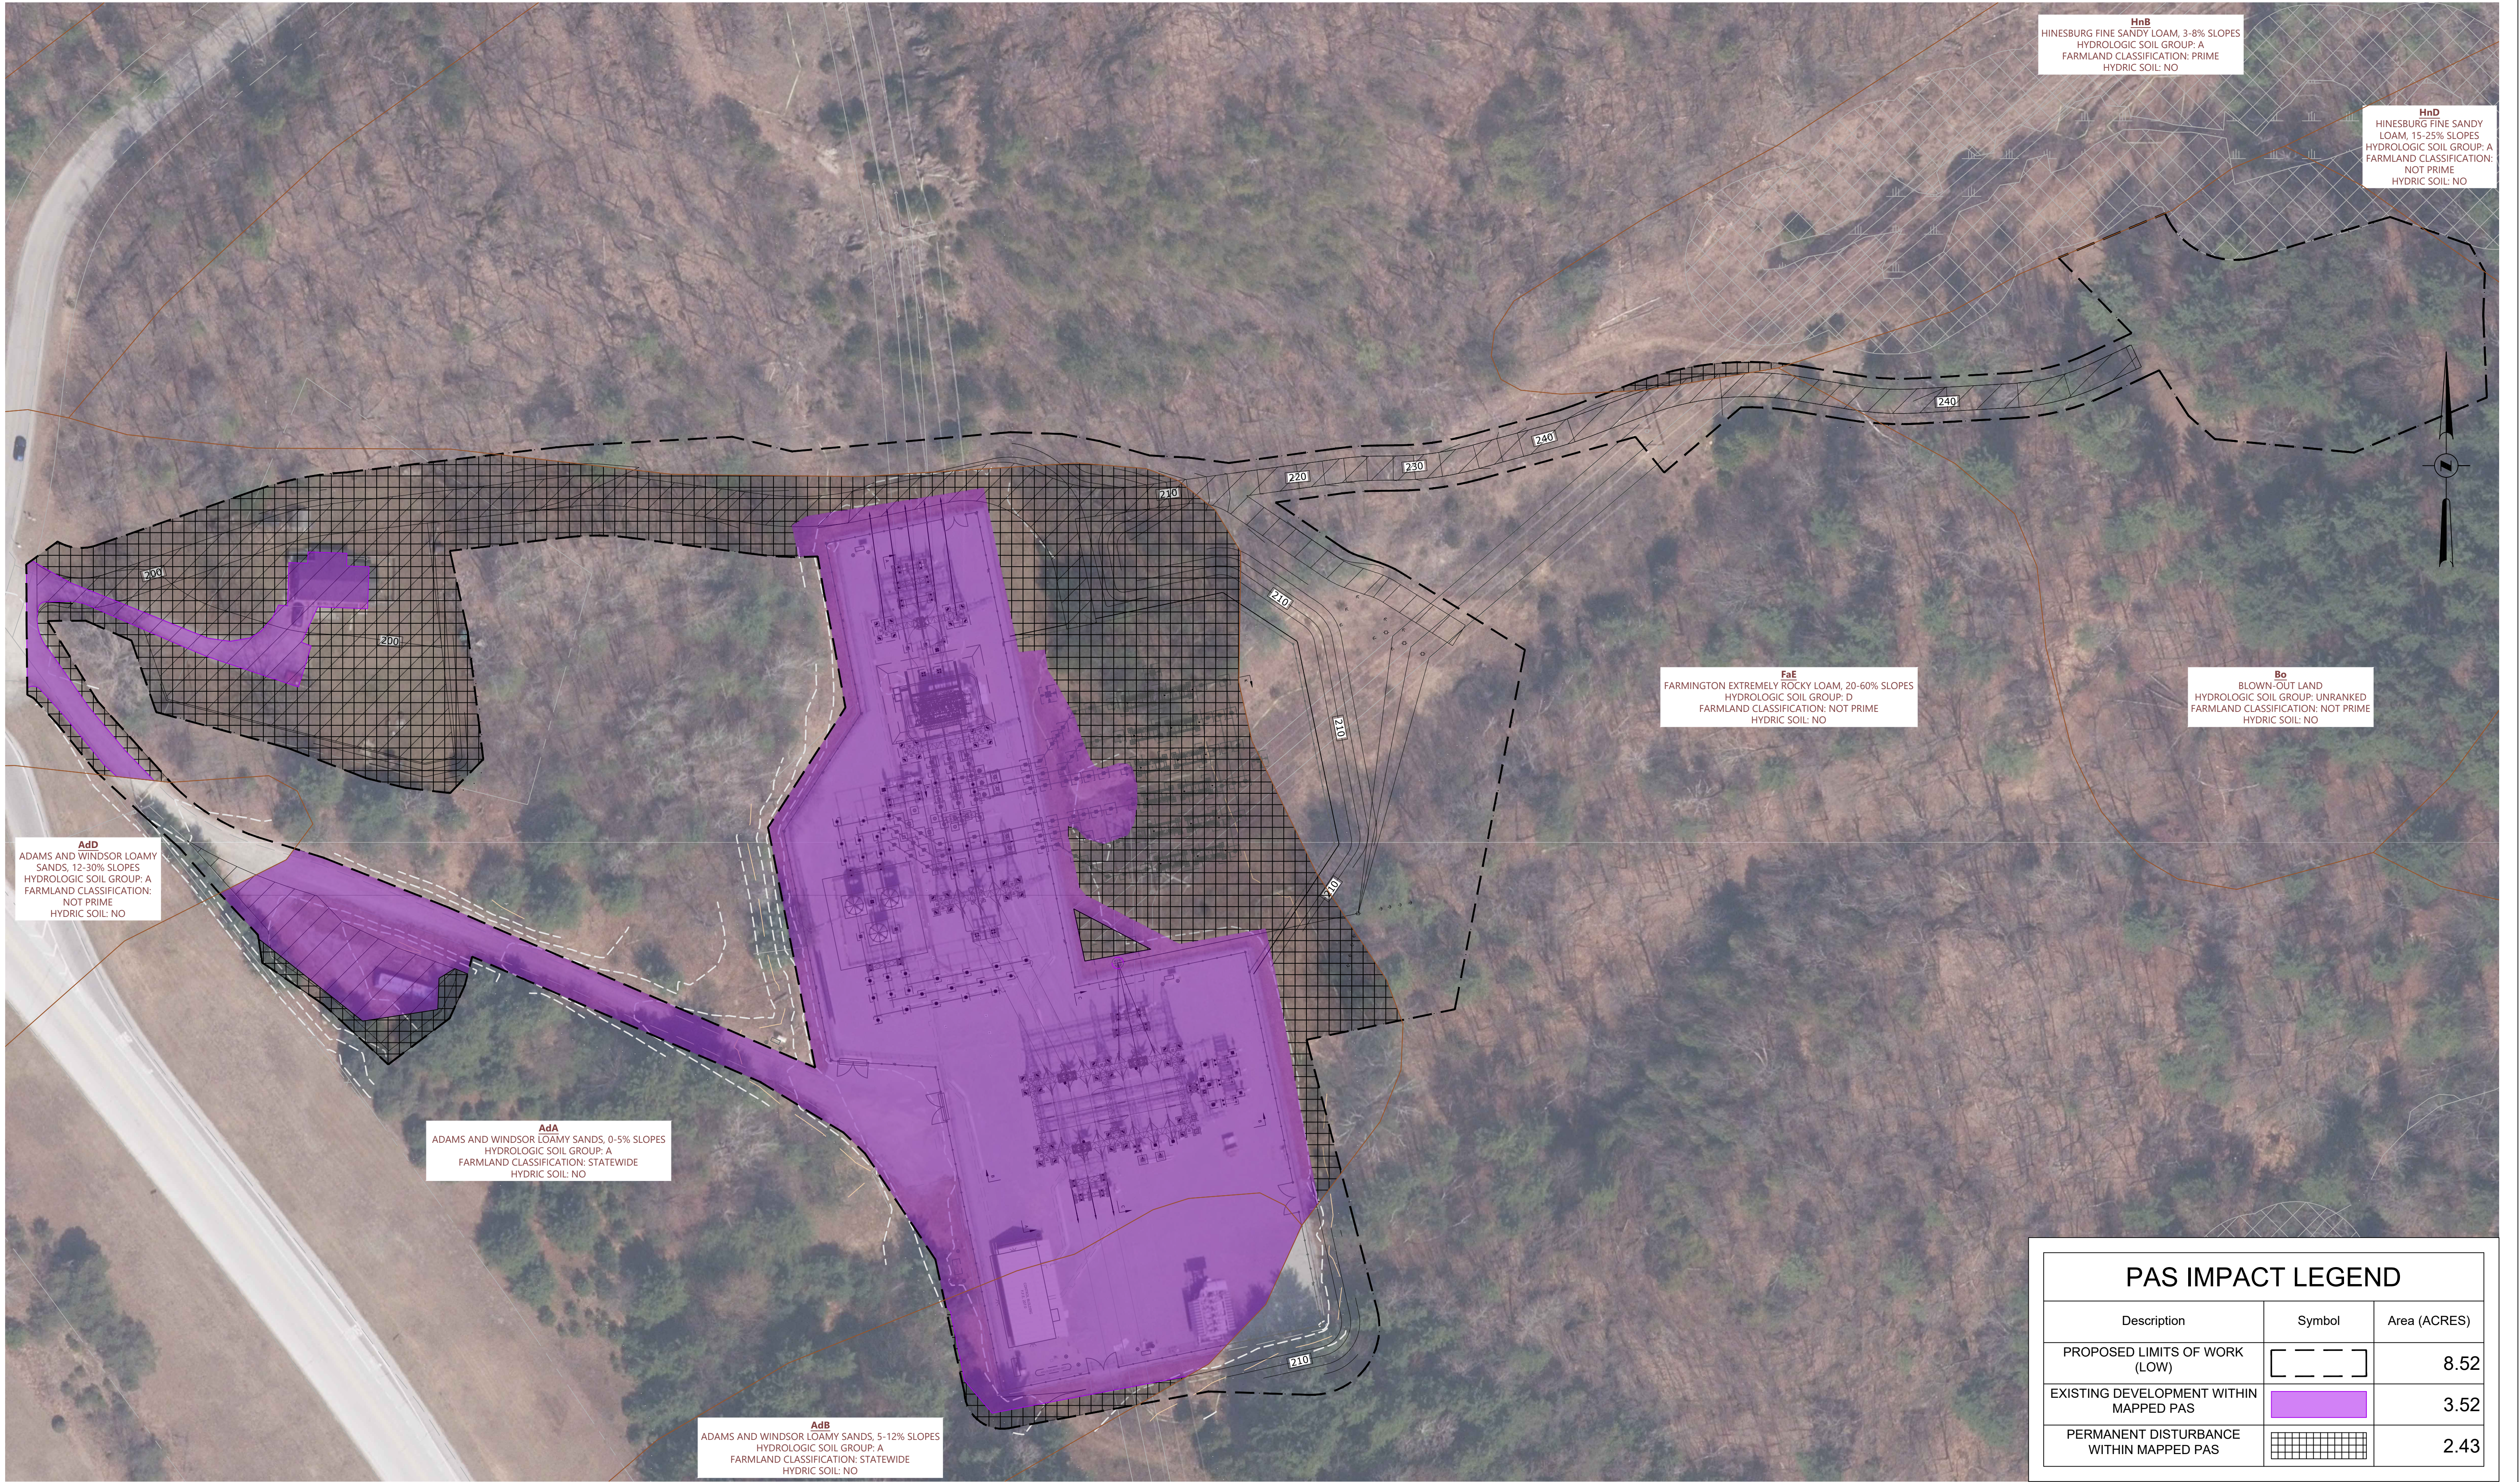
PAS Impact Exhibit

Description	Symbol	Area (ACRES)
PROPOSED LIMITS OF WORK (LOW)		8.52
EXISTING DEVELOPMENT WITHIN MAPPED PAS		3.52
PERMANENT DISTURBANCE WITHIN MAPPED PAS		2.43

Based on absence of agricultural value of the soils mapped on-site, it is VHB's opinion that there will be no undue adverse effects to farming, farming potential, or PAS as a result of the Project based on existing land use and soil conditions.

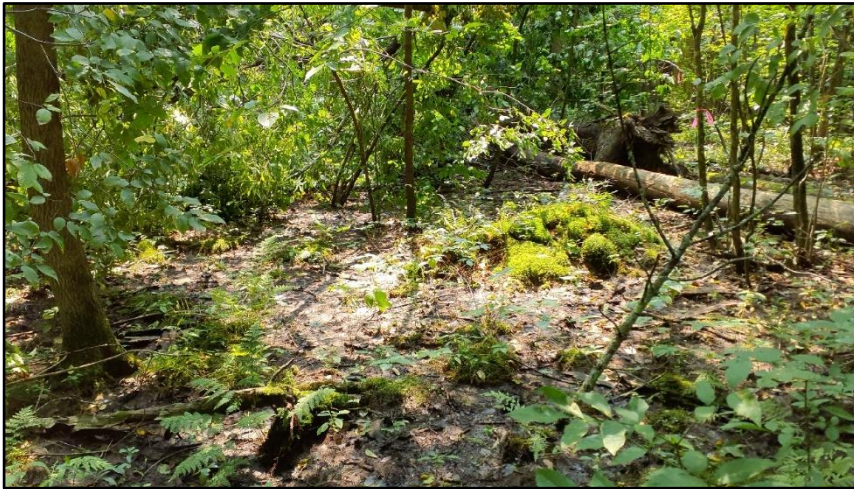
NO. 1 / 07.25.2024

A representative photograph of an isolated depressional wetland located in the east and southeast portions of the Study Area.

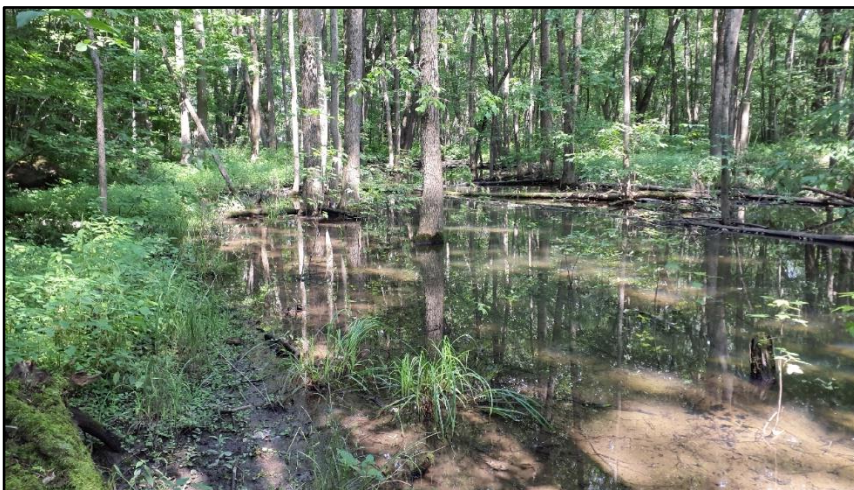
NO. 2 / 07.25.2024

A representative photograph of wetland MI-11, located in the southern portion of the Study Area.

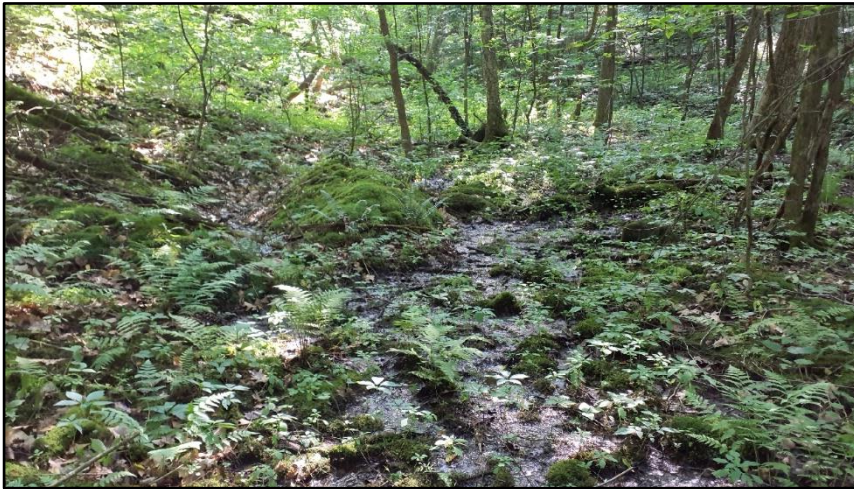
NO. 3 / 07.25.2024

A representative photograph of a seep, which are present in the east and southeast portions of the Study Area.

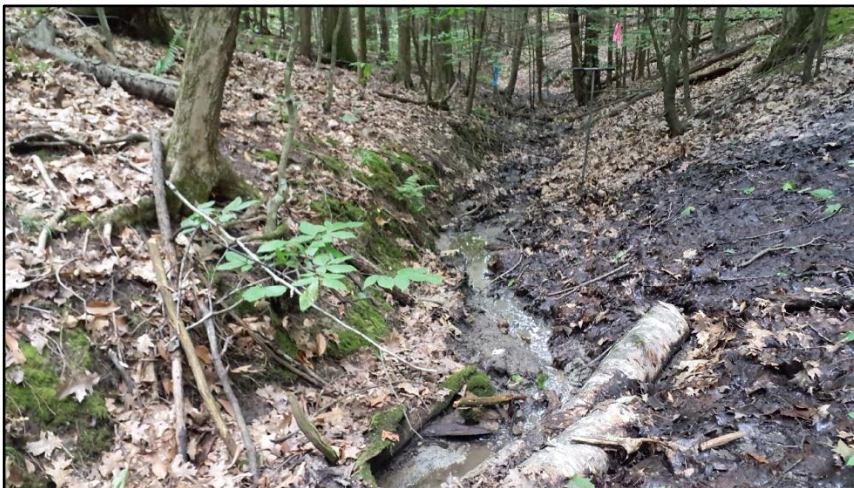
NO. 4 / 07.24.2024

A representative photograph of ephemeral streams located in the east and southeastern portions of the Study Area.

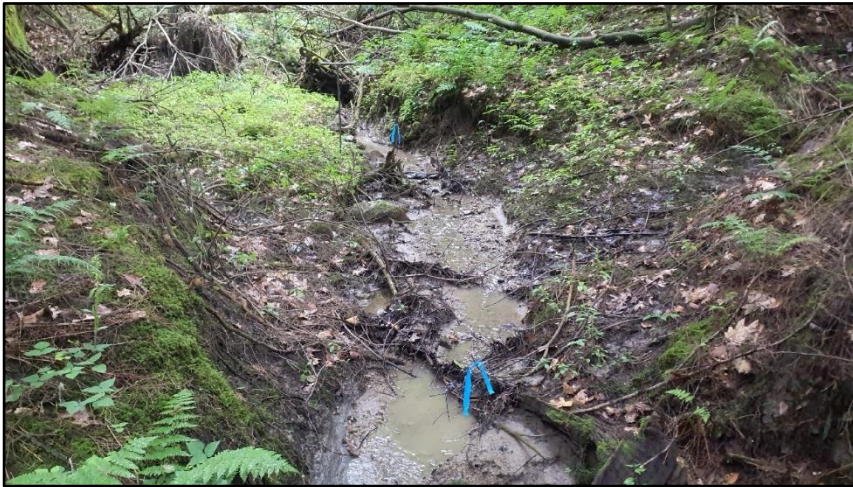
NO. 5 / 09.26.2024

A representative photograph of intermittent streams occurring within the Study Area.

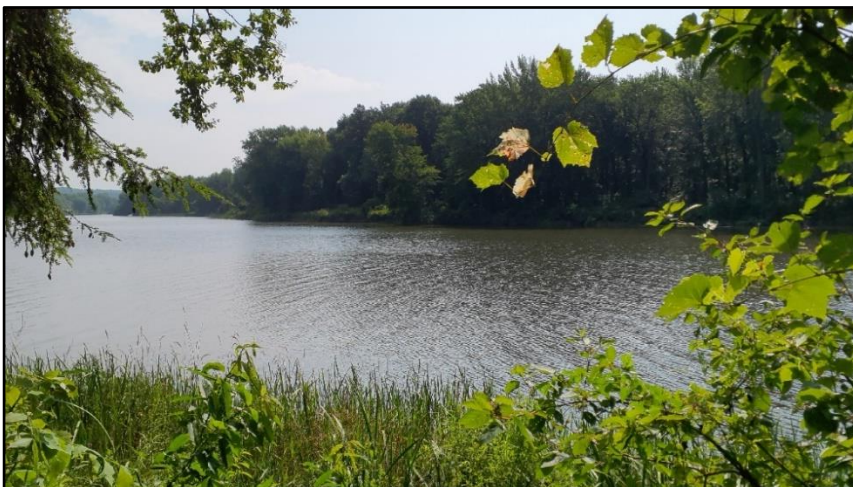
NO. 6 / 09.26.2024

A representative photograph of the Lamoille River along the eastern boundary of the Study Area.

The Study Area borders the Lamoille River and no lakes or ponds. The shoreline associated with the Lamoille River will remain in its current condition as the Project work will not occur near the river. The shoreline and waters will maintain existing conditions, and no changes in access will result from the Project. Vegetative cover will remain the same and the banks will remain stabilized.

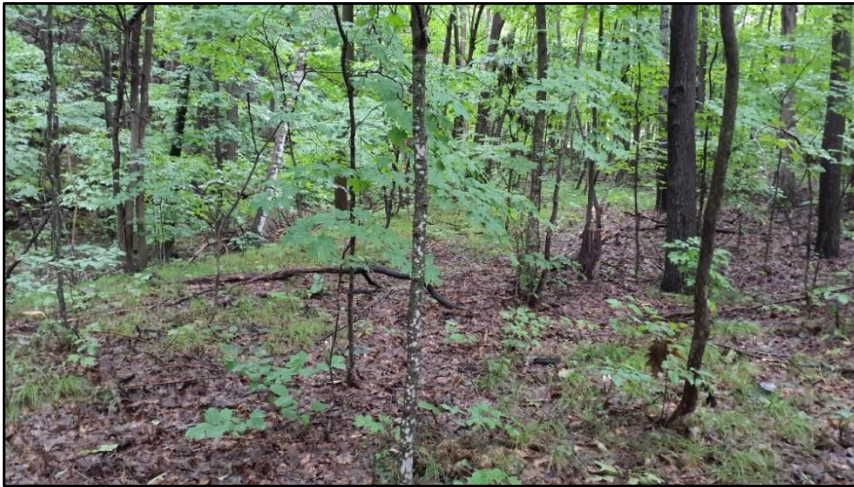
NO. 7 / 07.19.2024

A representative photograph of the Dry-Oak-Hickory-Hophornbeam Forest located in the northern and southern portions of the Study Area.

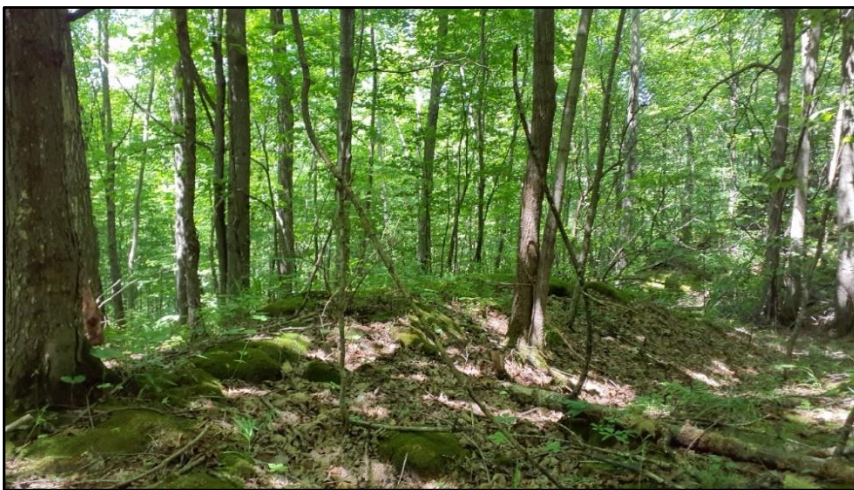
NO. 8 / 07.19.2024

A representative photograph of the Dry-Oak-Hickory-Hophornbeam Forest located in the northern and southern portions of the Study Area.

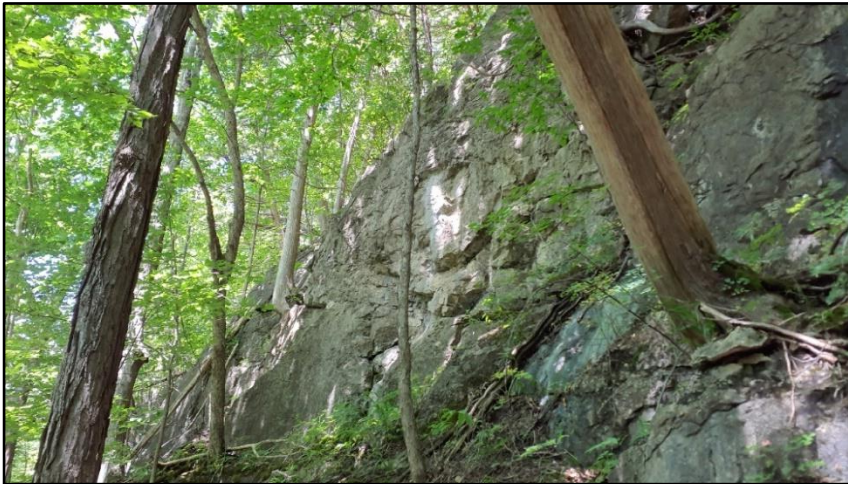
NO. 9 / 07.19.2024

A representative photograph of Dunham Dolostone ledges in northern portion of the Study Area.

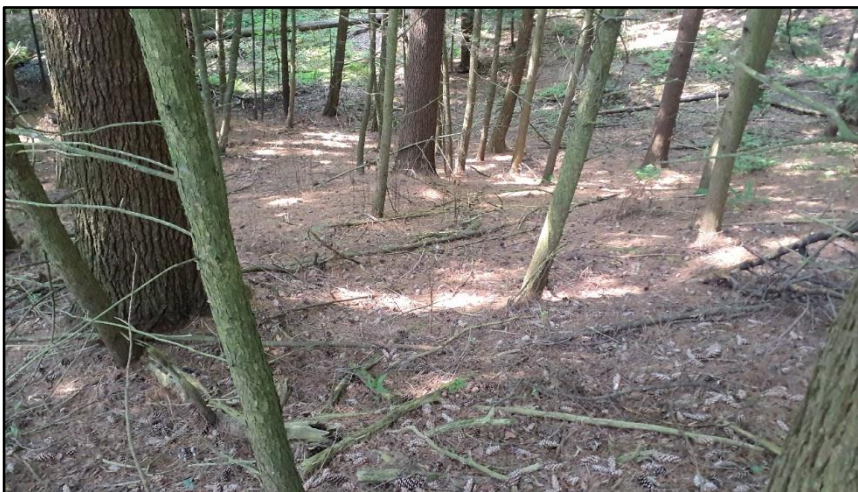
NO. 10 / 07.30.2024

A representative photograph of the Deer Winter Area located in the northeastern portion of the Study Area.

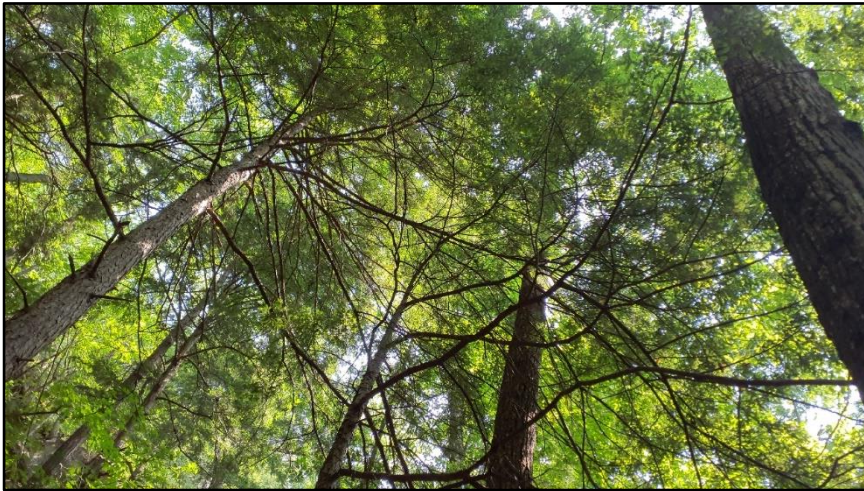
NO. 11 / 07.30.2024

A representative photograph of the canopy cover in the Deer Wintering Area located in the northeastern portion of the Study Area.

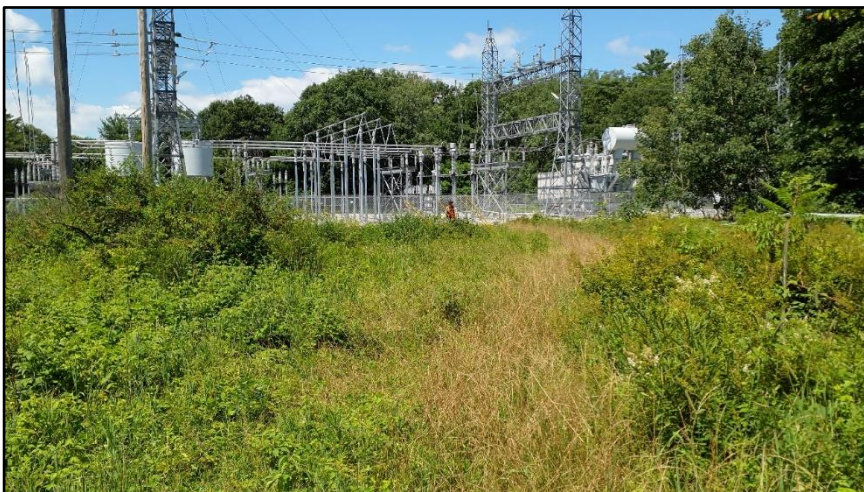
NO. 12 / 07.19.2024

A representative photograph of the proposed Project site east of the current substation yard.

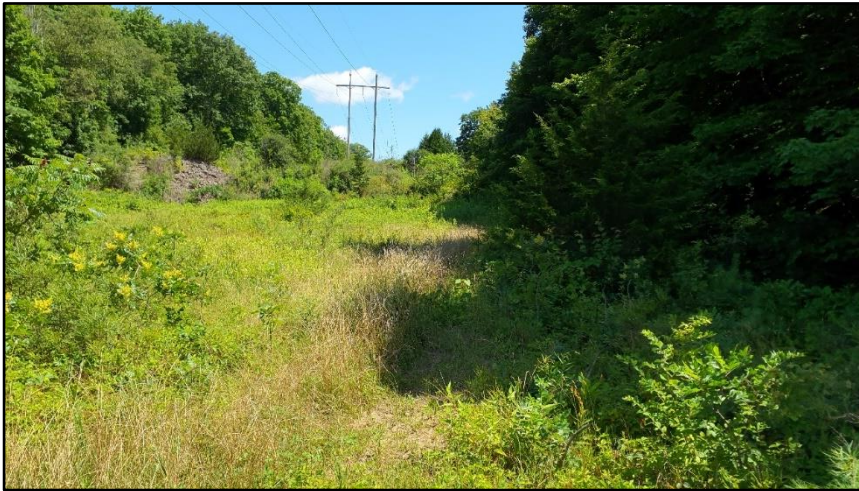
NO. 13 / 07.19.2024

A representative photograph of the maintained ROW east of the substation yard.

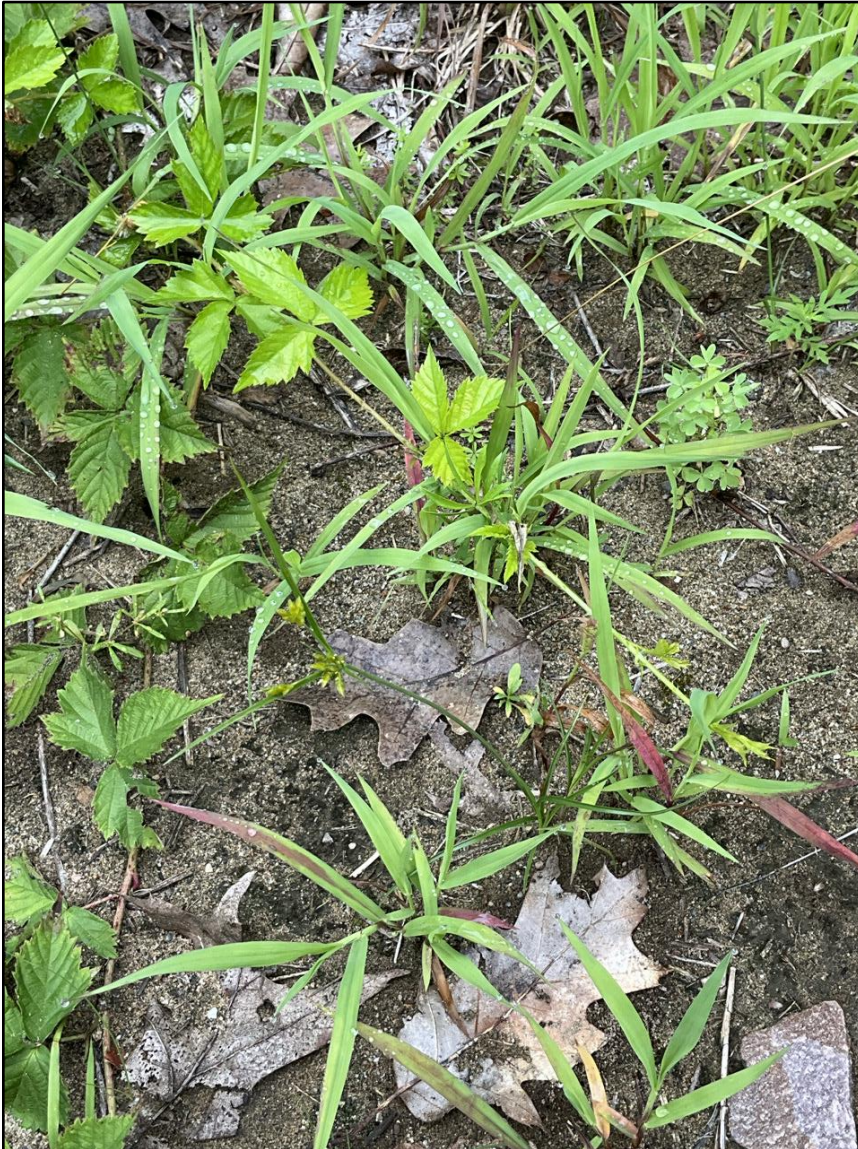
A representative photograph of RTE plant species present within the Study Area.

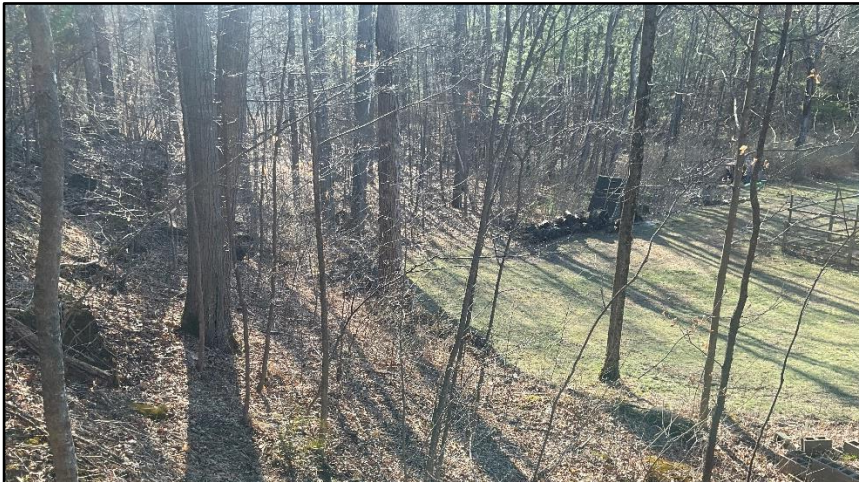
NO. 16 / 04.25.2025

A representative photograph of the forested conditions at the residential inholding parcel located to the west of the current substation.
