# Substation Inspections Following a Line Trip

Operating Committee  
Meeting

# Line Trip and Reclose Response

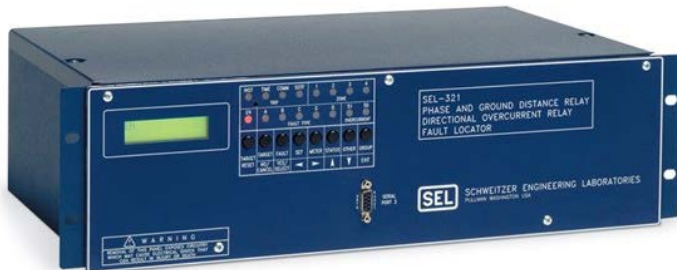
## SEL-321 Relay Record

- Example – Bennington K6 line
- Function – 21/67N
- Element Trip – Zone 1, Phase B-Ground
- Distance – 12.54 miles

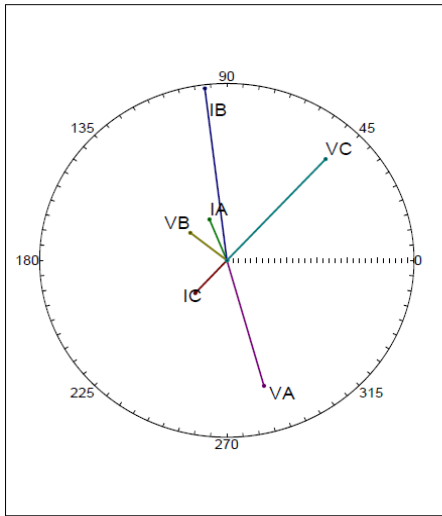
Phasor Elements

## Phasor and Sequence Elements

Relay/Terminal ID: ESSEX SUBSTATION K22(LINE)

Channel	Mag	Angle	Scale	Show	Ref
IR	6592.8	102.6	1	0	
IA	858.6	112.0	1	1	
IB	6099.7	96.9	1	1	
IC	564.8	227.6	1	1	
VA	59.7	285.6	1	1	
VB	17.8	141.4	1	1	
VC	63.1	47.3	1	1	
I0	2197.6	102.6	1	1	
I1	1950.7	203.5	1	1	
I2	2029.5	343.6	1	1	
V0	15.0	0.0	1	1	1
V1	46.4	283.4	1	1	
V2	15.7	232.1	1	1

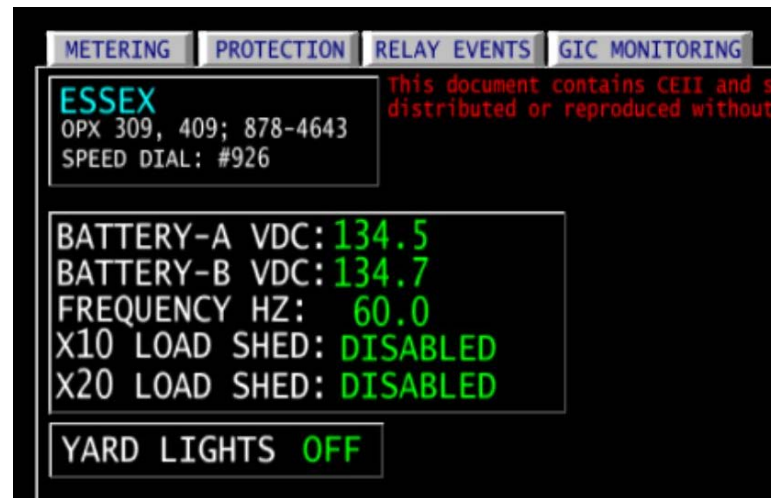
## VELCO Automatic Retrieval of Relay Event Information

- Protective relay event data provides improved situational awareness following a transmission or subtransmission line trip event
  - Relay targets
  - Fault type and phases involved
  - Relay element that operated, e.g. instantaneous or time delayed, high-speed communication-aided, overcurrent, stepped distance with zone, SOTF and line differential
  - Relay calculated fault distance
- Information can be viewed on the SCADA “Relay Events” display

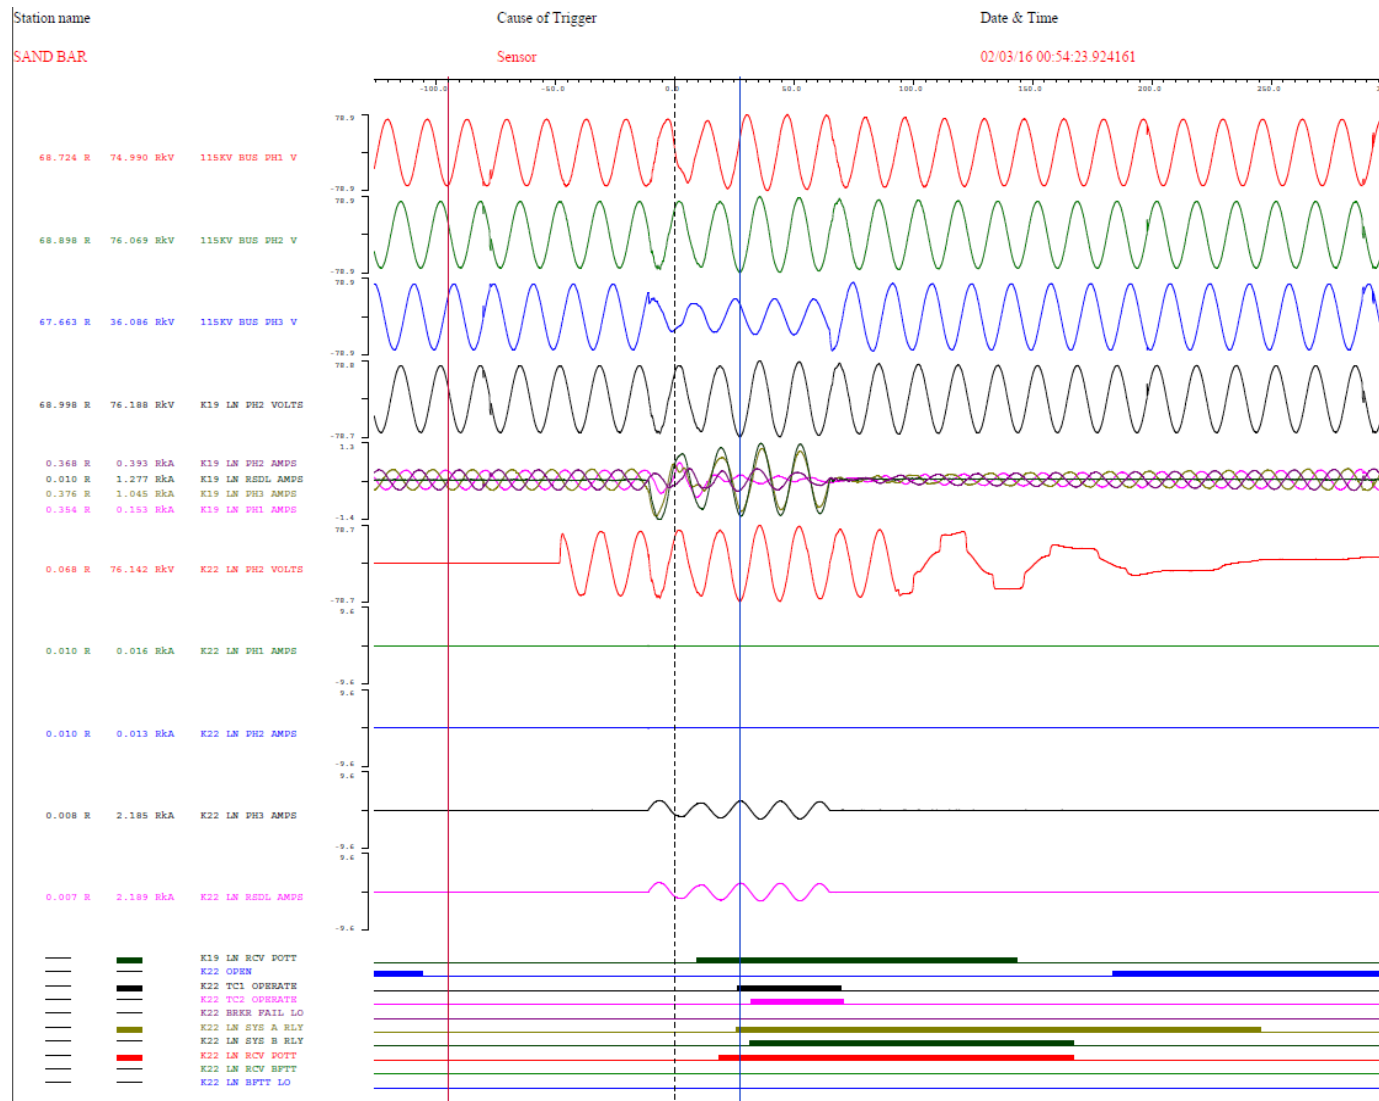
- DFR data – Feb 3, 2016 Essex to Sand Bar K22 event

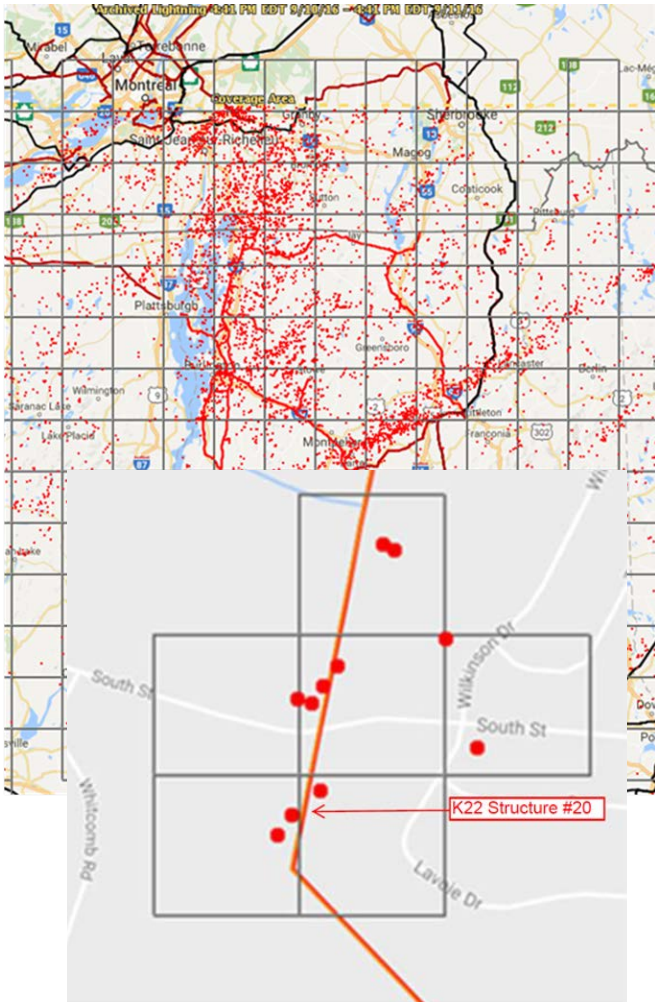
- Schneider DTN Weather Sentry® Lightning Detection
  - Accuracy of detection network 0.09-0.12 miles

Time	Latitude	Longitude	Polarity	Amplitude (kA)
5:16:52.200 AM EDT 9/11/16	44.4884	-73.1326	-	6
5:09:36.500 AM EDT 9/11/16	44.4872	-73.13212	-	20
5:09:36.400 AM EDT 9/11/16	44.4867	-73.13448	-	6
5:09:36.200 AM EDT 9/11/16	44.4894	-73.13354	-	30
5:09:36.100 AM EDT 9/11/16	44.4877	-73.13483	-	6
5:09:36.000 AM EDT 9/11/16	44.4877	-73.13461	-	8
5:09:35.900 AM EDT 9/11/16	44.4893	-73.13337	-	14
5:09:35.800 AM EDT 9/11/16	44.4865	-73.13491	-	6
5:09:35.700 AM EDT 9/11/16	44.4881	-73.13423	-	14
5:09:35.700 AM EDT 9/11/16	44.4879	-73.13444	-	6
5:09:35.600 AM EDT 9/11/16	44.4863	-73.13513	-	8

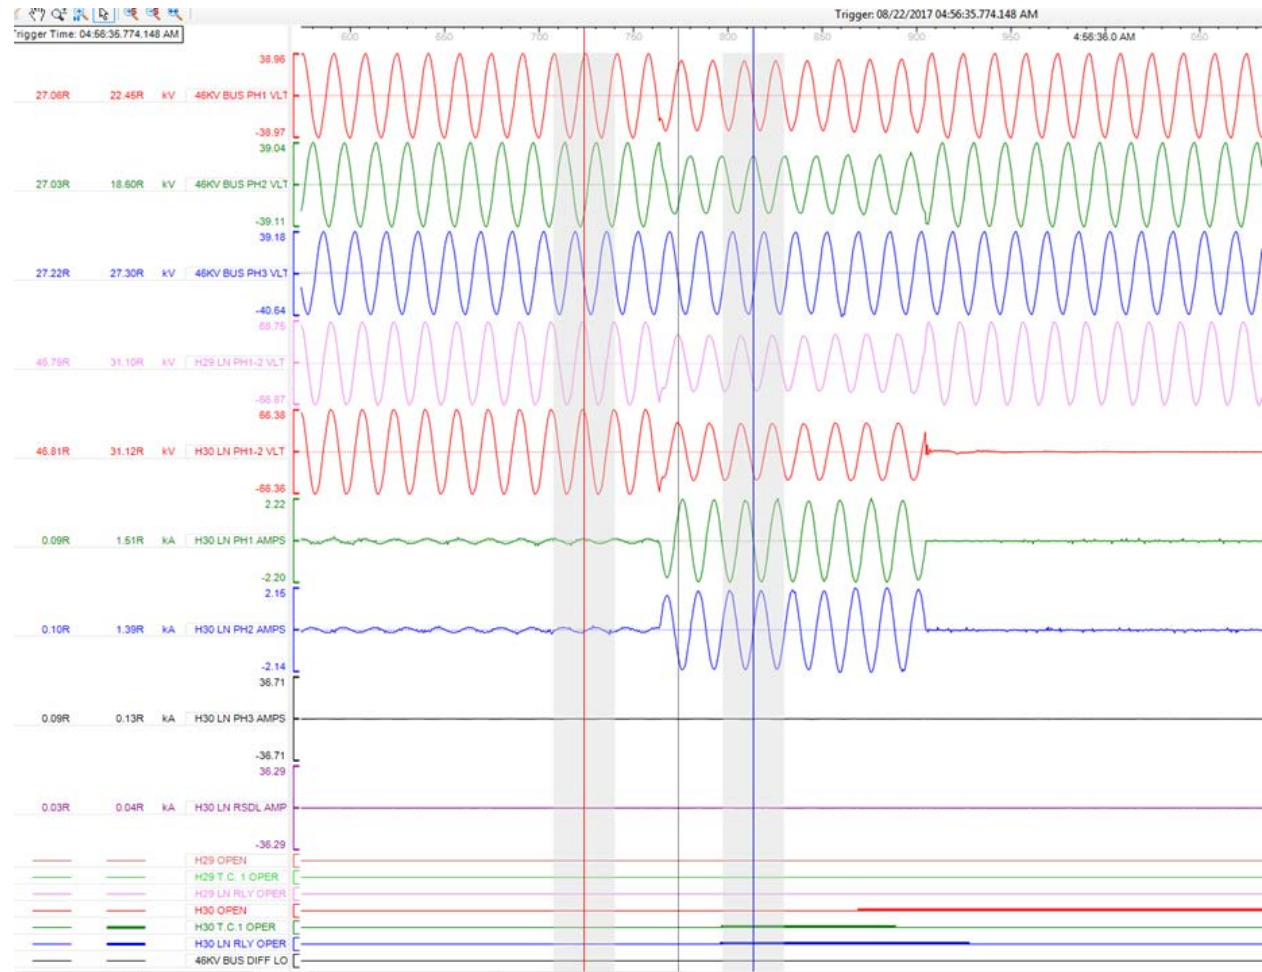
## Blissville H30 (W. Rutland line) 8/22/2017 operation

- DFR record provides phase voltage and current values

- Ph1 = 22.42kV
- Ph2 = 18.06kV
- Ph3 = 27.25kV

- Ph1 = 1,490A
- Ph2 = 1,410A
- Ph3 = 130A
- **Residual = 40A**

- Ph1 = 90A
- Ph2 = 100A
- Ph3 = 90A
- **Residual = 30A**
