# ARCHITECTURAL RECONNAISSANCE SURVEY FRANKLIN COUNTY LINE UPGRADE PROJECT

Franklin County, Vermont

August 3, 2023

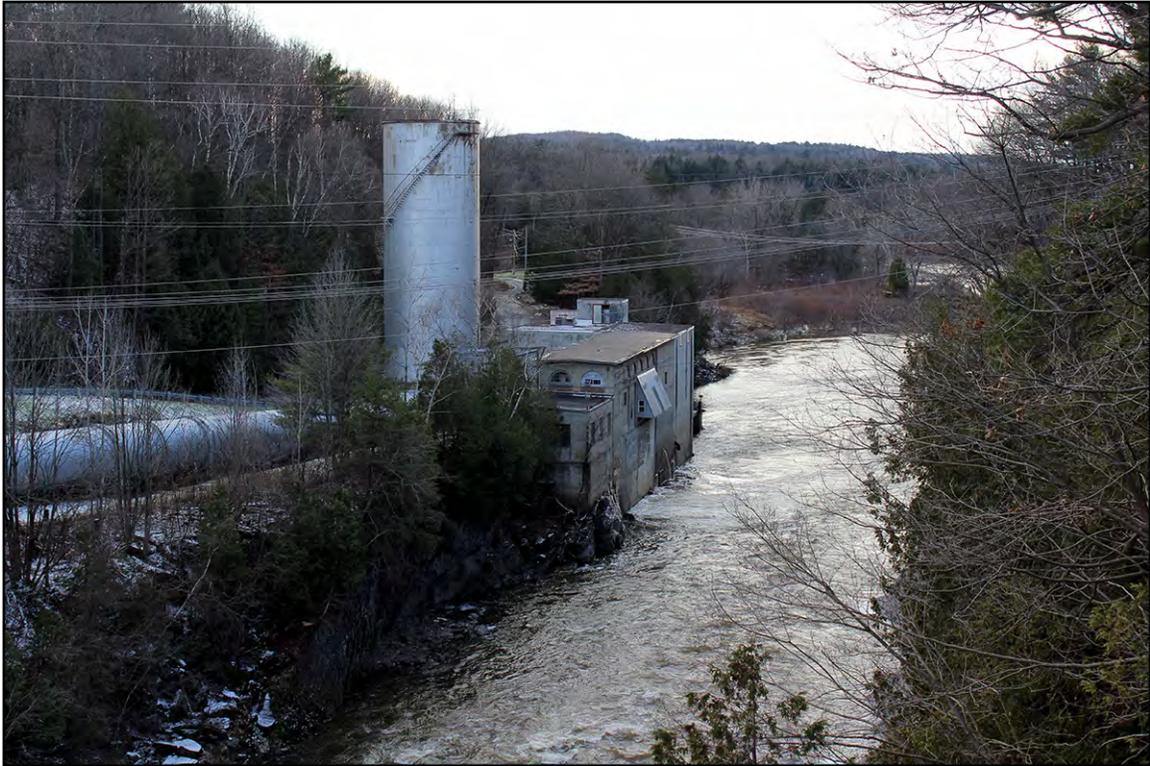
The ca. 1920 Highgate Falls Power Plant is a three-story rectangular-plan reinforced-concrete hydroelectric power plant along the south bank of the Missisquoi River downstream from the Douglas & Jarvis Patent Parabolic Truss Iron Bridge and Highgate Falls. The main block of the structure has a shallow iron and concrete gable roof. Fenestration consists of recessed 19-light semi-circular windows atop 12-over-12 sashes, infilled on the north elevation along the river. Centered on this elevation is a cantilevered shed room sheathed in corrugated metal and two louvered windows. The plant is flanked on the west and east by flat-roofed wings, with the east end at a lower height. A bulkhead sits atop the west wing. The plant is powered by a 4,070-horsepower turbine driving a 2800kw generator in the west wing and two 1,340-horsepower vertical turbines powering two 900kw generators in the east. Located in the east wing are the control room and switching gear.

PLATE 2: Highgate Falls Power Plant, Baker Road Along the Missisquoi River, Looking Southwest

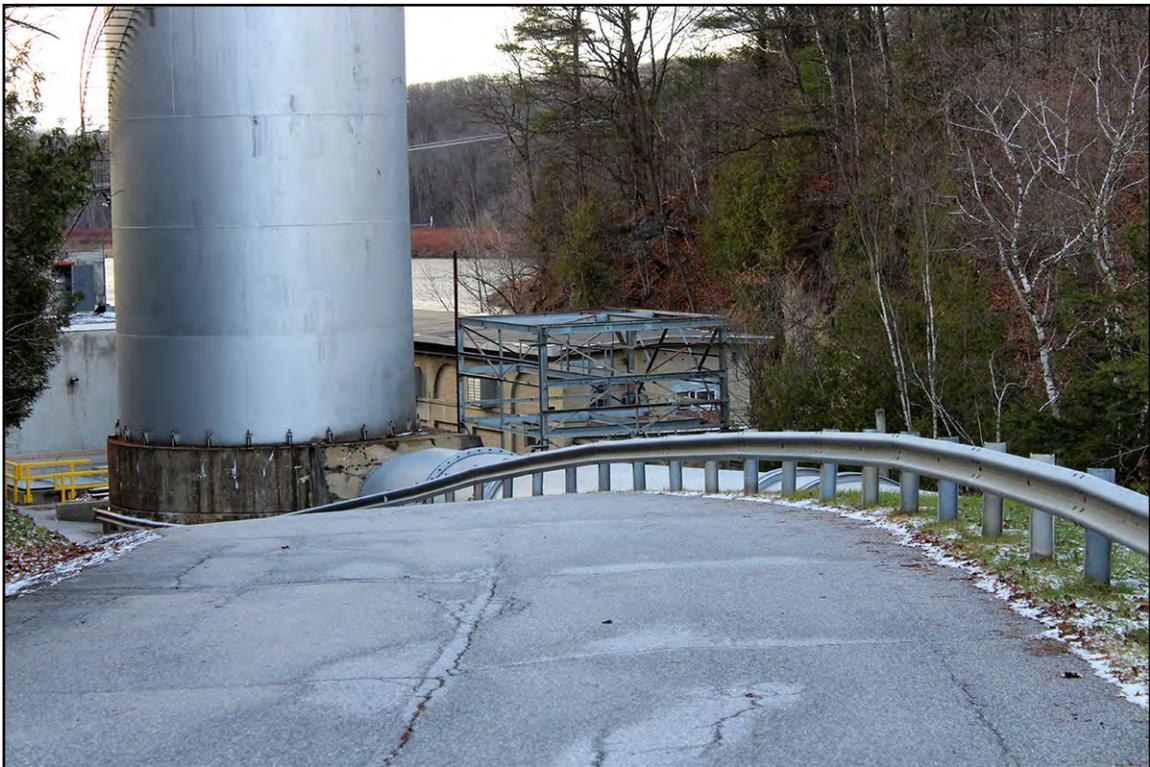
PLATE 3: Highgate Falls Power Plant, Baker Road Along the Missisquoi River, Looking Southwest

The parcel contains a ca. 1915 cylindrical metal surge tank on a poured concrete foundation, a ca. 1930 three-bay shed-roof garage, and a concrete dam 240 feet long and 25 feet high connected to a 200-foot-long gravity dam linking a 12-foot-diameter conduit penstock to the surge tank.

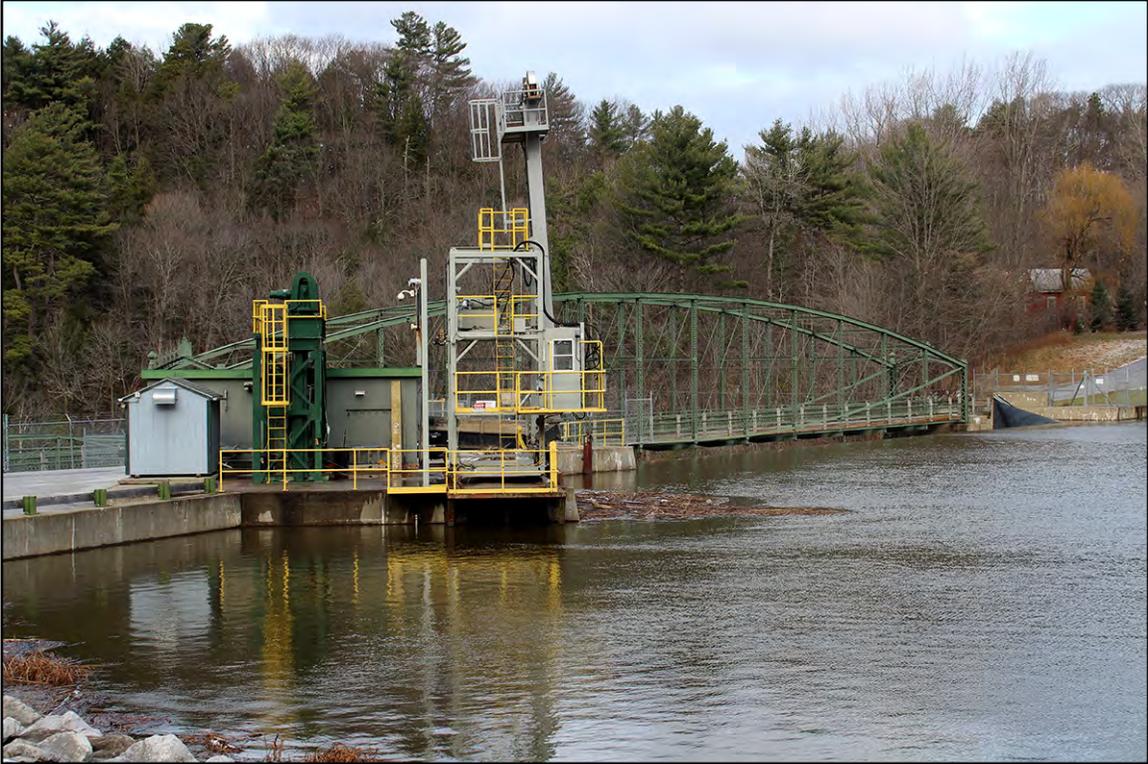
The substructure includes a wood-plank deck anchored by random ashlar and concrete abutments, and a rusticated stone pier with a concrete cap supporting the deck joint. The diagonal floorbeams are pin connected to correlative vertical trusses by rods. The deck is flanked by slotted guard rails reinforced by bolted tapered wood posts.

PLATE 4: Douglas & Jarvis Patent Parabolic Truss Iron Bridge, Crossing the Missisquoi River, Looking Northeast

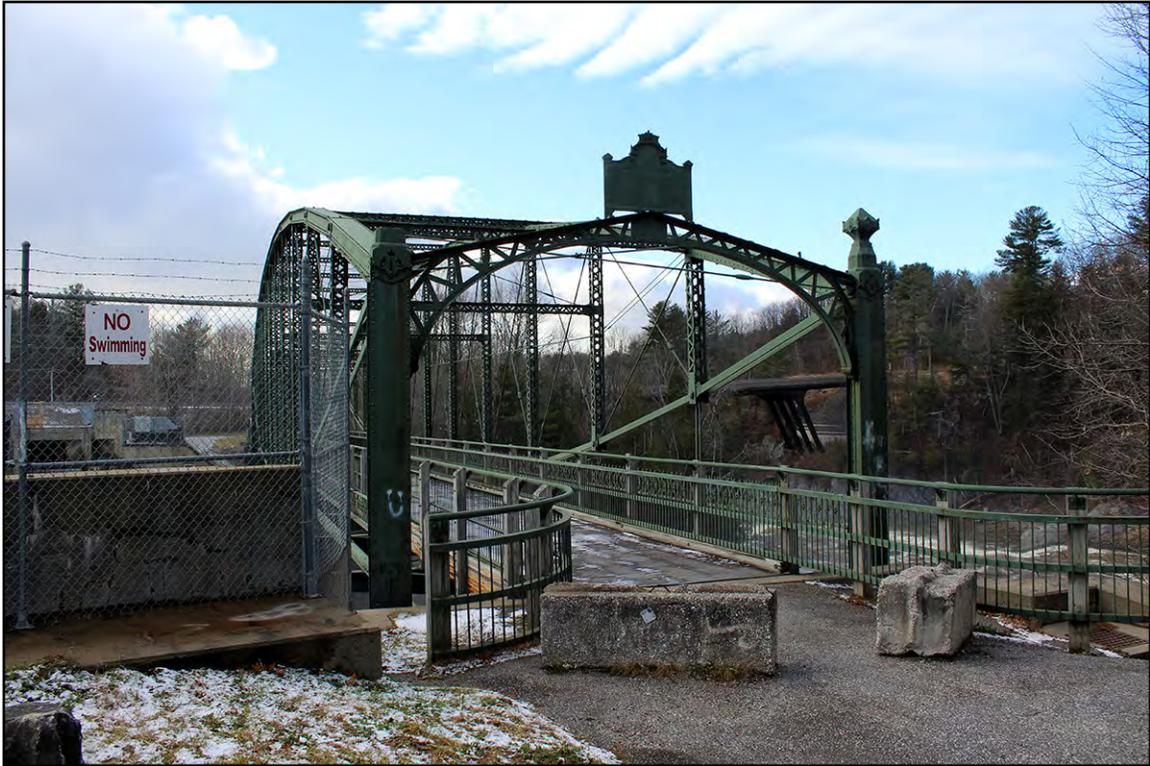
PLATE 6: Douglas & Jarvis Patent Parabolic Truss Iron Bridge, Crossing the Missisquoi River, Looking West

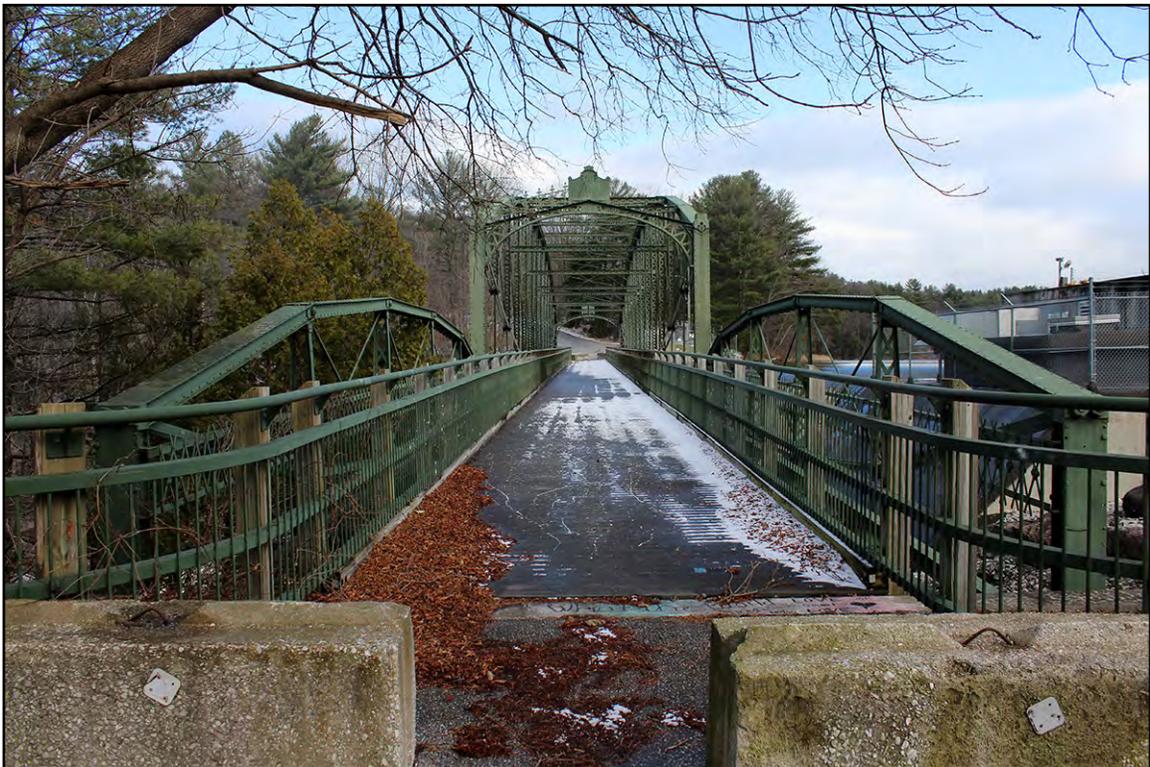
PLATE 7: Douglas & Jarvis Patent Parabolic Truss Iron Bridge, Crossing the Missisquoi River, Looking East-Northeast

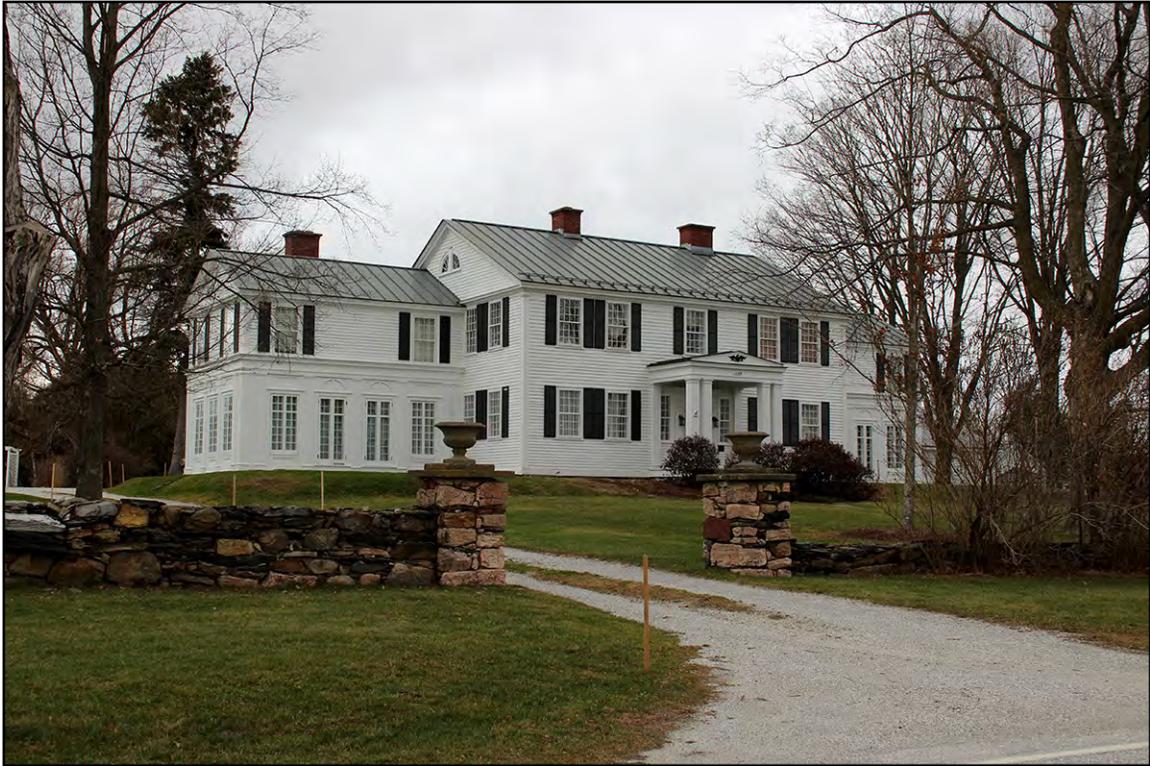
Built in 1799, the Rockledge Farm is anchored by a two-and-one-half-story Federal farmhouse that rests on a cut-stone foundation. The side-gable roof is covered in standing-seam metal and is pierced by paired interior brick chimneys. The symmetrical clapboarded five-bay main block has 12-over-12 double-hung sash windows. The top floor fenestration engages a denticulated cornice carried by corner pilasters with

PLATE 8: Rockledge Farm, 2396 Highgate Road, Swanton, Looking Northwest

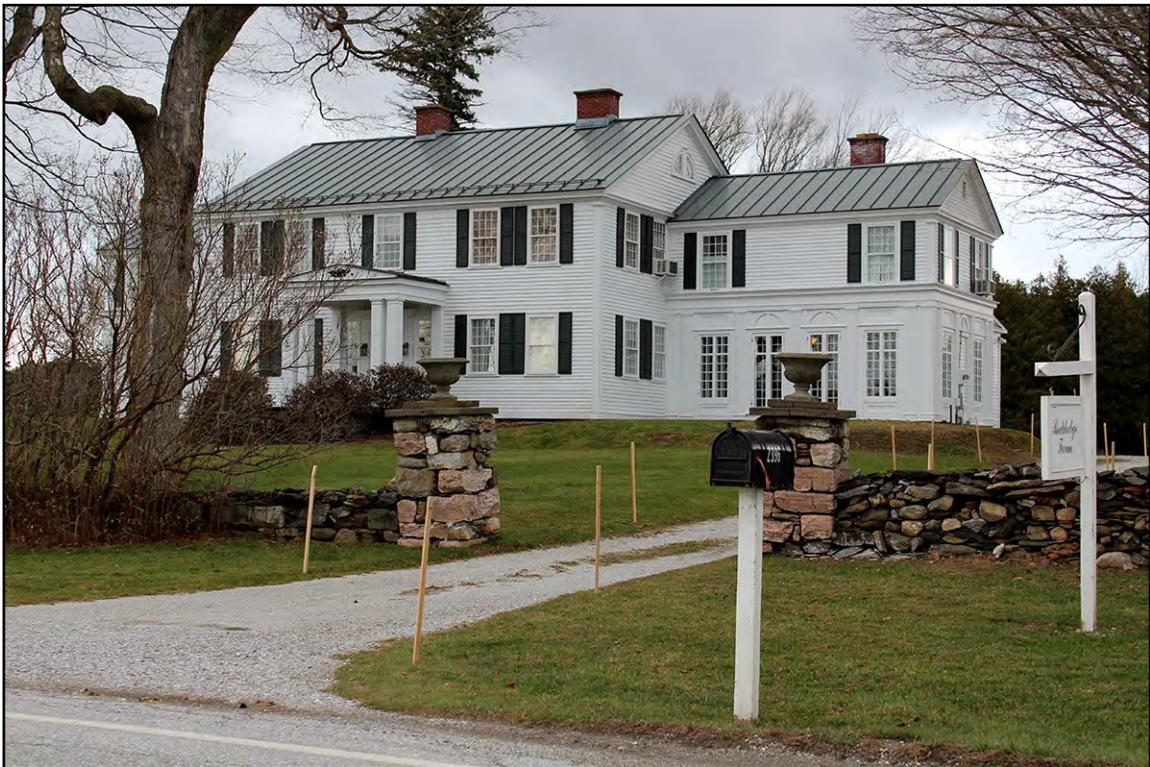
PLATE 9: Rockledge Farm, 2396 Highgate Road, Swanton, Looking Southwest

molded capitals. The entrance is contained within fluted pilasters and six-by-six sidelights surmounted by a full entablature. A pedimented portico on full entablature supported by two pairs of square columns carried by fluted pilasters shelters the entrance. The quarter-round attic windows, likely added during ca. 1918 renovations, sit within pedimented gables (Visser 1994). The rear elevation features a one-story clapboarded shed-roof addition.

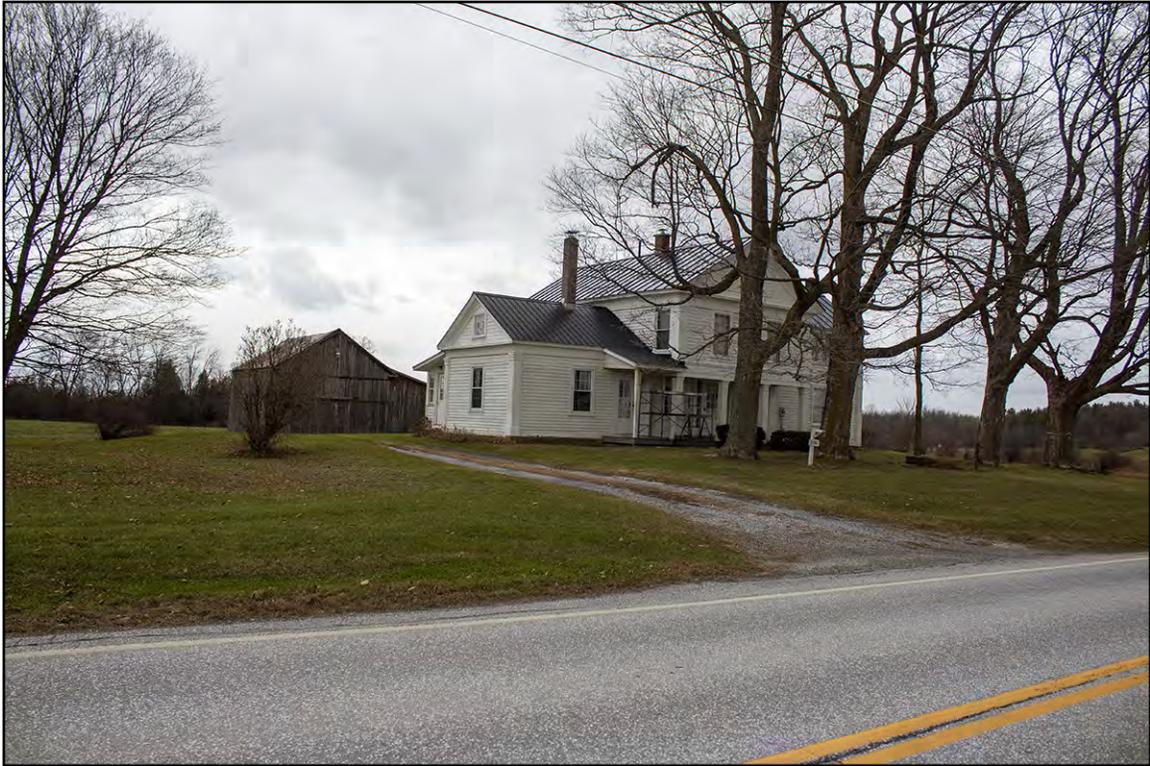
The ca. 1835 Tarte House is a restrained Greek Revival farmhouse that stands two and one-half stories tall on a stone foundation. The temple-front residence with flanking wings is sheathed in clapboards and corner pilasters. The pedimented front-gable roof is covered in standing-seam metal and is pierced by a central ridgeline brick chimney. The pediment rests on plain entablature and has a flush weatherboard tympanum with a triangular attic vent. The symmetrical three-bay façade is lit by six-over-six double-hung sash windows in plain surrounds. The central entrance is a 12-light door flanked by sidelights contained in a simple trabeated frame. Four square columns with recessed paneling support the second-story overhang. The appearance of the wings largely mirrors the main unit. Both wings have cinderblock chimneys. The northeast wing has a second-story addition with paired one-over-one modern windows on the top floor. The first bay on the shorter southwest wing is occupied by a modern six-over-six window, and the second bay is opened by a multi-light door. The door is sheltered by a shed-roof extension on square posts. The shed-roof additions extend from the rear of the main unit and wings.

Modifications to the house since the original survey (VDHP 1982b) include the three replacement windows, painted fenestration, and metal roofing on the main unit. These alterations are minimal and do not detract

PLATE 12: Tarte House, 2384 Highgate Road, Swanton, Looking North

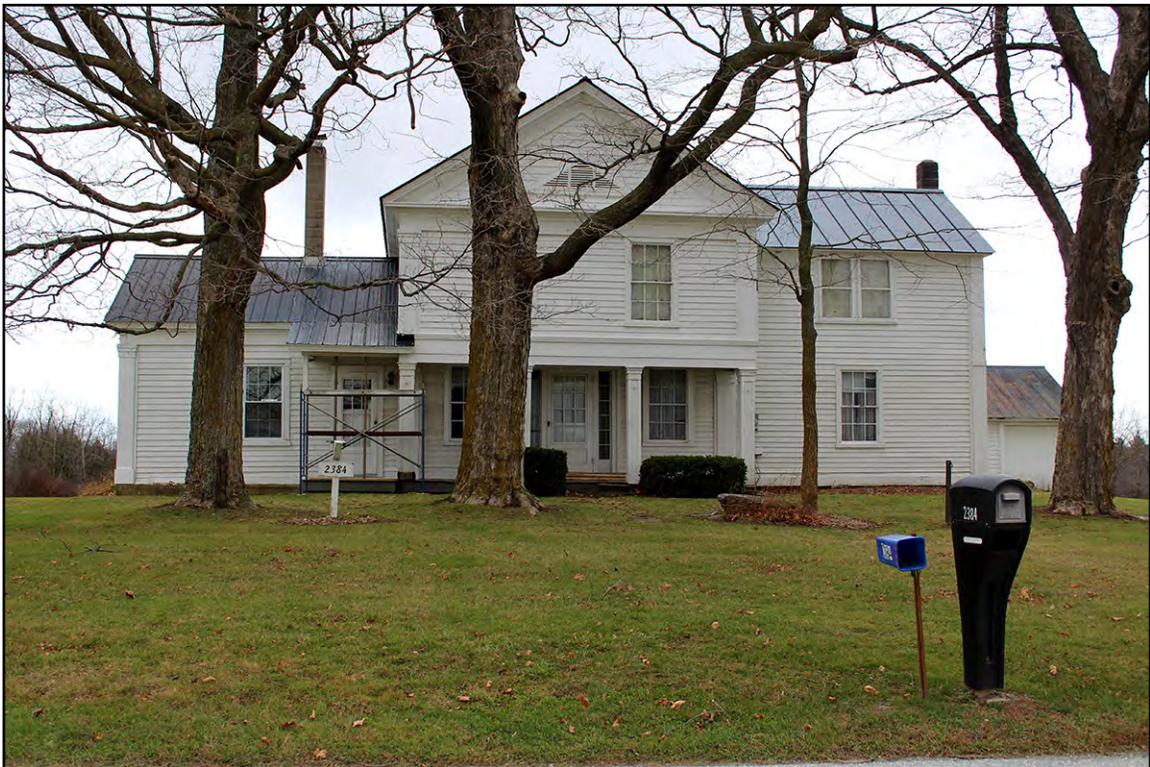
PLATE 13: Tarte House, 2384 Highgate Road, Swanton, Looking West-Northwest

from the property's overall character. The house is an excellent example of a rural Greek Revival farmhouse with good integrity. Therefore, in WSP's opinion the Tarte House should remain listed in the SRHP and is eligible for the NRHP.

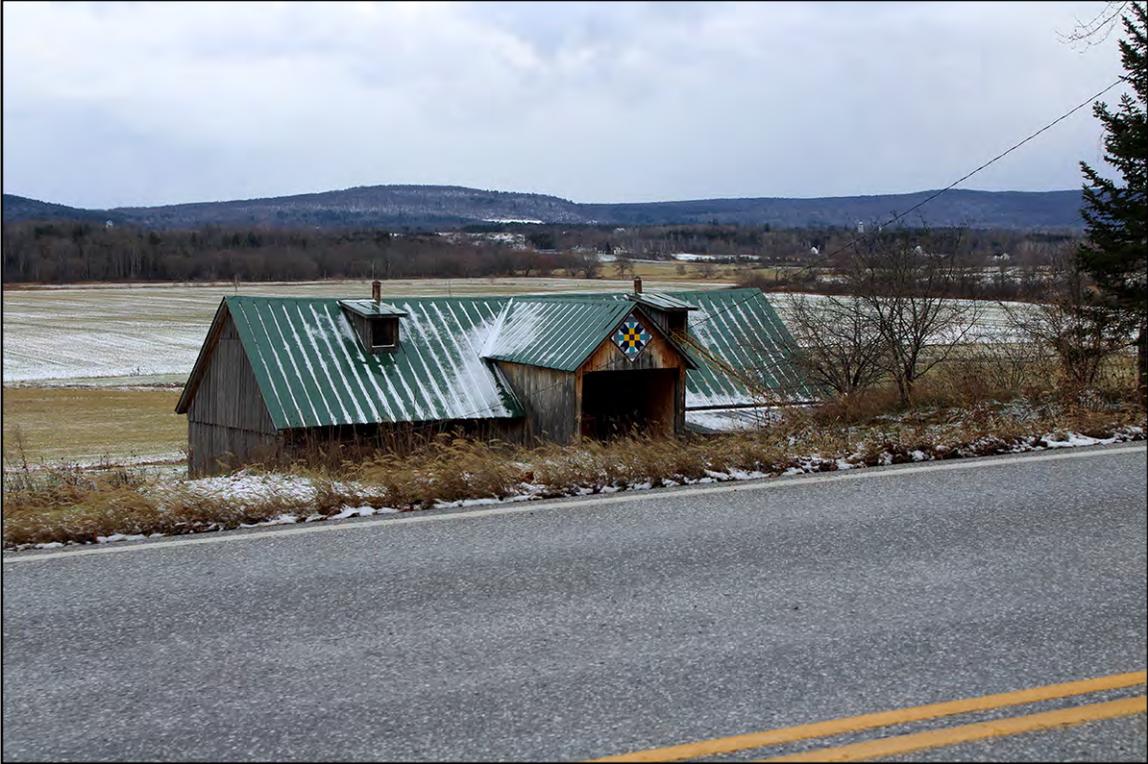
PLATE 17: Garrett Barn, 2013 Highgate Road, Swanton, Looking Southeast

The barn has been extensively rehabilitated since its purchase in 2001. The owner noted that the barn, originally used for dairy production, was abandoned in 1986 and dilapidated when acquired. Changes since the acquisition consist of roofing, windows, concrete footings/foundation, lumber sills, beams, and posts (VDHP 2012). The barn is a good example of a late English barn with sufficient integrity. The repairs adhere to the original form, structure, and massing. Therefore, in WSP's opinion the Garrett Barn should remain listed in the SRHP and is eligible for the NRHP.

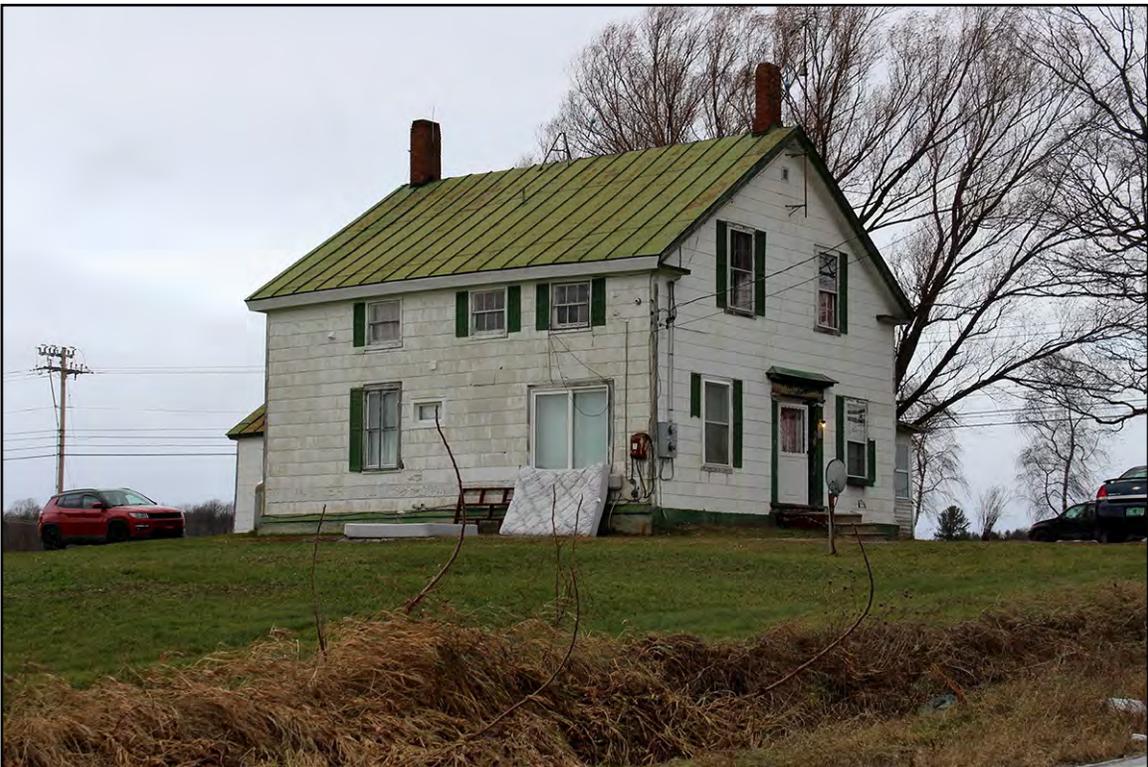
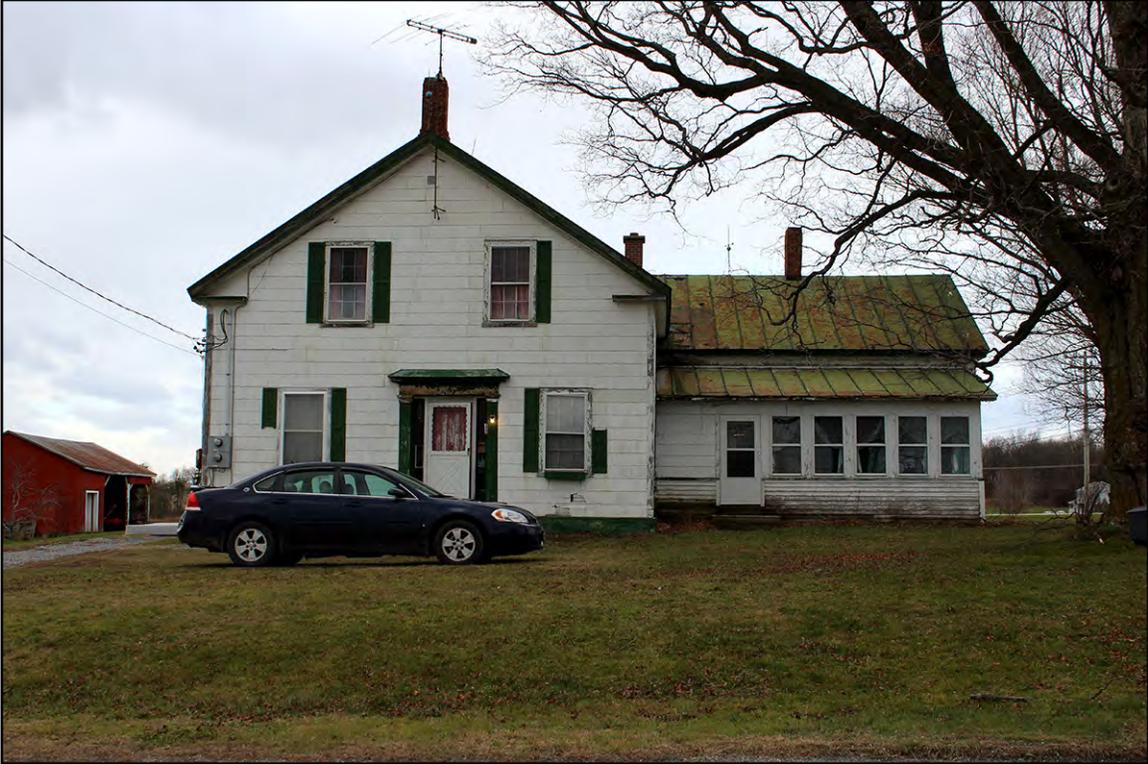
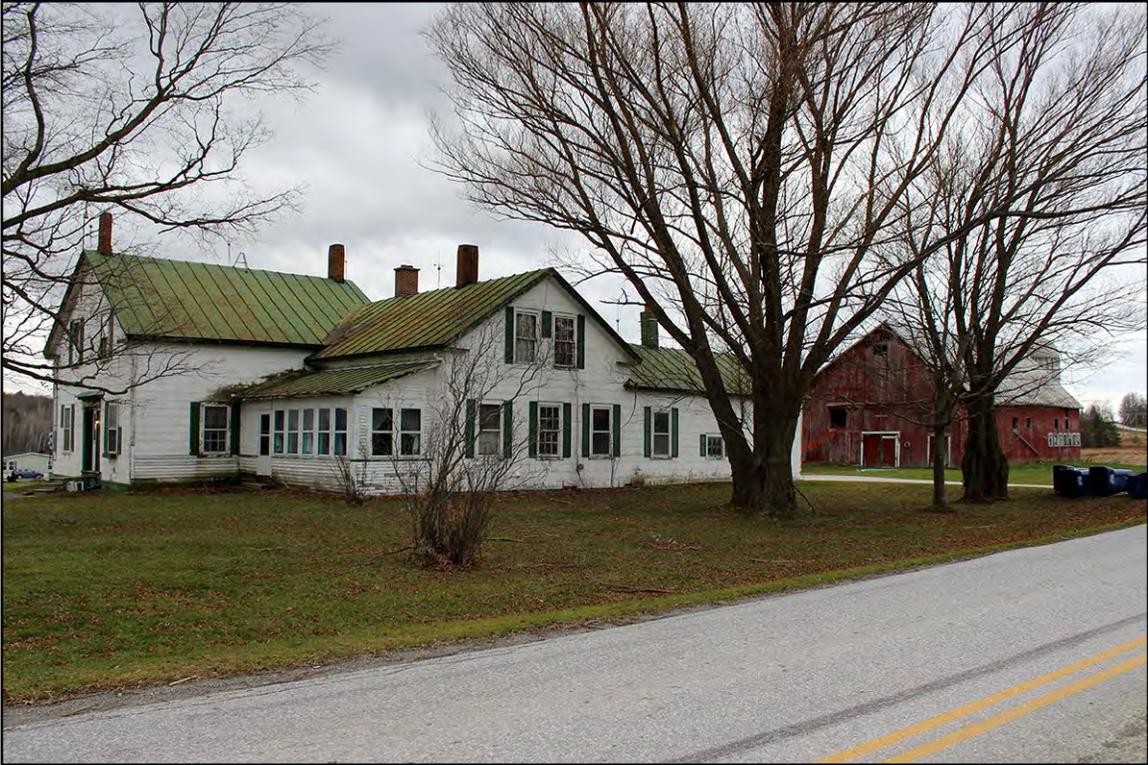
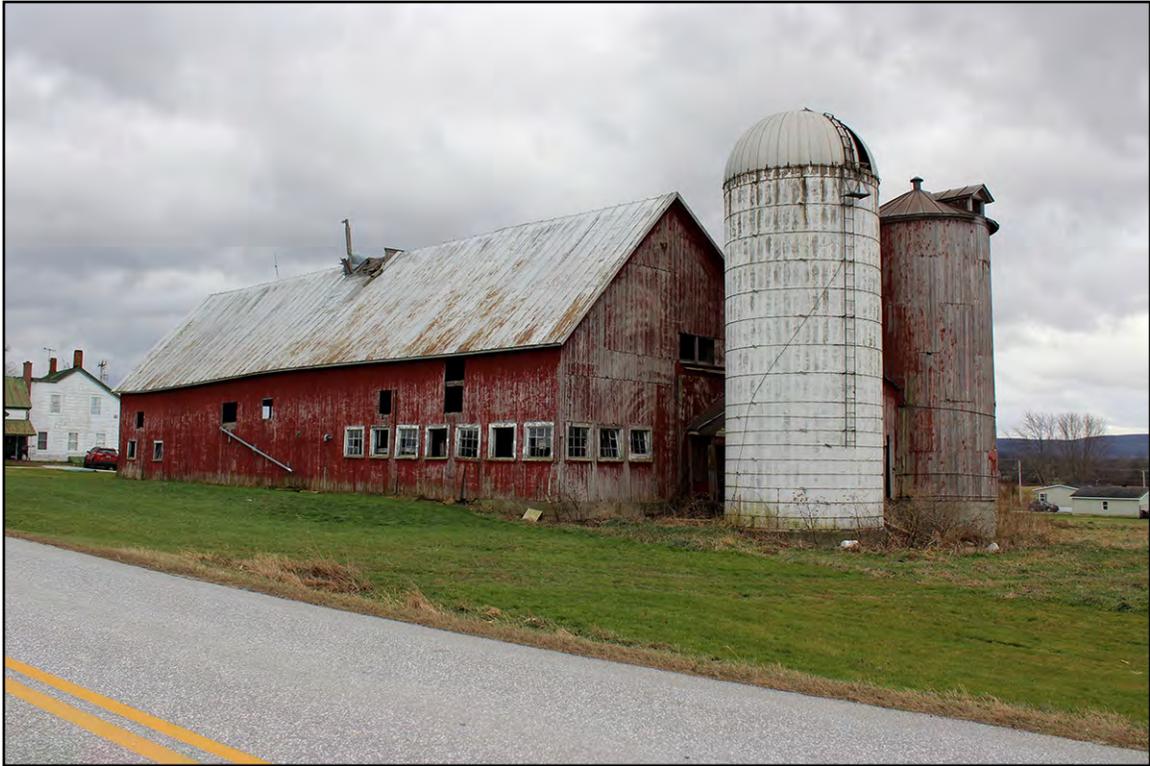
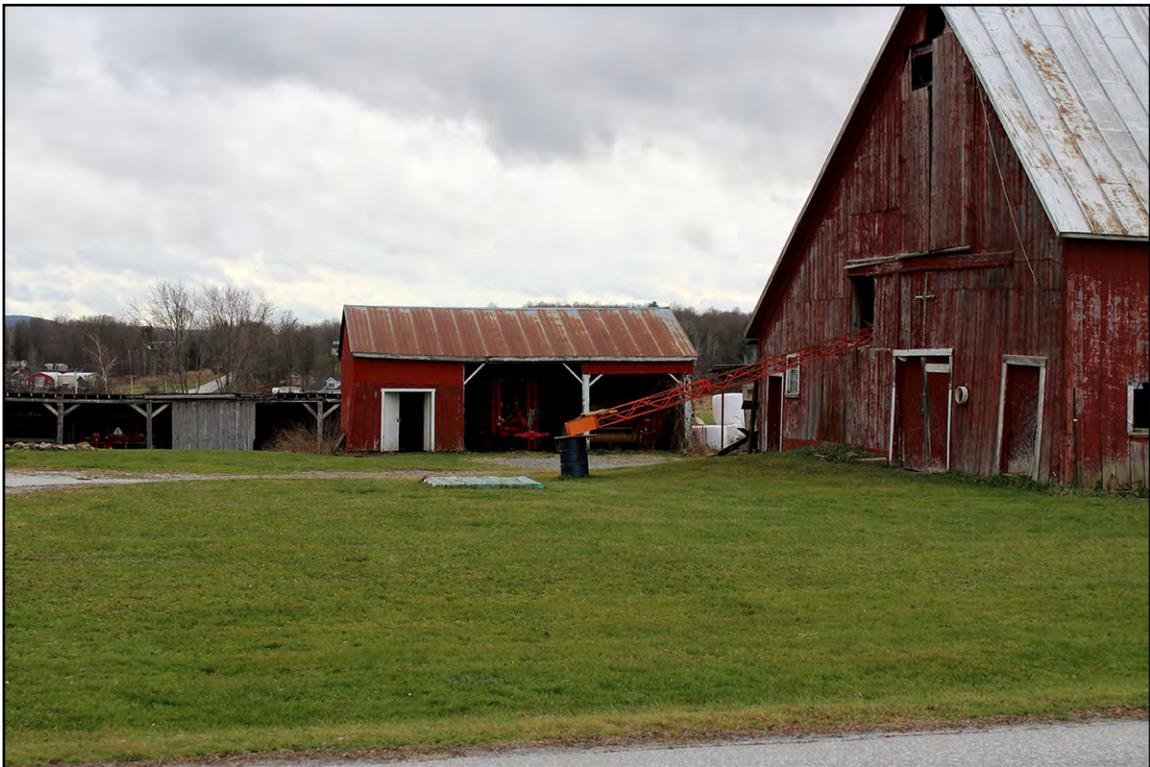
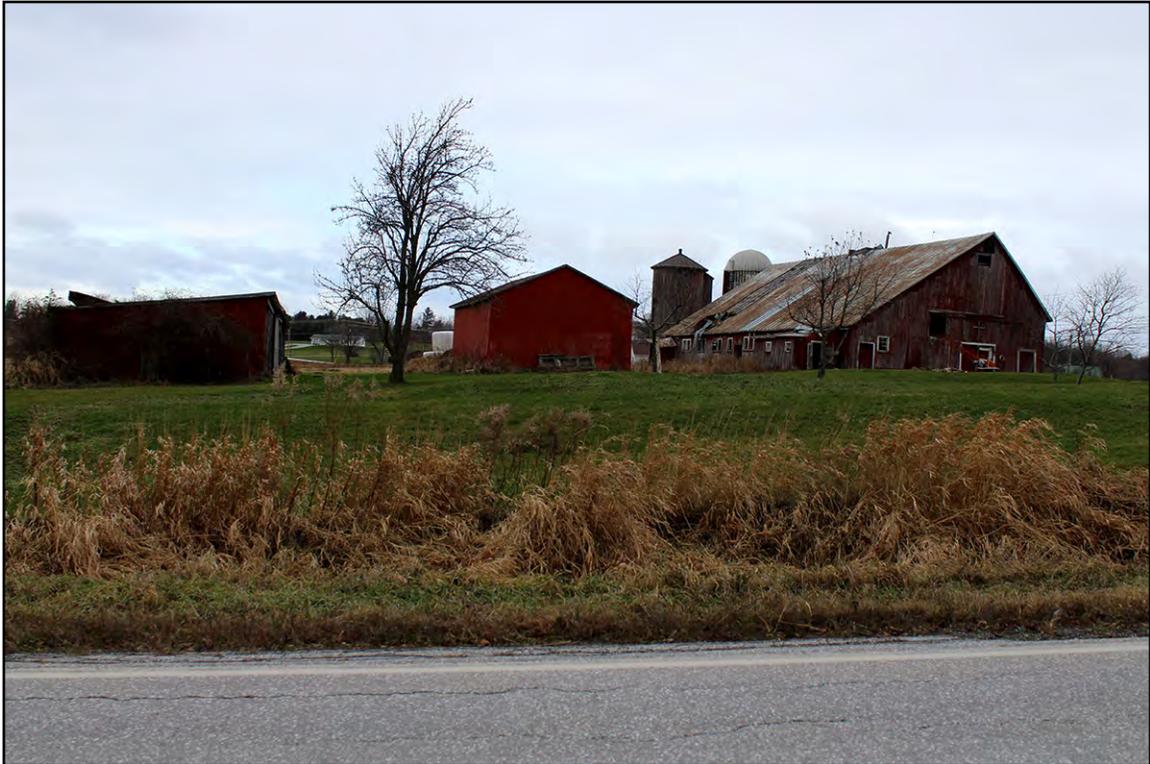
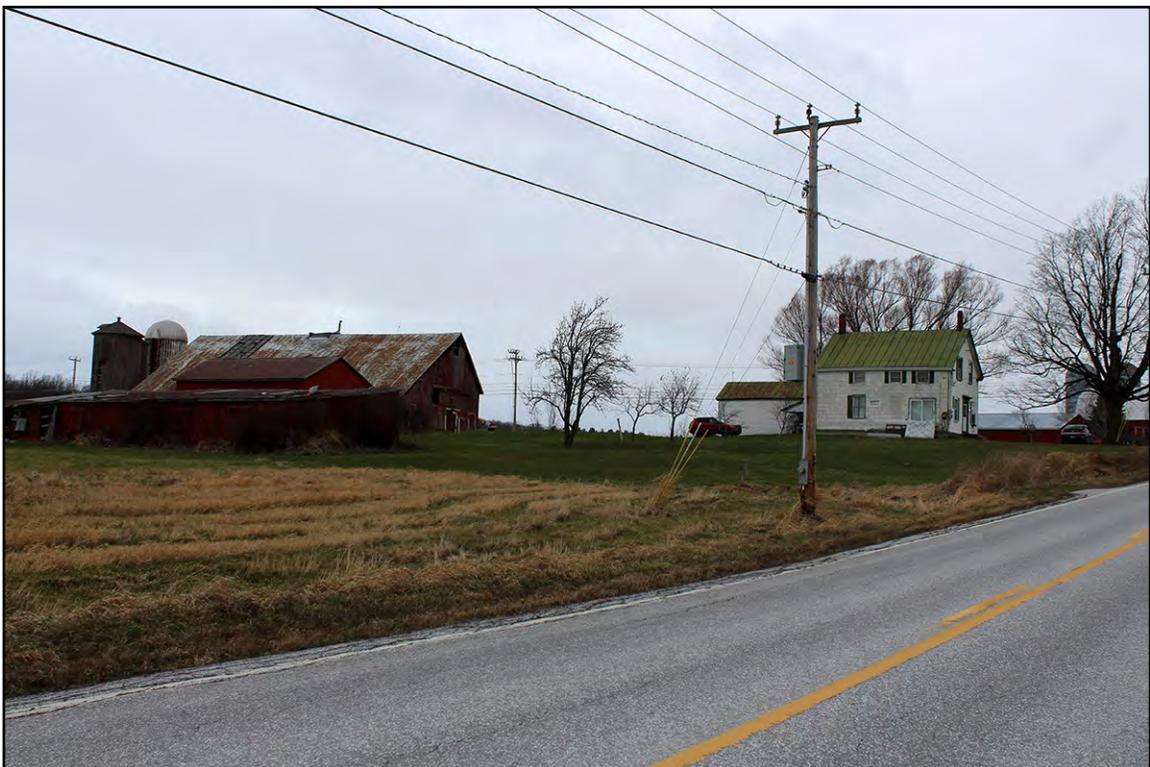
PLATE 18: Jennison-Hubbard Farm, 2162 Highgate Road, Swanton, Looking Northwest

The ca. 1835 dwelling on the Jennison-Hubbard Farm is a gable-front-and-wing farmhouse that stands one and one-half stories tall on a stone foundation. The residence has a roof covered in standing-seam metal with internal gable-end brick chimneys and molded cornice with returns. The exterior (including the wing) is clad in asbestos shingles. The fenestration consists of six-over-six double-hung sash windows primarily on the irregular three-bay façade. The first and third bays on the façade are lit by a modern one-over-one and five-over-five windows, respectively, and the first bay on the south elevation has by a modern one-over-one window. A row of three three-over-three attic windows extend just below the south eaves. The off-center entrance is flanked by sidelights and headed by an entablature surmounted on pilasters. A wing extending from the north elevation is pierced by two ridgeline brick chimneys. The gable-end bay configuration, fenestration, cornice returns, and cladding reflect those of the main unit. A full-width shed-roof enclosed porch sheathed in clapboards extends across the wing. An ell extends from the northwest corner of the wing.

The parcel contains three outbuildings: a large saltbox dairy barn with concrete tile and wood frame silos, and two tractor sheds.

Alterations to the property since the original survey (VDHP 1982b) are limited to some windows and the front door. The asbestos siding obscures much of the original material; however, the siding falls within the 50-year historic threshold. Furthermore, the outbuildings remain intact and in use. The residence is a good example of a vernacular Greek Revival farmhouse with moderate integrity. Therefore, in WSP's opinion the Jennison-Hubbard Farm should remain listed in the SRHP and is eligible for the NRHP.

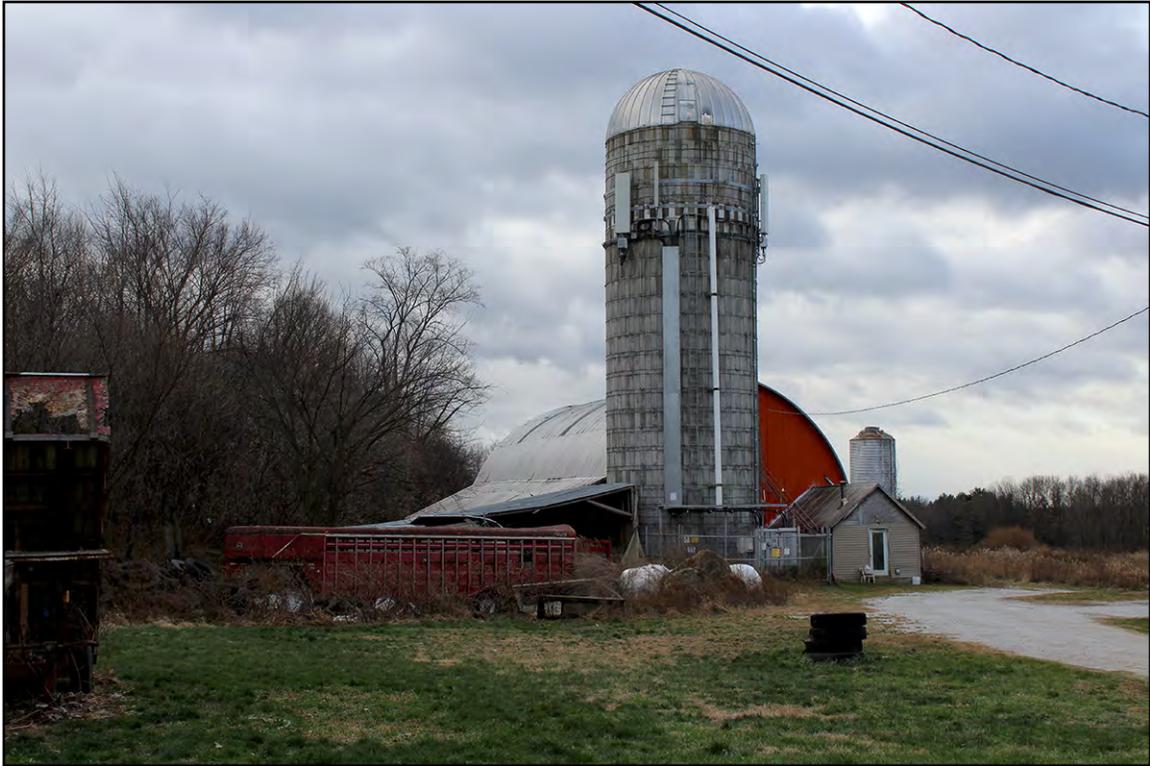
The ca. 1950 Machia Silo and Barn are active outbuildings on a 141.1-acre working farm on the south side of Woods Hill Road. The silo is a concrete-stave subtype topped by a standing-seam metal dome. The exterior retains its chute and ladder and has been fitted with a telecommunications array. Adjacent to the silo is a ground-level stable barn with a curved corrugated-metal arch roof. The exterior has vertical metal panels imitating boards, a north gable hay loft, and a series of eave-side windows. A single-bay gabled milk house extends from the façade. Shed-roof additions are found on the east elevation and southwest corner. A short steel granary stands next to the barn and milk house.

The property has remained relatively unmodified since the original survey (VDHP 2009). In addition to the telecommunications antennas, which precipitated the survey, the cladding on the residence and the milk house cladding appear to have been replaced. The silo and barn remain excellent examples of mid-twentieth-century agricultural outbuildings with good integrity on an active farm. Therefore, in WSP's opinion the Machia Silo and Barn should remain eligible for the NRHP.

PLATE 25: Machia Silo and Barn, 54 Woods Hill Road, Swanton, Looking South

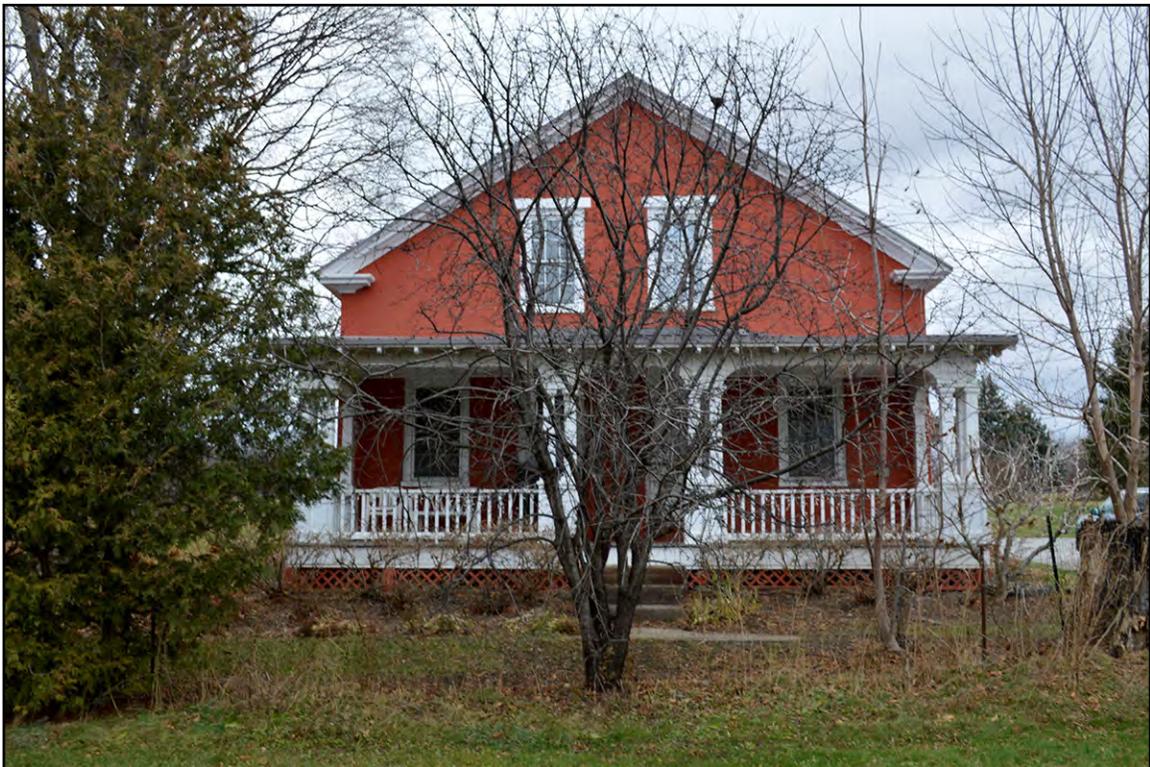
The ca. 1840 front-gable McMahon House stands one-and-one-half stories tall on a stone foundation. The vernacular Greek Revival residence has a painted brick exterior and a corrugated-metal roof with a molded cornice and returns. An internal chimney rises from the south slope. The four-bay façade contains replacement six-over-six double-hung sash windows set within recessed wood surrounds and flat lintels. Small nine-light attic windows are located on the north and south elevations. The full-width façade porch has a hipped roof with exposed rafters surmounted on paired square columns. A smaller version of the front porch shelters the secondary south elevation entrance. The one-story rear ell has been converted into a two-bay garage. The house is partially obscured by evergreens and ornamental shrubs.

The house has been altered since the original survey (VDHP 1982b), notably the windows and porch railings. The replacement windows do not detract from the overall character as they adhere to Greek Revival light configurations with unaltered openings. Therefore, in WSP's opinion the McMahon House should remain listed in the SRHP and is eligible for the NRHP.

PLATE 29: McMahon House, 543 St. Albans Road, Swanton, Looking Northeast

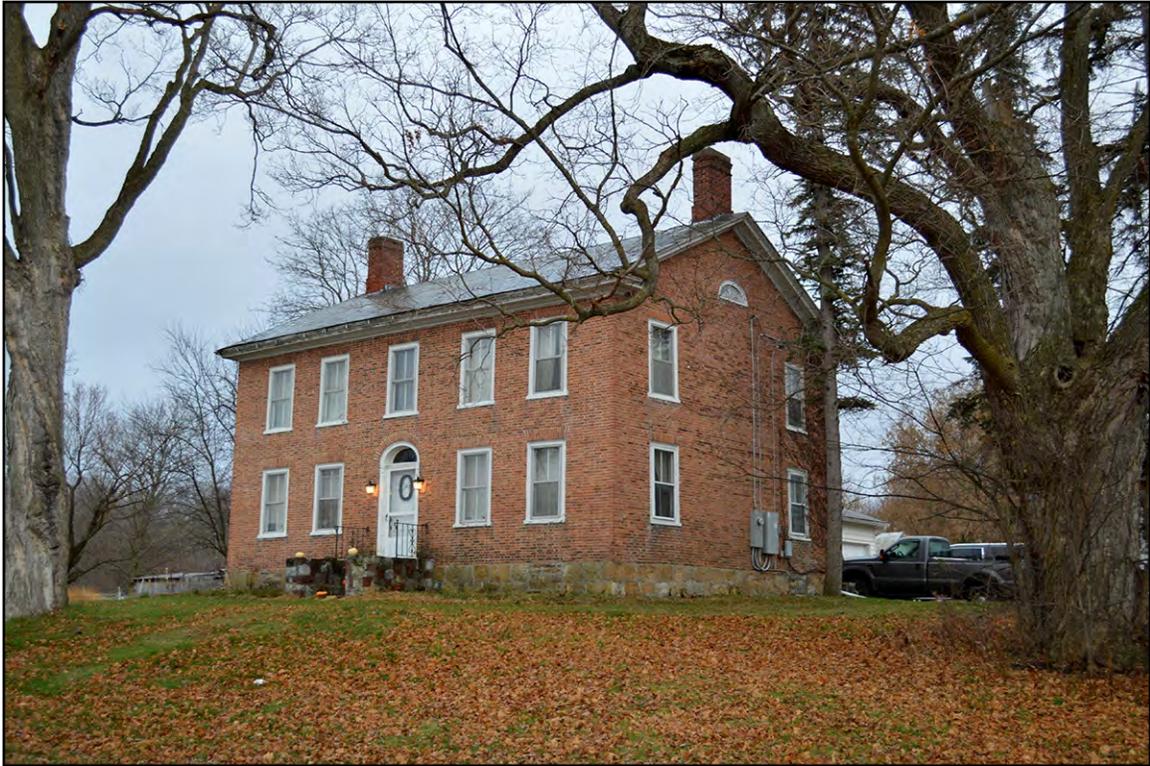
The Tullar-Dunsmore Farm is anchored by a ca. 1815 Federal farmhouse. This massed side-gable residence stands two and one-half stories on a stone foundation. The roof is covered in slate and has two interior end chimneys. The gently molded cornice has returns and runs atop the second-story windows. The brick exterior is faced in Flemish bond on the façade and American bond on the gable ends. The symmetrical five-bay façade contains two-over-two double-hung sash windows topped by flat brick splayed lintels. Additional fenestration includes two-light semi-elliptical attic windows at both gables. The central entrance is a recessed paneled door surmounted by a segmental arch fanlight with radiating muntins; the stone steps were added ca. 1950 (VDHP 1985). The one-story rear ell with an integrated garage is slightly offset from the northeast corner.

PLATE 32: Tullar-Dunsmore Farm, 2764 Kellogg Road, St. Albans, Looking Northeast

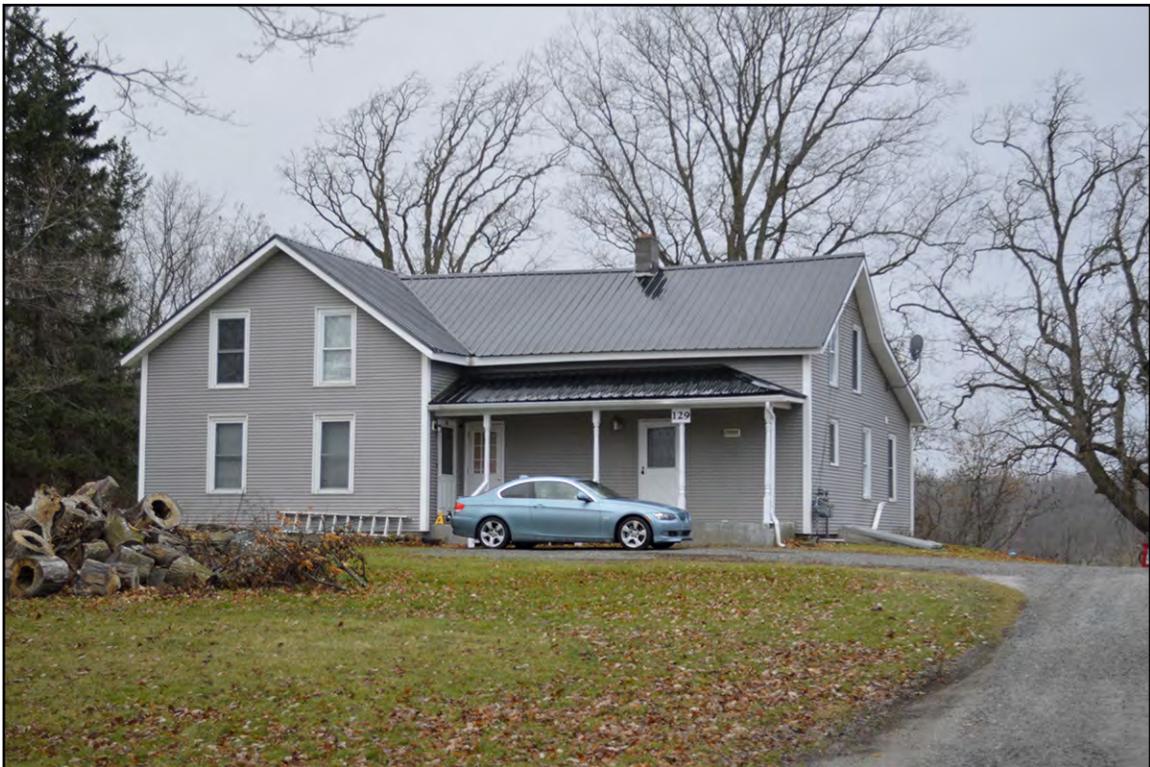
The Brigham-Lareau Farm is anchored by a ca. 1870 gable-front-and-wing house set back from Brigham Road. The one-and-one-half-story house has a corrugated-metal roof, replacement one-over-one windows, an aluminum siding exterior, and a rear ell. A hipped-roof porch on turned posts extends across the wing. Shed-roof additions are located on the rear elevation and the ell's south elevation.

PLATE 35: Brigham-Lareau Farm, 129 Brigham Road, St. Albans, Looking West

The property has been extensively altered since the VDHP (1985) survey. The house's fabric and stylistic elements have been replaced by modern materials and no longer convey any association as a mid-nineteenth-century rural farmhouse. Furthermore, the outbuildings could not be sufficiently evaluated from the public ROW because of obstructions. Therefore, in WSP's opinion the Brigham-Lareau Farm is no longer eligible for the SR/NRHP.

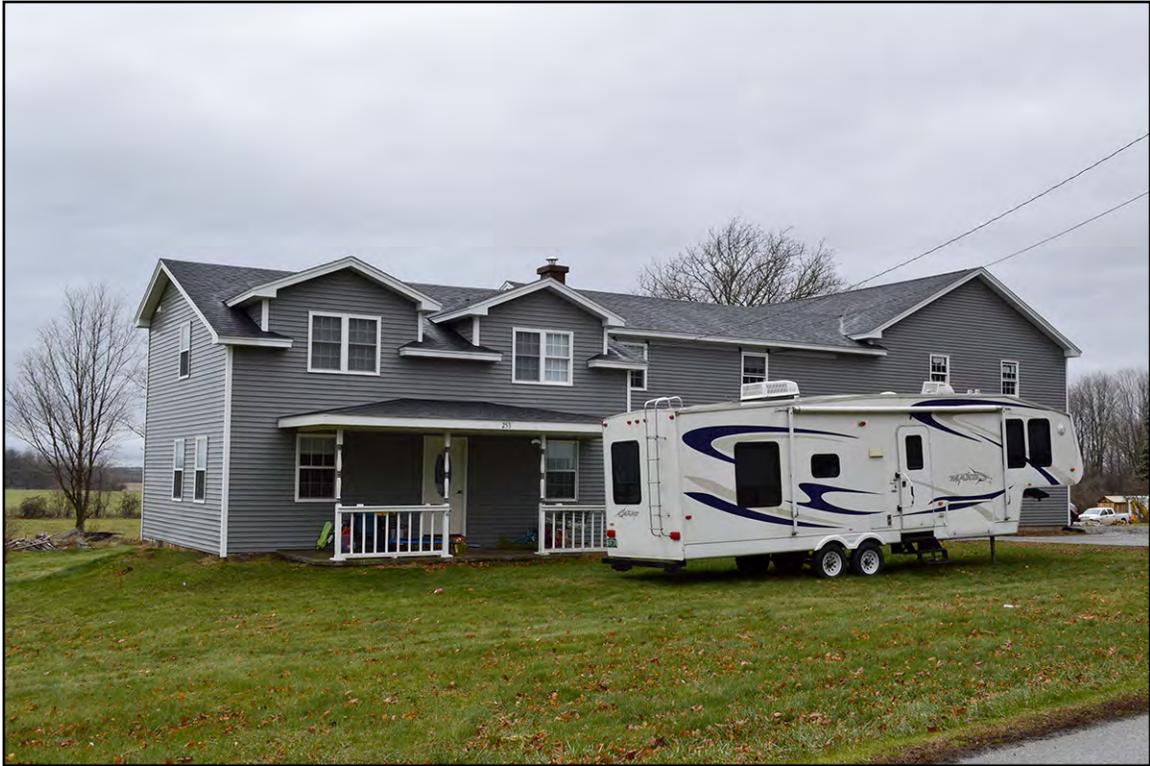
The ca. 1835 Old Wright House stands one and one-half stories tall on a stone foundation. The residence has an asymmetrical side-gable roof covered in asphalt shingles, an internal brick chimney, modern six-over-six windows, and aluminum siding. A hipped-roof porch on turned spindles protects the three-bay main unit façade. A two-story cross-gable wing on the north elevation features the same exterior materials and fenestration of the main block, albeit with window openings with slightly different dimensions. The front-gable portion includes a two-bay garage. A hipped hood shelters the garage doors and the central recessed entry.

The house has been drastically modified since the initial evaluation (VDHP 1985). These changes consist of an altered roof; replacement windows, doors, and siding; façade porch, and second-floor and garage additions on the wing. Because of severely comprised integrity, in WSP's opinion the Old Wright House is no longer eligible for the SR/NRHP.

PLATE 38: Old Wright House, 255 Kellogg Road, St. Albans, Looking Northwest
