# ARCHITECTURAL RECONNAISSANCE SURVEY FRANKLIN COUNTY LINE UPGRADE PROJECT

Franklin County, Vermont

August 3, 2023

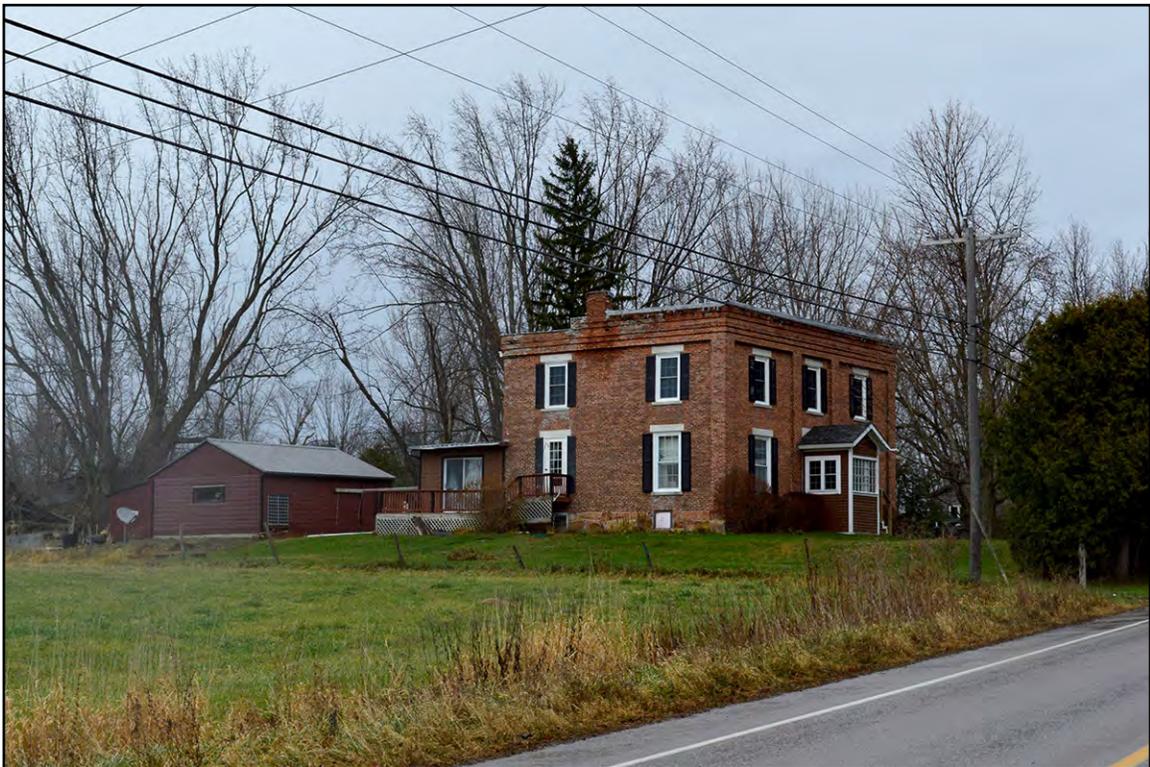
The Old Pelkey Farm is anchored by a ca. 1845 two-story square-plan tempered Greek Revival house faced in common bond on a stone foundation. The parapeted roof has two internal brick chimneys, on the east and west elevations. A corbeled frieze partitions brick plasters on the corners and the three-bay façade. The pilaster grouping creates unequal bays opened by modern six-over-six double-hung sash windows with flat lintels and lug sills. The cellar windows are boarded and align with each bay. The central entrance is sheltered by a clapboarded gabled vestibule with a large 28-light window. A hipped-roof porch with short tapered columns and a clapboarded apron protects the east elevation entrance. The one-story rear addition has a shed roof, shingled exterior, sliding glass doors, and a wood deck.

The alterations since the original evaluation (VDHP 1985) consist of replacement windows and cladding on both porches. The windows honor Greek Revival light configurations, and the modern cladding does not detract from the house's peculiar composition. The house has good integrity and is a unique example of a

PLATE 41: Old Pelkey Farm, 447 Lake Road, St. Albans, Looking East-Northeast

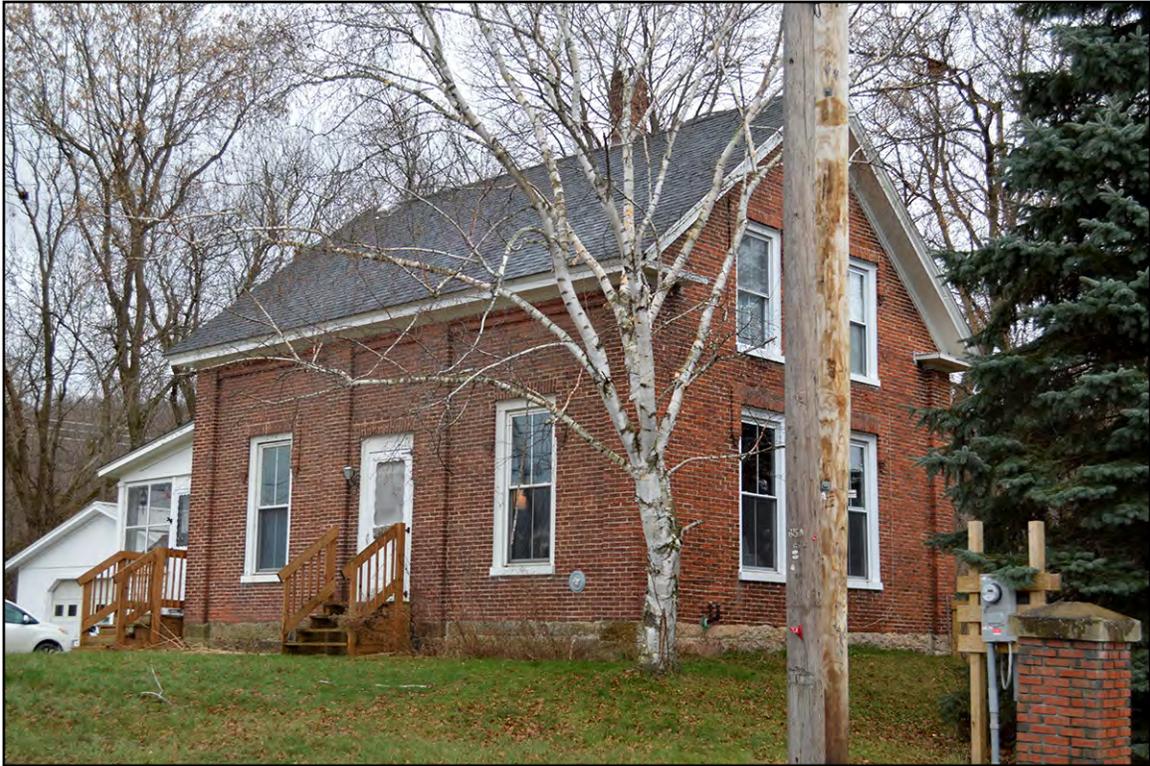
The Bascom House is a ca. 1870 one-and-one-half-story side-gable Classic Cottage faced in running bond that rests on a stone foundation. The asphalt-shingle roof is pierced by a central ridgeline brick chimney and has a molded cornice with returns. The corbeled frieze and pilasters, which unevenly divide the three-bay façade, mirror those of the neighboring Old Pelkey Farm house. The Italianate details are intimated by flat brick drip molds with terminating corbels heading four-over-four double-hung sash windows and the central entrance. The east elevation has an enclosed shed-roof porch with large fixed four-light windows and a clapboarded apron. Wood stairs lead to the primary and porch entrances.

PLATE 42: Bascom House, 460 Lake Road, St. Albans, Looking Southeast

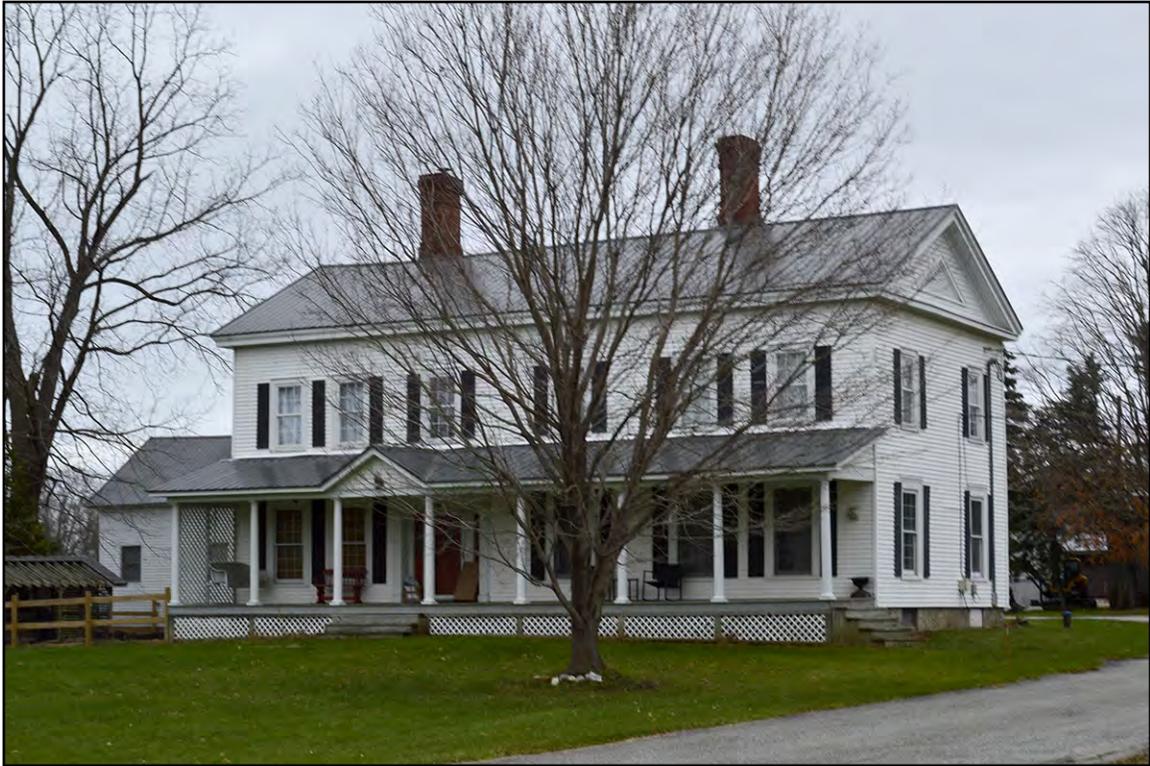
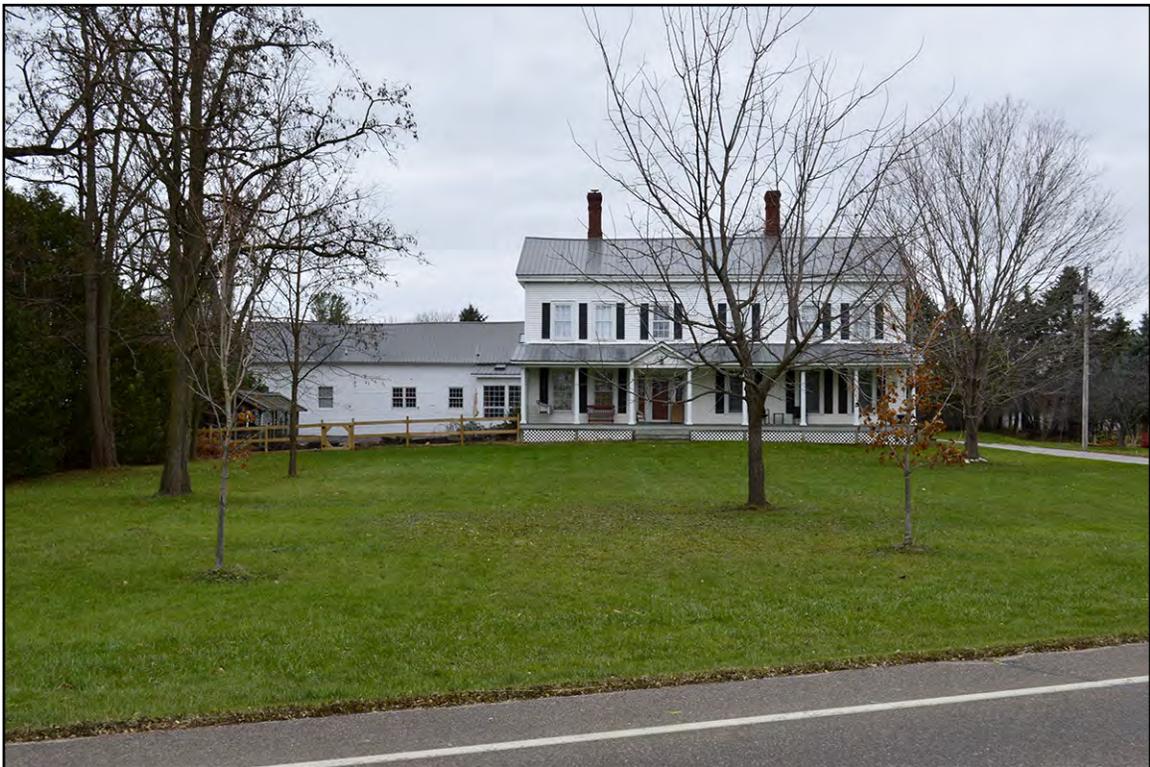
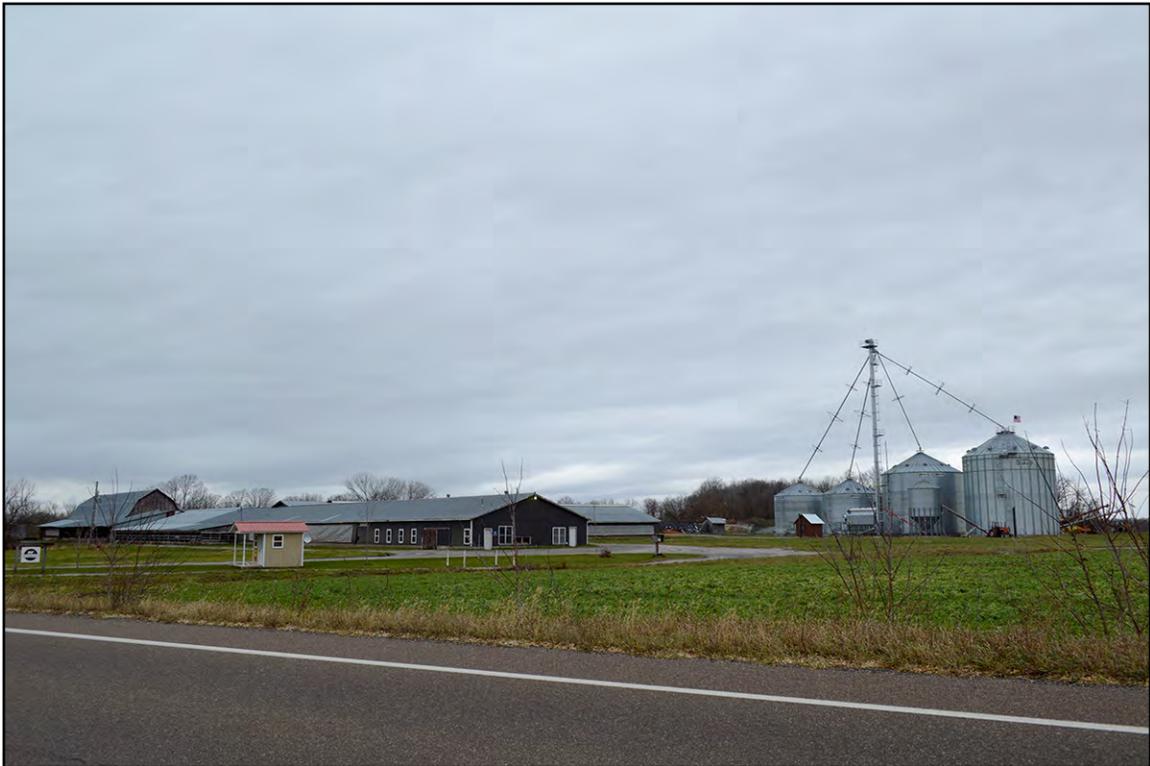
PLATE 44: Burton-Guay-Boissoneault Farm, 549 Lake Road, St. Albans, Looking Northwest

Greek Revival sash configurations and the lintels are intact. Furthermore, the outbuildings are not associated with nineteenth-century agricultural practices and have been recently altered or constricted, specifically the grain bins. As a result, in WSP's opinion the Burton-Guay-Boissoneault Farm is not eligible for listing in the NRHP under the Agricultural Resources of Vermont MPDF.

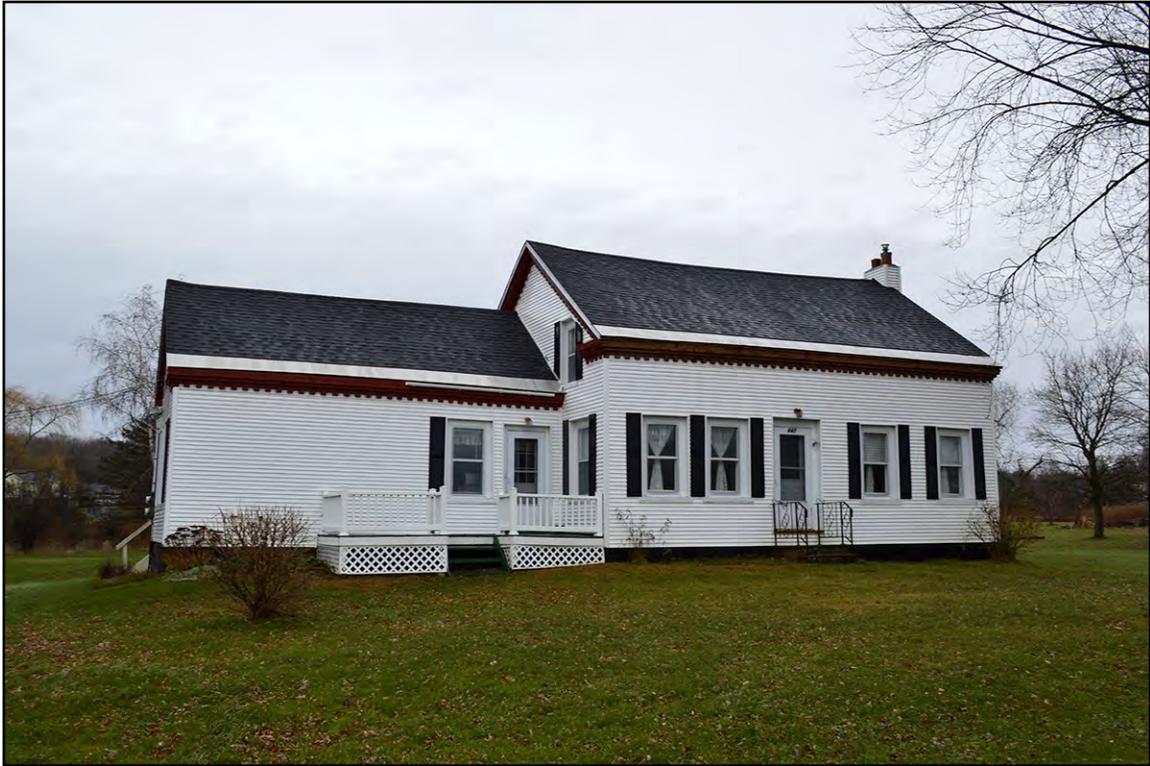
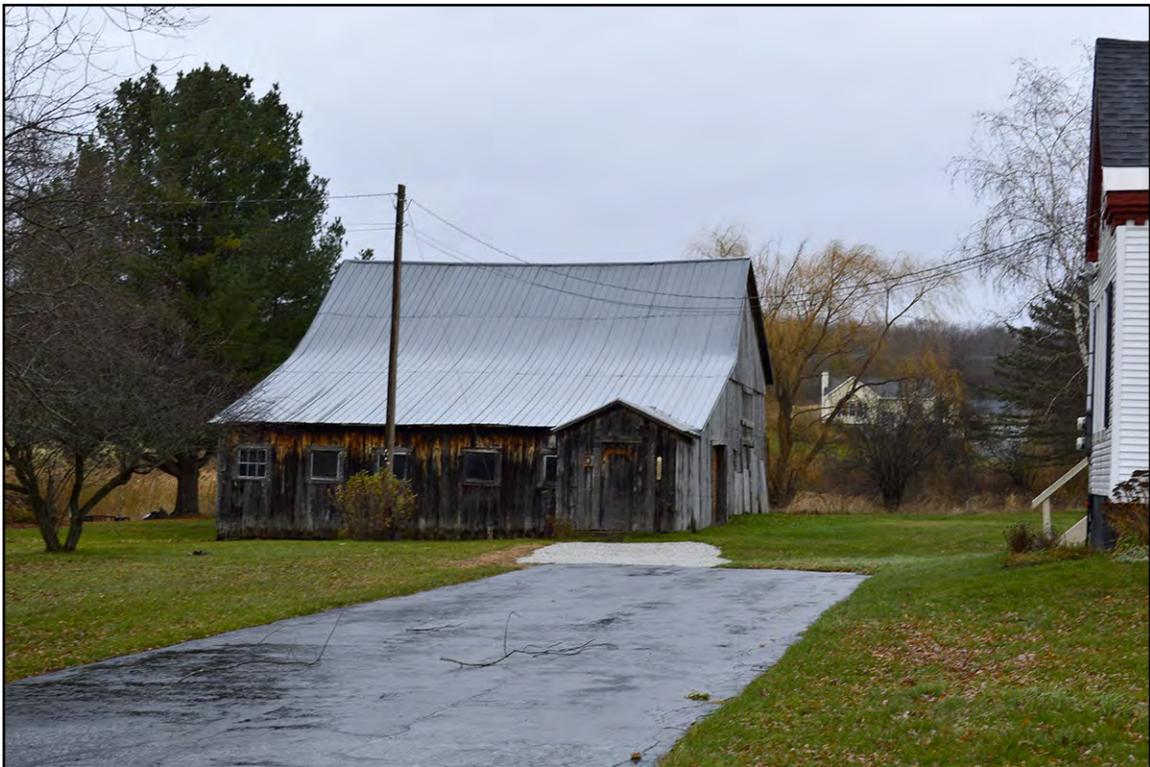
PLATE 51: Bronson-Wakefield House, 847 Bronson Road, St. Albans, Looking Northwest

The ca. 1840 Bronson-Wakefield House stands one and one-half stories tall on a poured concrete foundation. The side-gable brick house has an asphalt-shingle roof with a potted gable-end chimney clad in siding. Aluminum siding covers the irregularly spaced five-bay façade except for the returning brick cornice and frieze corbeling. The modern one-over-one windows have lug sills and are slightly recessed within simple casing. The materials and fenestration of the one-story wing mirror the main block. The door at the wall junction opens to a porch with railings and lattice skirting. Located immediately west of the house is a front-gable Early Barn with a corrugated-metal roof and vertical-board sheathing. The road-facing eaves end has a shed-roof addition and vestibuled entrance.

Changes to the house since the VDHP (1985) survey include replacement windows, aluminum siding, and wing porch. These drastic alterations have compromised the house's integrity, and it no longer represents a rural Classic Cottage with restrained vernacular Greek Revival details. As a result, in WSP's opinion the Bronson-Wakefield House is not eligible for the SR/NRHP.

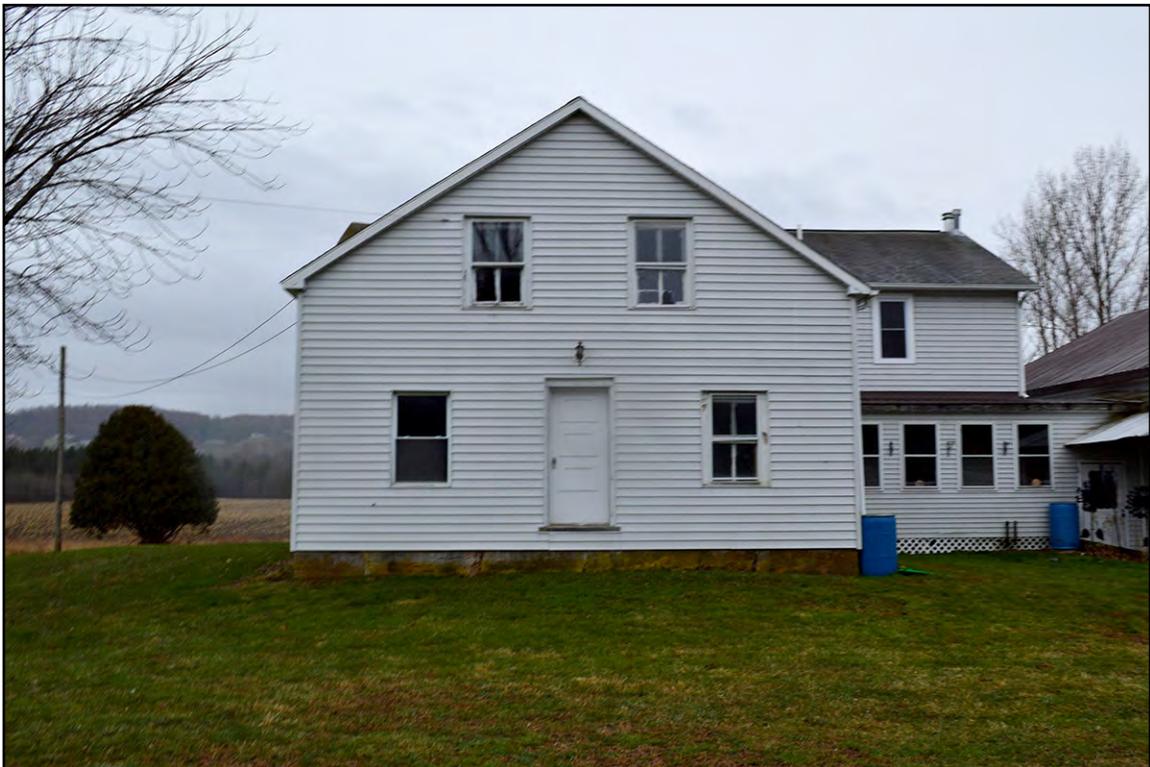
PLATE 53: Smith-Stevens House, 742 Bronson Road, St. Albans, Looking East-Northeast

The ca. 1850 Smith-Stevens House is a broad front-gable residence standing one and one-half stories tall on a stone foundation. The symmetrical three-bay façade retains most of the historic four-over-four double-hung sash windows. The asphalt-shingle roof has a shallow boxed cornice. The ca. 1975 rear cross-gable two-story ell has modern one-over-one windows and an octagonal window near the wall junction. The south gable end has an external truncated chimney topped by steel pipes. A shed-roof enclosed porch extends across the wing and joins a large modern two-bay garage. The house is entirely clad in vinyl siding. The sole outbuilding is a small shed southeast of the house.

Major alterations to the house since the VDHP (1985) survey include modern exterior fabric, windows, and garage. The replacement siding obscures the brick exterior and Greek Revival traits such as the corbelled eaves, cornice returns, and rectangular lintels. These changes have undermined the house's integrity. Therefore, in WSP's opinion the Smith-Stevens House is not eligible for the SR/NRHP.

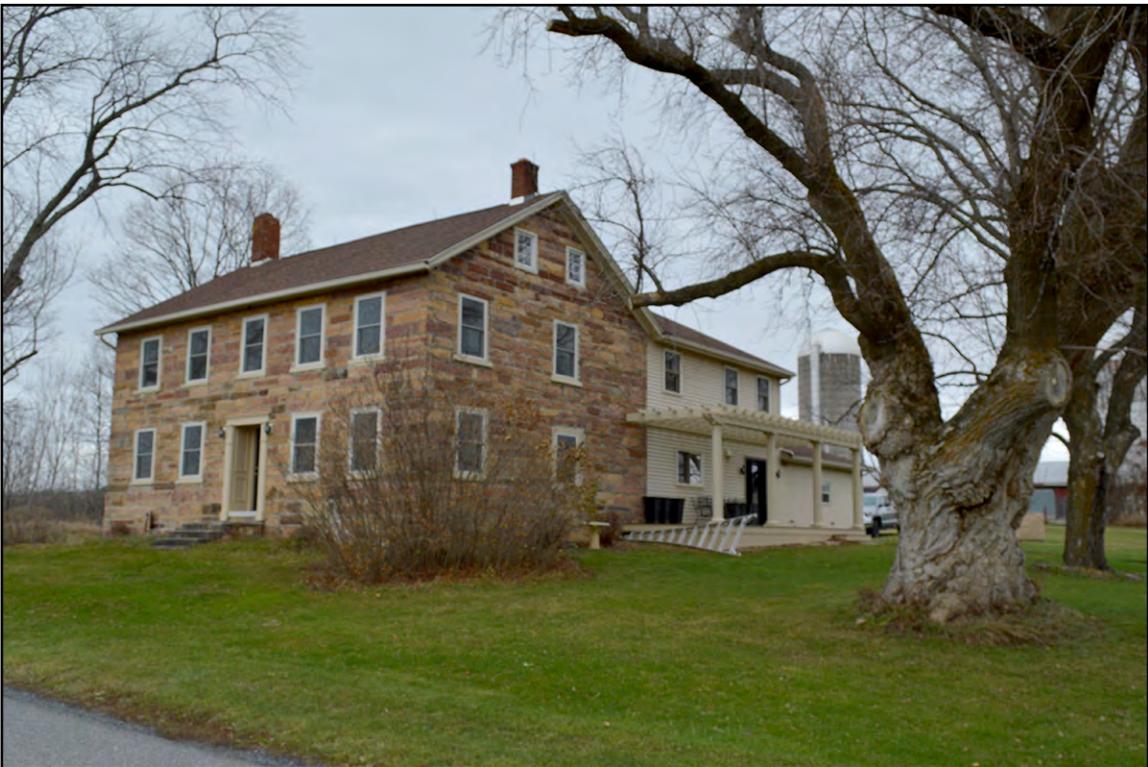
PLATE 56: Georgia Poor Farm, 846 Mill River Road, Georgia, Looking Northeast

The Georgia Poor Farm is anchored by a ca. 1828 two-story double-pile residence resting on a stone foundation. The load-bearing masonry Georgian-plan house has an asphalt-shingle side-gable roof with a molded cornice and brick gable end chimneys. The exterior is clad in locally quarried coursed rough-cut stones sized to distinguish structural elements: large (foundation); medium (wall planes); medium rectangular (lintels); and narrow (stringcourse). The symmetrical five-bay façade is opened by modern six-over-six double-hung sash windows in simple casing with lug sills. Both gables have small paired four-light windows. A Connecticut River Valley doorway surmounts fluted pilasters flanking the central recessed entrance. The two-story hipped-roof rear ell has a garage addition.

The alterations since the VDHP (1985) survey involve the replacement windows and the faux doorway surround. The latter component is historically, architecturally, and geographically incompatible. The style of doorway is unique to the region for which it is named, nearly 150 miles to the southeast, and is a Georgian feature, a style that predates the house by 70 years, both of which are only extant in southern Vermont. The modern windows honor Federal light configurations, and the frontispiece minimally impacts the overall form and materials of the house; however, the modern outbuildings, especially the Quonset hut, detract from the property's character as an 1820s farmstead. The farmhouse has good integrity and is a rare example of a rural vernacular farmhouse built with locally quarried stone. Therefore, in WSP's opinion the farmhouse should remain listed in the SRHP but the Georgia Poor Farm is not eligible for listing in the NRHP under the Agricultural Resources of Vermont MPDF.

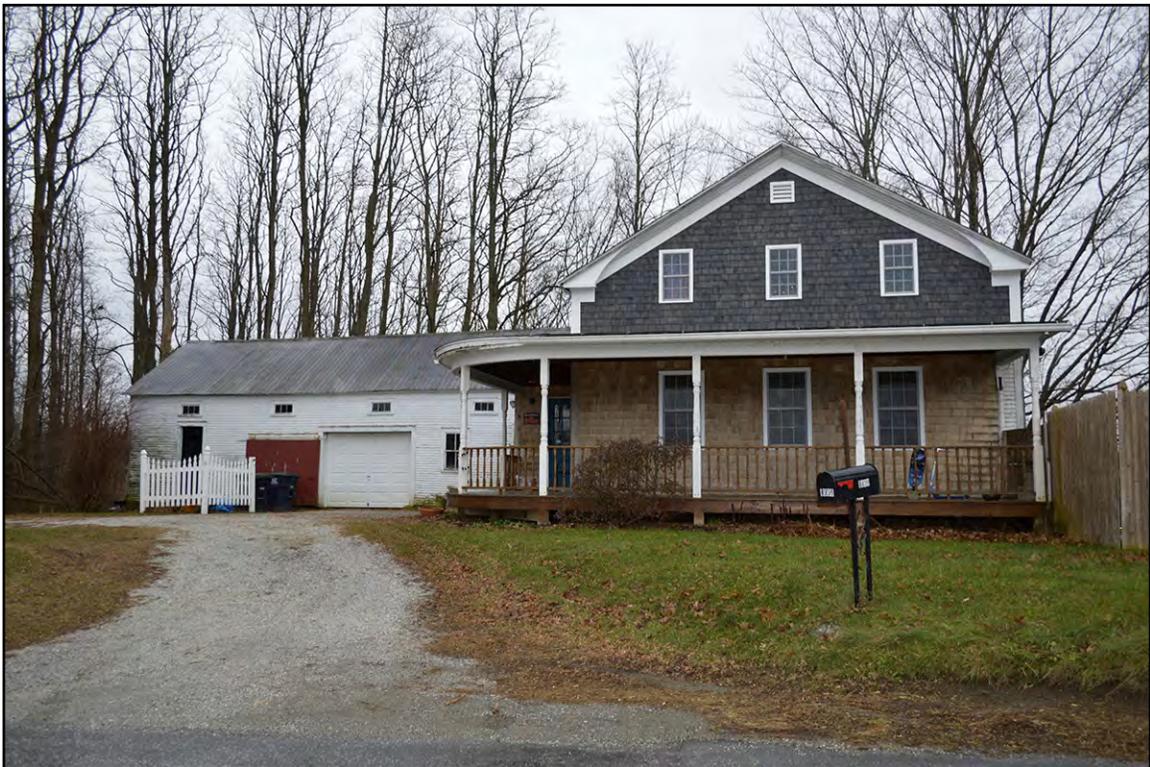
PLATE 60: Meigs-Armstrong House, 1039 Mill River Road, Georgia, Looking Southwest

The ca. 1865 Meigs-Armstrong House is a front-gable residence that stands one and one-half stories tall on a stone foundation. The dwelling's Statement of Significance in the VDHP (1980) survey notes its curved L-shaped metal-tiled roof porch with spindle work valance and railing: "This sound vernacular building has a very unusual and beautiful curve porch exhibiting masterful carpentry work. There are none like it in Georgia and probably very few in the region." Since then the valance has been removed and the railing replaced, and like the house's main roof, the porch roof is now covered with asphalt shingles. The house's central entrance has been removed, and an enclosed foyer built under the porch. Originally clapboarded, the house is now clad in novelty wood-shingle siding. All of the windows have also been replaced, and the cornice return eaves have been altered. The interior end brick chimney at the rear of the house remains, but the others have been removed.

A large side-gable attached carriage barn is located at the southeast corner of the dwelling. The barn is five bays wide with clapboard siding and metal roofing. Part of the sliding barn door entrance has been replaced with a modern steel garage door, but the rest of the fenestration appears to remain intact with two-over-two double-hung wood windows on the main level and three-light kneewall windows.

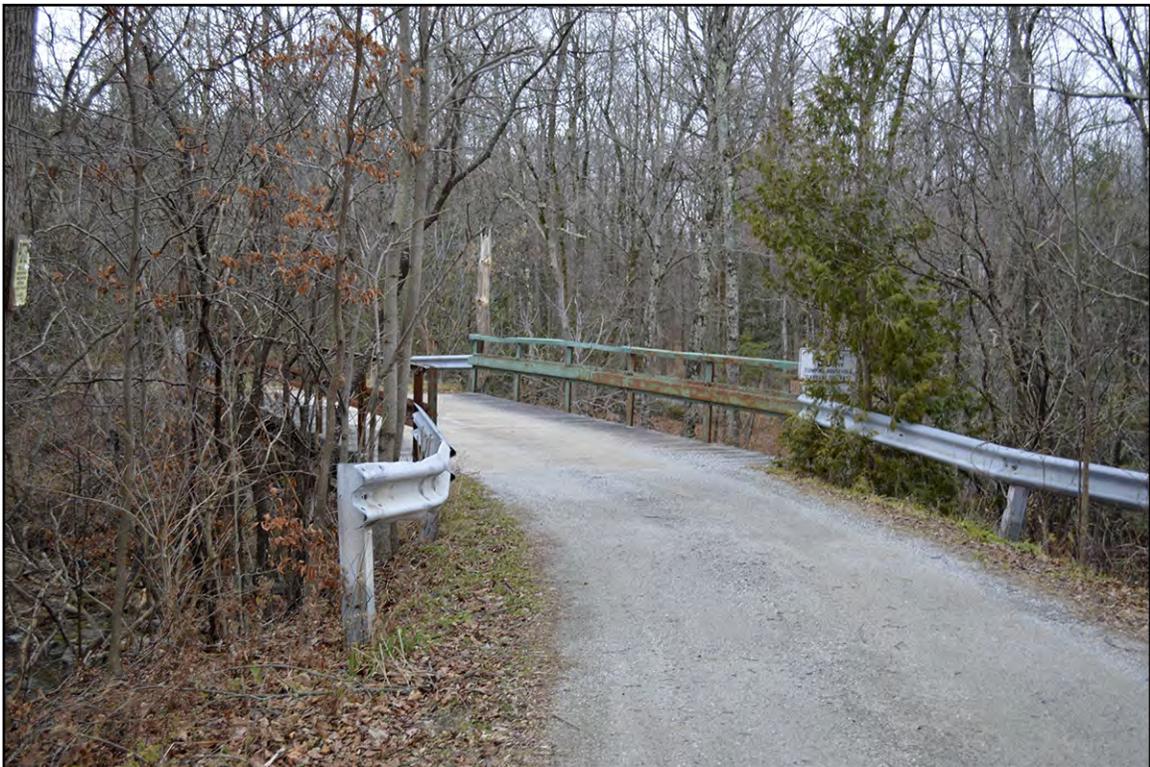
PLATE 62: Pony Truss Bridge, Falls Road over Mill River, Georgia, Looking North

The 1906 pony truss bridge is located on Falls Road, spanning the Mill River. The steel guardrails have a top chord with vertical posts and a center rail. The rolled I-section floorbeams are covered with a wood-plank deck surface. The stacked rubble abutments appear to have been recently repaired with concrete patching and a poured concrete base on the south abutment.

Changes to the bridge since the VDHP (1985) evaluation include the removal of the diagonal eye bars and inclined end posts and replacement with modern steel guardrails, as well as concrete patching of the abutments. The bridge is significant as a transitional type, using the standard Pratt truss type but also pinned connections, which by that date had fallen out of use in favor of welded connections. The bridge, although no longer a Pratt truss, remains a good example of a once ubiquitous pony truss bridge type. In WSP's opinion, the bridge retains sufficient integrity to remain listed in the SRHP but, because of the alterations, the bridge is not eligible for the NRHP.

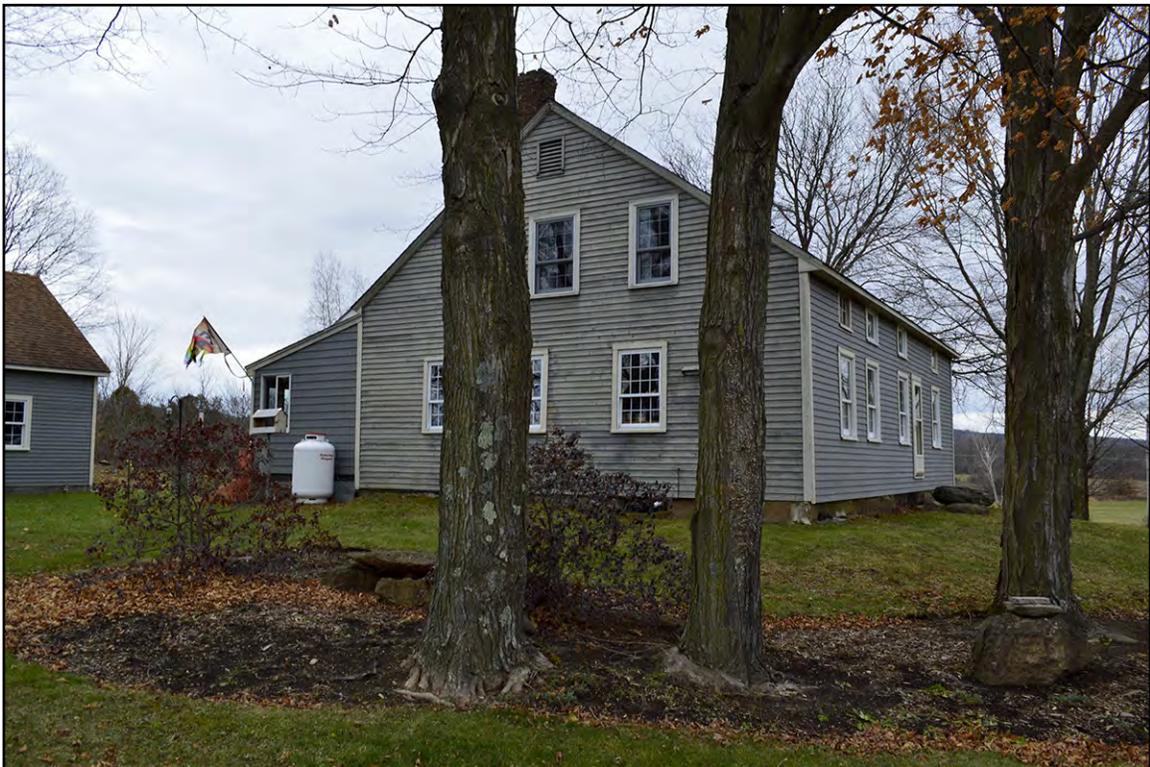
PLATE 65: Reuben Evarts House, 2143 Polly Hubbard Road, Georgia, Looking North

The ca. 1788 Reuben Evarts House is a massed side-gable residence that stands one and one-half stories high on a stone foundation. The utilitarian house has an asphalt-shingle gable roof with opposing gable end corbelled brick and cinderblock chimneys. The clapboarded asymmetrical five-bay façade has 12-over-eight double-hung sash windows. Thin cornerboards carry a molded cornice. Each window has a

corresponding six-light attic awning. The first-floor gable end windows are modern replacements with light configurations mirroring the façade fenestration. On the second story, the first and third bay windows are nine-over-six double-hung sashes. The windows and off-center primary entrance are framed in plain wood surrounds. A shed-roof addition is located on the rear façade.

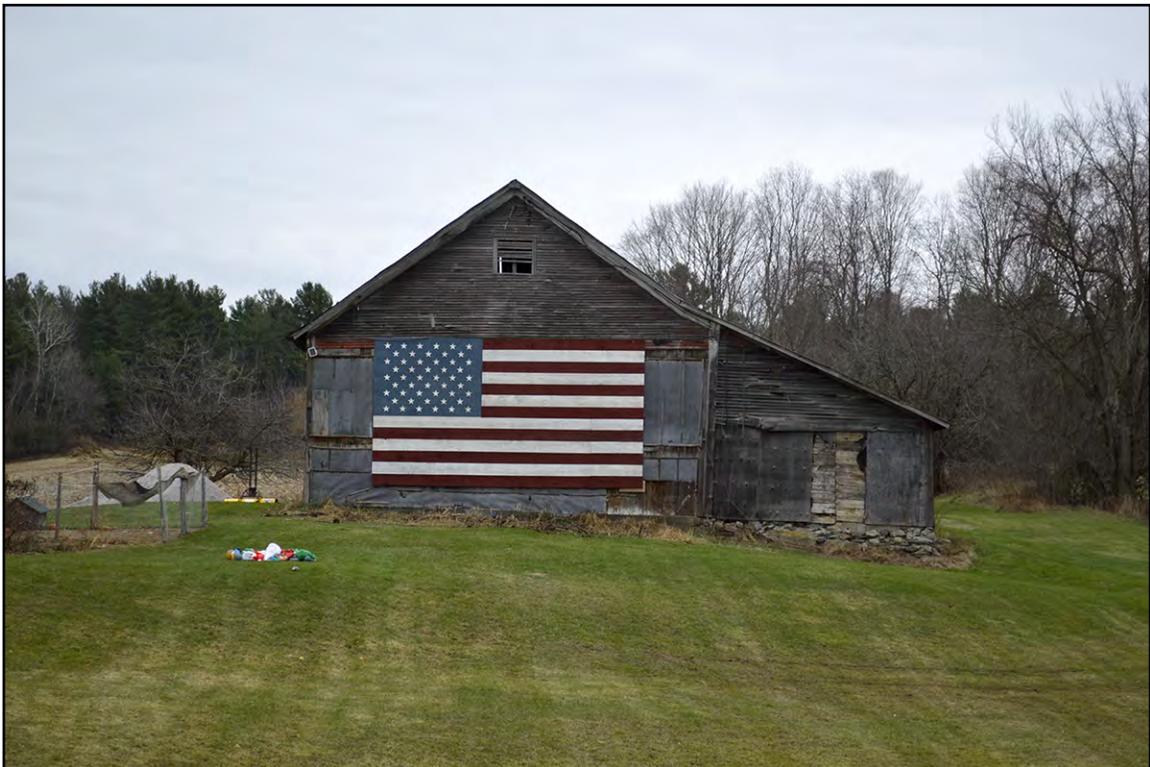
PLATE 86: Dutton-Wimble House, 976 Sodom Road, Georgia, Looking Northeast

A late nineteenth-century gable roof barn is located southeast of the house, with a cow stall added in 1964. A large modern one-and-one-half-story garage with a poured concrete foundation has been recently constructed behind (east of) the dwelling.
